Bridge Inspection Report

US 80

CHUNKY RIVER
LAUDERDALE County

- INSPECTION DATE 04/20/2023
- STRUCTURE NUMBER 210008003812330
- BRIDGE ID 12377

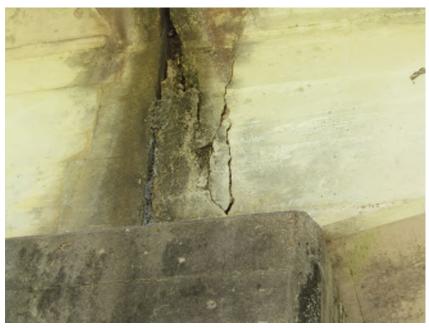
Girders: Fair beam 1 at span 3,3 delams and 1 spall exposed rebar, beam end spalled b-2

span 2 beams 1 and 2,b-3 span 3 beams 1 and 3,b-4 span 4 beams 1 and 3,b-8 span 8 beam 1,b-9 span 8 beam 1,b-10 span 10 beams 1 and 3,4'

PHOTO 1 General, Superstructure Description back of beam end spalled

- 1. REPAIR BEAM ENDS
- 2. REPAIR JOINTS OVER BENTS 6 AND 7

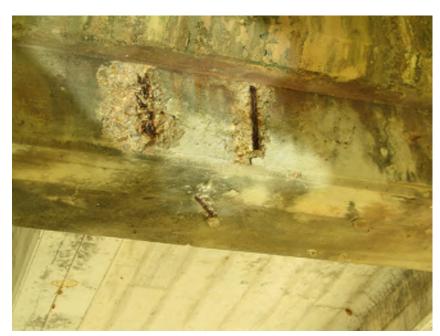
beams 3 and 4 2'x1', exposed rebar in face of cap b-4 span 4

PHOTO 2 General, Substructure Description exposed rebar in face of cap

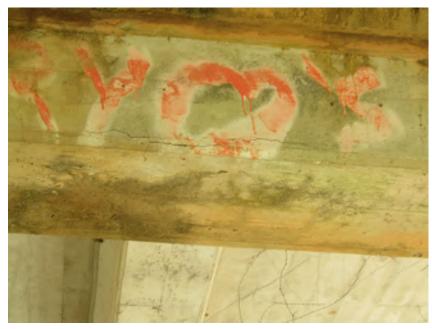
horizontal crack in beam 3 span 5, span 9 beam 3 12' horizontal crack

РНОТО 3 General, Superstructure Description horizontal crack in beam

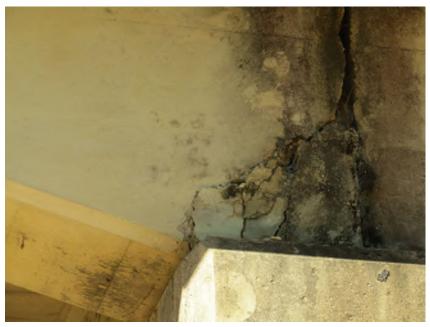
PHOTO 4 General

back of beam end spalled Description

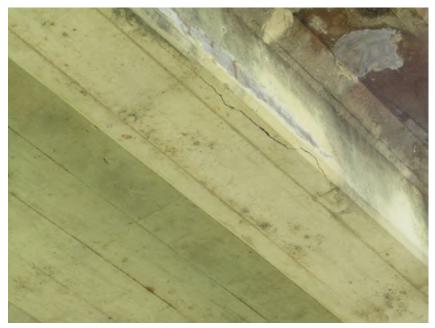
PHOTO 5 General

Description horizontal crack in beam

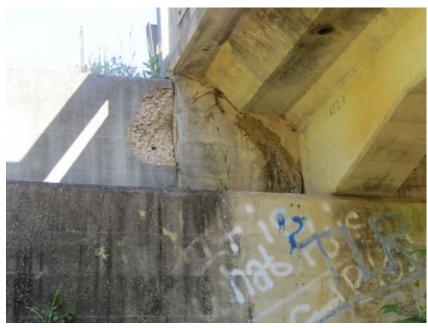
Backwall: Good spall sw corner 3'x1'

PHOTO 10 General endwall spalled Description

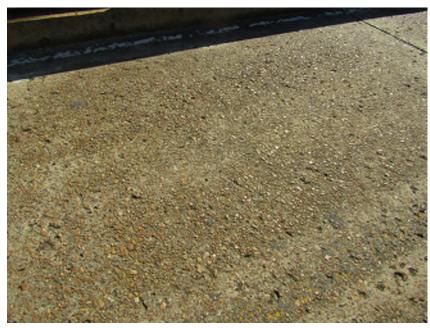
bridgerail post coll. damage at bent 2,b-e north side,heavy deck scaling,

PHOTO 12 General deck scaling Description

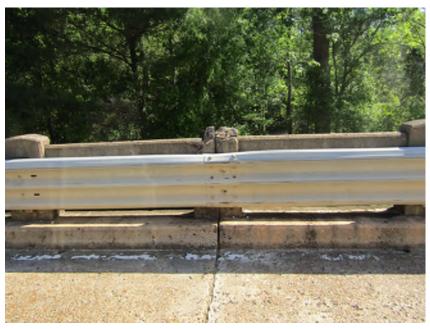
Structure: Fair curb below bridgerail spalled at b-5 north side, spalled at b-3 north side, top of

PHOTO 13 General

Description top of bridgerail spalled

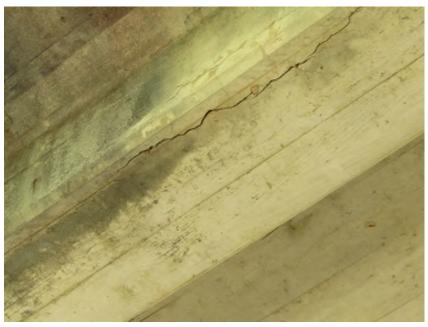
PHOTO 14 General

Description horizontal crack in beam
