Bridge Inspection Report

SR 29

FLYNT CREEK

- INSPECTION DATE
10/27/2022
- STRUCTURE NUMBER
310002906600120
- BRIDGE ID
14535

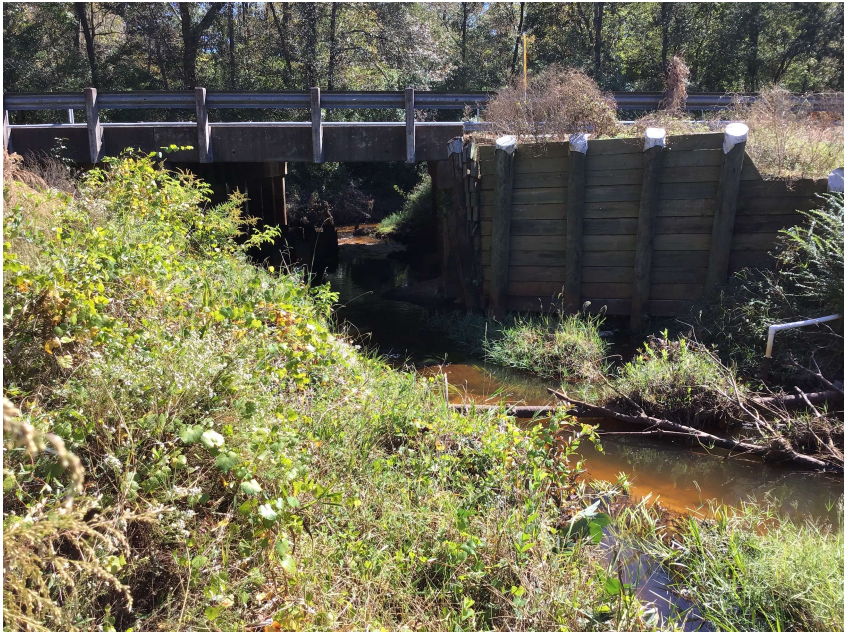
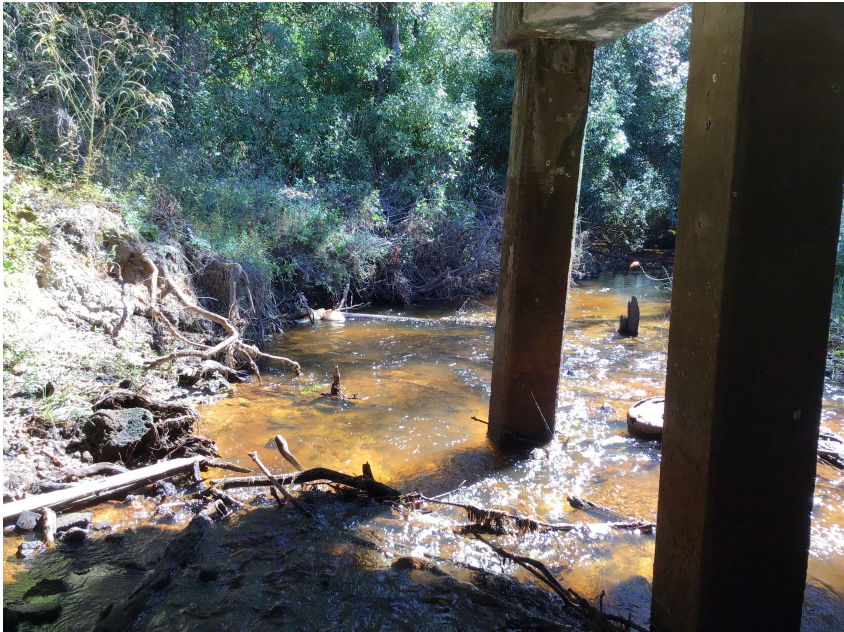
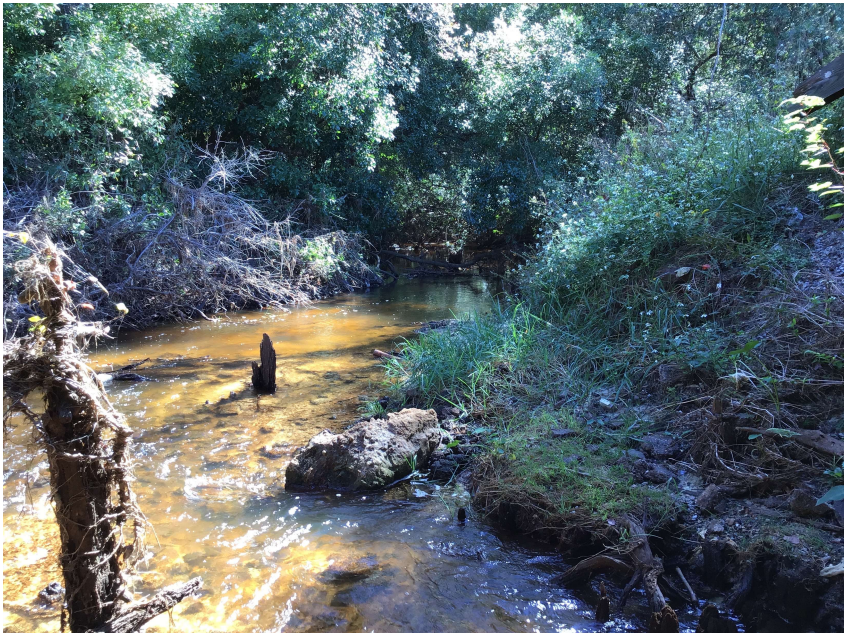
DESIGN MAIN CHANNEL SPAN		CURRENT MAIN CHANNEL SPAN
BANK CONDITION-UPSTREAM	Fair	Minor bank slumping.
BANK CONDITION-SITE	Poor	Minor bank erosion and slumping. The South abutment is encroached into the channel. The North abutment is exposed to the channel during a high water event. With the decay of the timber wing walls, fill material is spilling through and allowing roadway settlement.
BANK CONDITION-DOWNSTREAM	Fair	Minor bank slumping. Grassing in the channel is restricting channel flow.

PHOTO 3 Channel
Description Looking downstream

PHOTO 13 Channel
Description Looking downstream

PHOTO 16 Channel
 Description Looking downstream

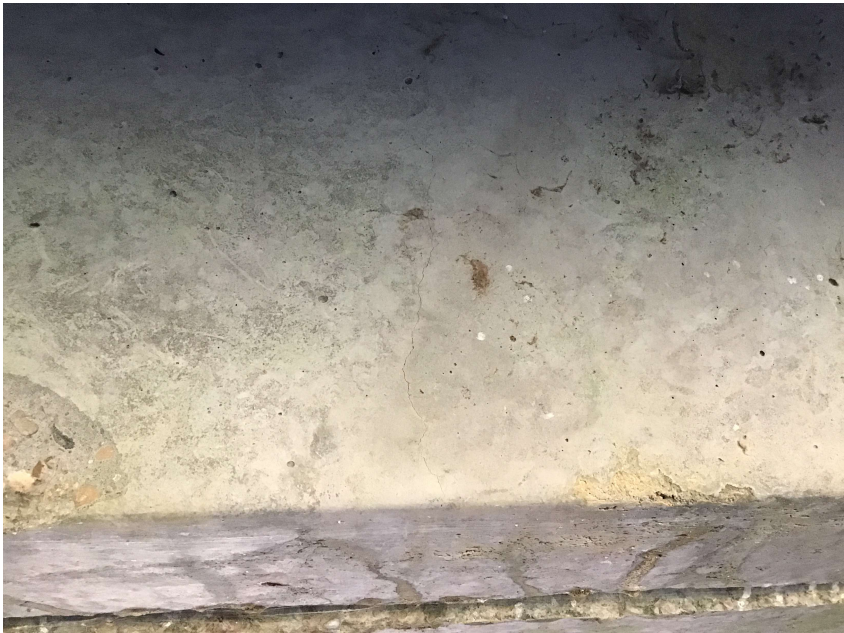
Channel Beams: The channel beams are in overall good condition. The top flange of the channel beams has an asphalt overlay and couldn't be inspected. Minor flexure cracks in the webs of the channel beams. Minor spall in the channel beam located above pile 6 of bent 1. Small spalls with exposed rebar in the channel beams located above bent 2. Spall with some exposed rebar around the connection bolts of the beams located above bent 2.

<u>Condition</u>	<u>Notes</u>
Girders:	Good	Very minor flexure cracks in the channel beams. Spall in channel beam above pile 6 of bent 1.
Floor Beams:	NA	
Stringers:	NA	
Steel Risers:	NA	
Bearings:	NA	
Hinge Pins/Hangers:	NA	
Diaphragms/Cross Frames:	Good	Spalls with some exposed rebar around the connection bolts at bent 2.
Paint:	NA	
Collision Damage:	NA	
Deflection/Vibration:	Good	
Cap/Girder Debris:	Good	
Navigation Lighting:	NA

PHOTO 4 Superstructure
Description Typical cracks in channel beams

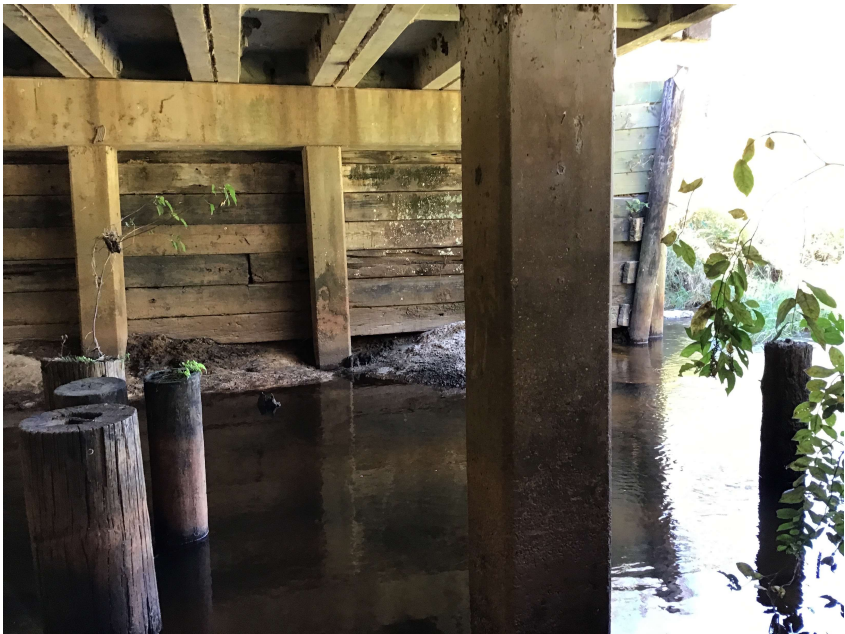
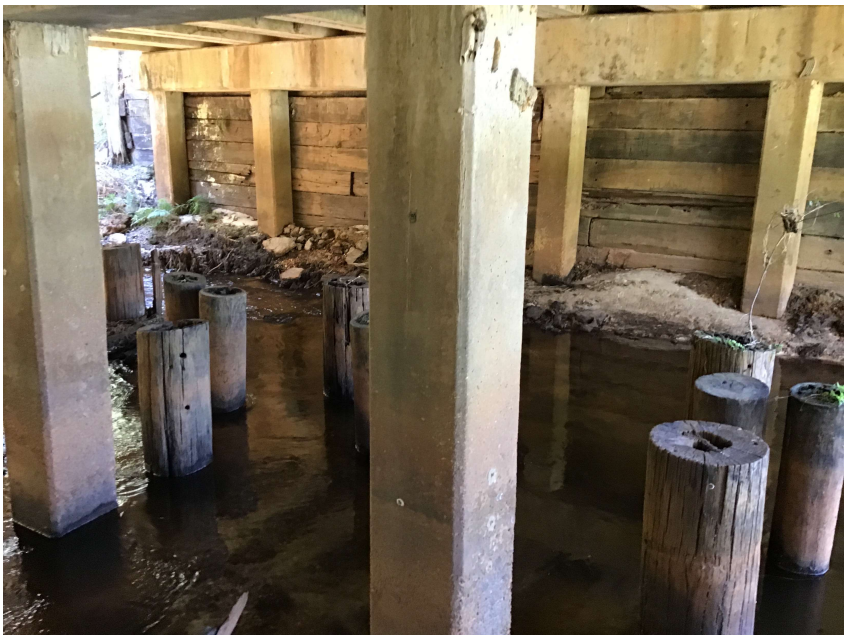
Substructure: The substructure is in overall fair condition. The bulkheads at both abutments have moderate to severe decay issues. The timber wingwalls have settled and have minor to moderate decay issues. The decay has allowed fill material to spill through causing roadway settlement. The Southwest wingwall has been replaced. Spall in pile 5 of bent 1. The piles located in bent 2 have minor to moderate waterline abrasion issues.

<u>Condition</u>	<u>Notes</u>
Backwall:	NA	
Bulkhead:	Poor	Moderate and severe decay in both bulkheads.
Wing Walls:	Poor	All timber wing walls are settling, and have decay issues. Southwest wing has been repaired.
Cap:	Good	
Footings:	NA	
Piles:	Good	Spall in pile 5 of bent 1
Embankment:	Fair	Minor slumping and erosion issues.
Slope Paving:	NA

PHOTO 5 Substructure
Description South abutment

PHOTO 6 Substructure
Description South abutment

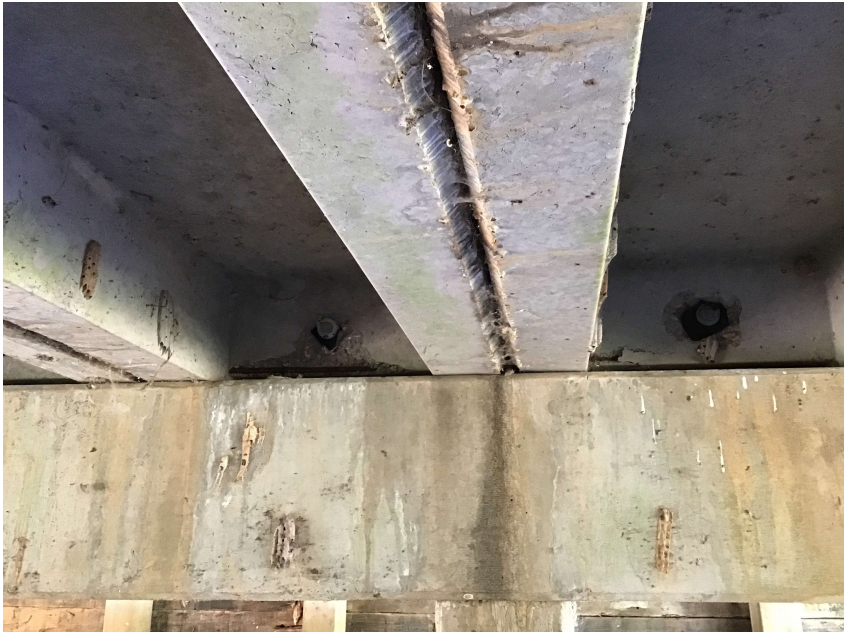
PHOTO 7 Superstructure
Description Typical spalls with exposed rebar

- Spalls in the channel beams need to be patched.(Not complete)
 - Spall in pile 5 of bent 1 needs to be patched.(Not complete)

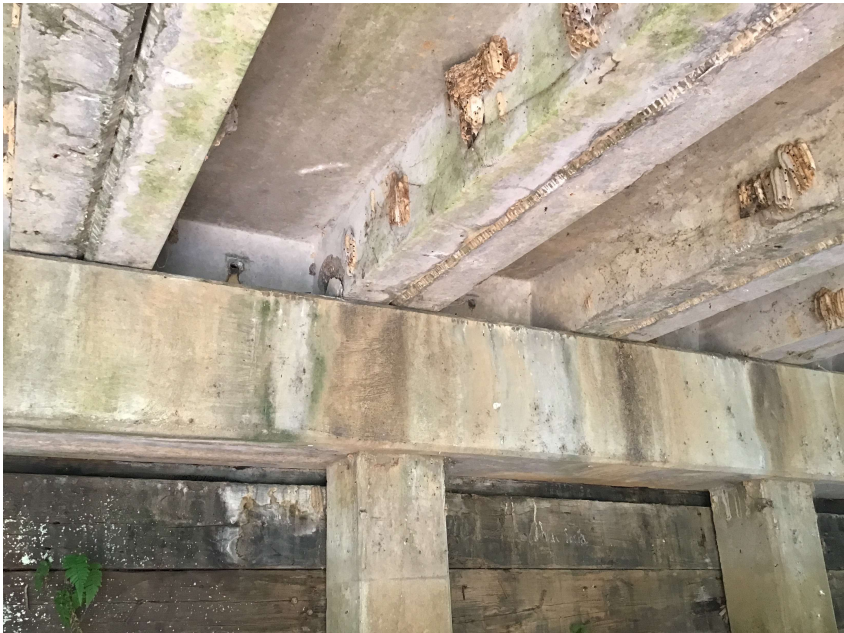
PHOTO 8 Superstructure
Description Minor spall in channel beam above pile 6 bent 1

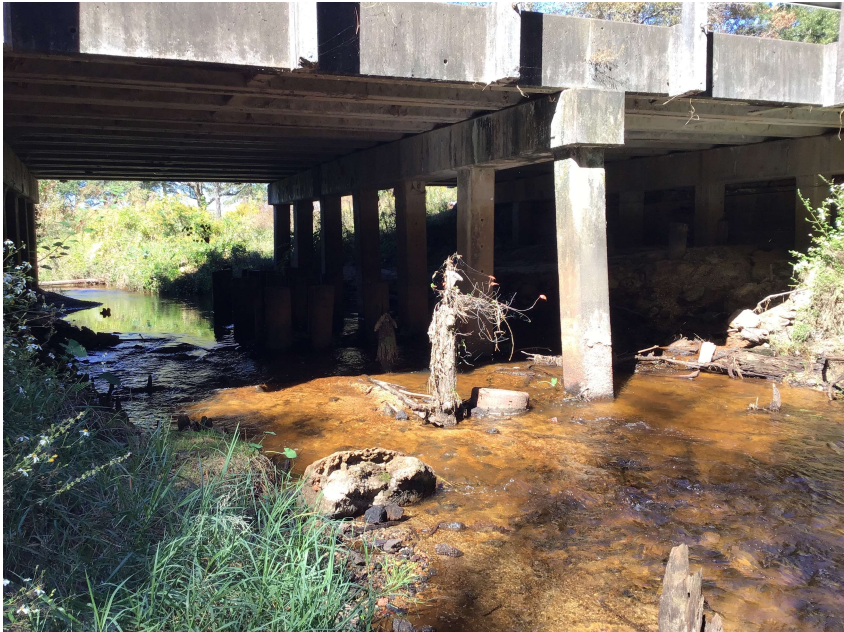
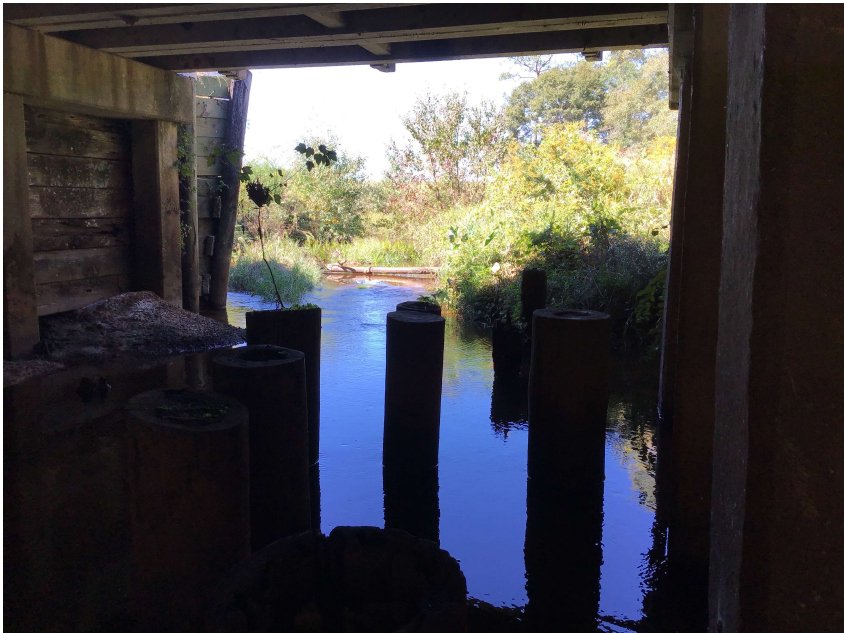
PHOTO 9

Looking upstream

PHOTO 14 Channel
Description Looking upstream

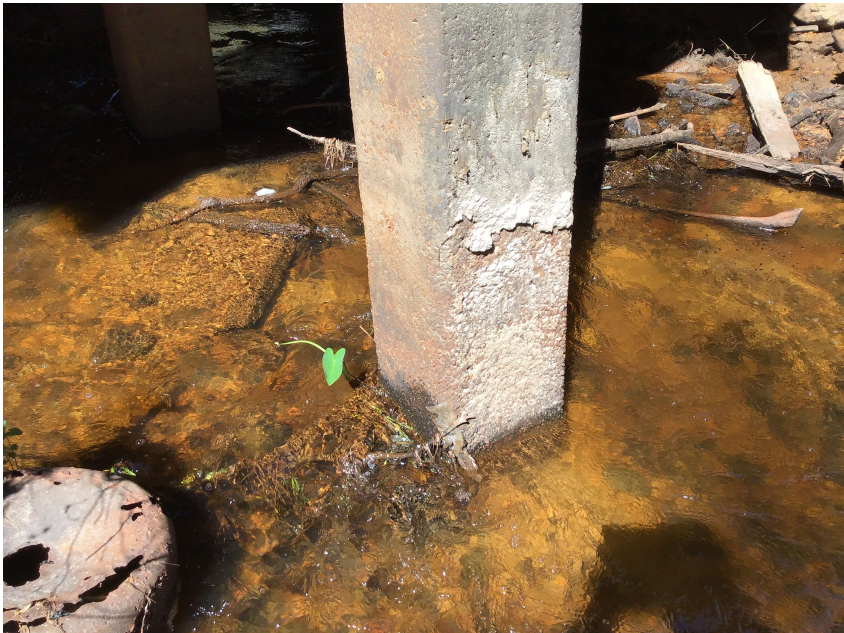
PHOTO 10

<u>Condition</u>	<u>Notes</u>
Cap:	Good	
Risers:	NA	
Columns/Piles:	Good	Piles located in bent 2 have minor to moderate waterline abrasion.
Footings:	NA	
Web Walls:	NA	
Bracing:	NA	
Pier Protection-Navigation:	NA	
Pier Protection Lighting:	NA

Typical waterline abrasion on piles bent 2

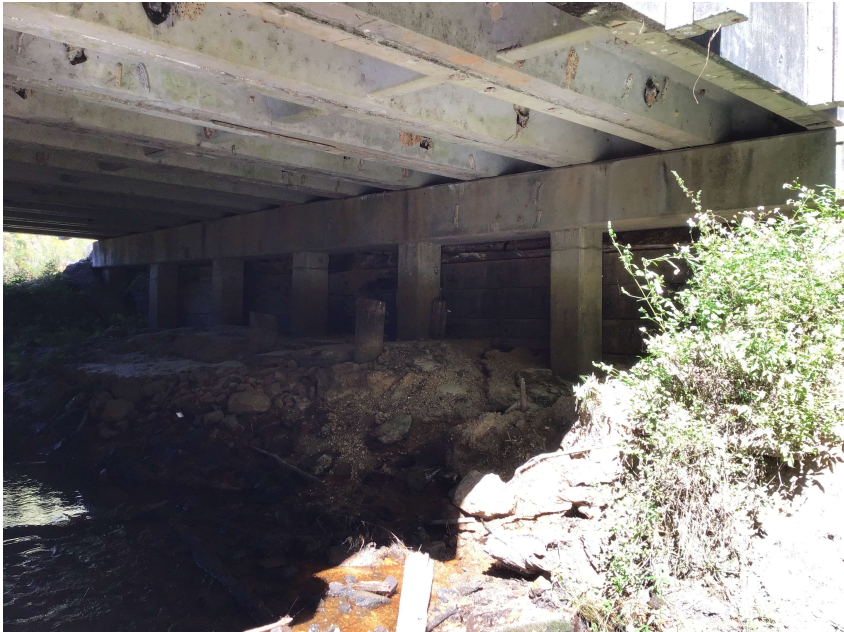
PHOTO 11 Substructure
Description North abutment

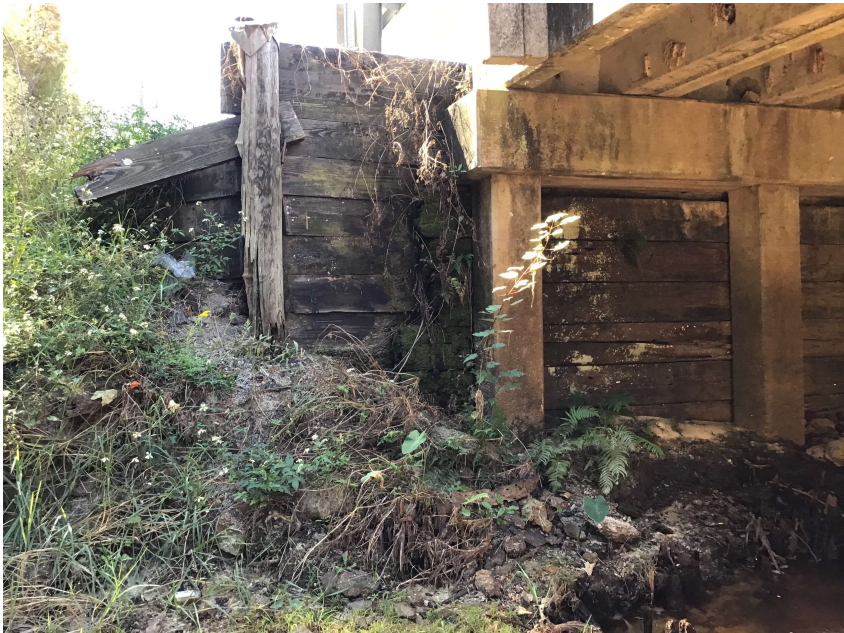
PHOTO 12 Substructure
Description Southeast wing wall

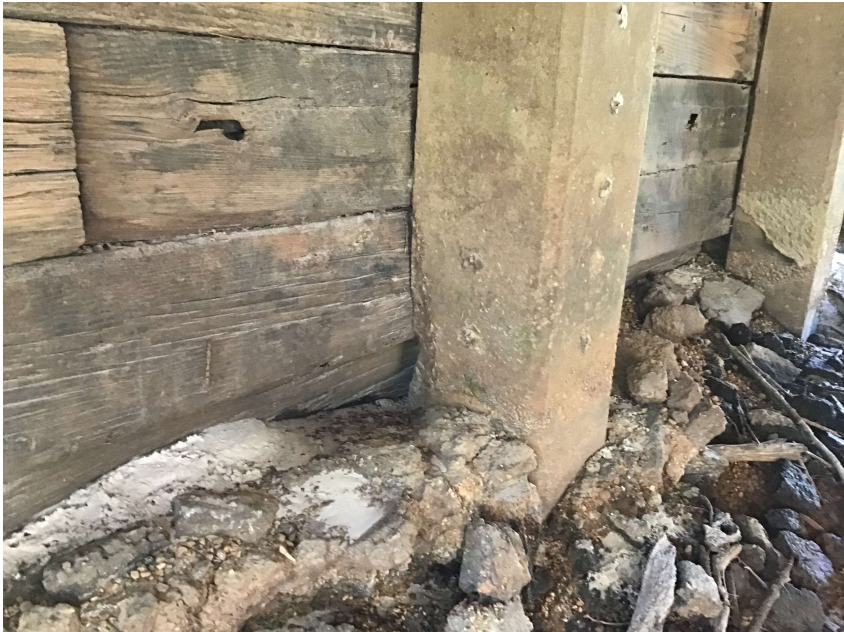
PHOTO 15 Substructure
 Description Spall in pile 5 of bent 1

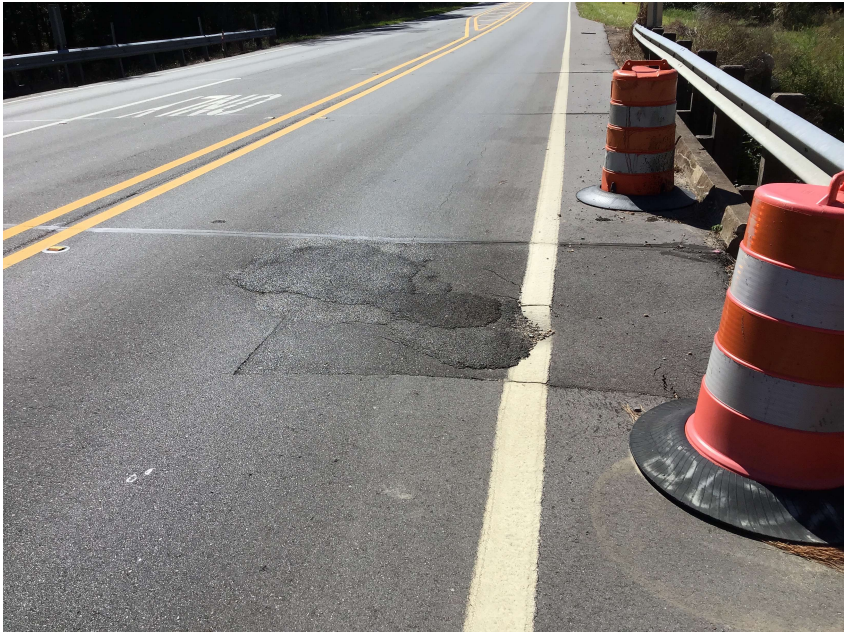
Appr Guardrail-rear Left Position	Good	
Appr Guardrail-rear Right Position	Good	
Appr Guardrail-forward Left Position	Good	
Appr Guardrail-forward Right Position	Good	
Appr Roadway Condition	Good	
Appr Roadway Transitions	Good	The roadway is settling at both approaches. Has been repaired since last inspection. Minor settling at Northwest approach.

PHOTO 19 Approach
 Description Settlement at Northwest corner of bridge

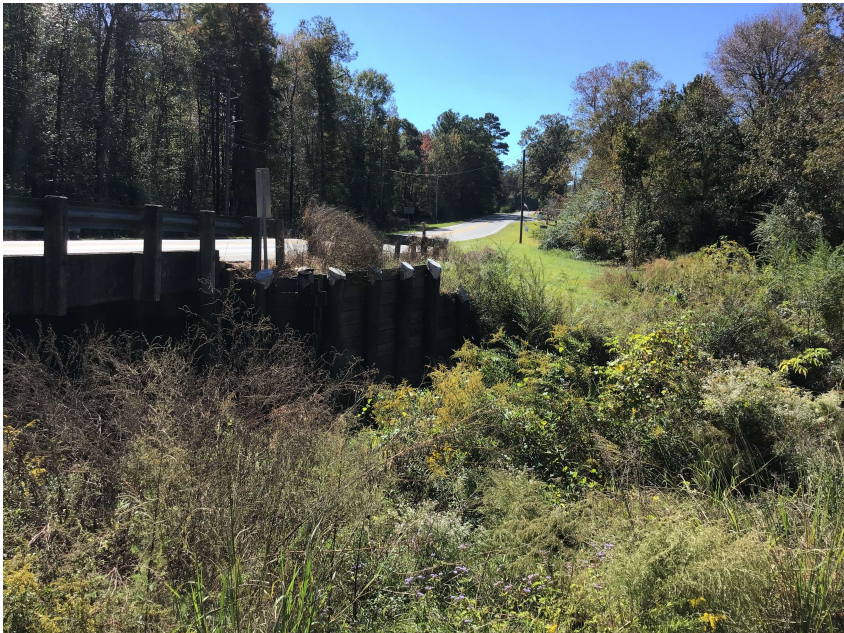
PHOTO 20 Substructure
 Description Southwest wingwall
