Bridge Inspection Report

US 80

CHUNKY RIVER NEWTON County

- INSPECTION DATE 02/14/2023
- STRUCTURE NUMBER 210008005112250
- BRIDGE ID 13542

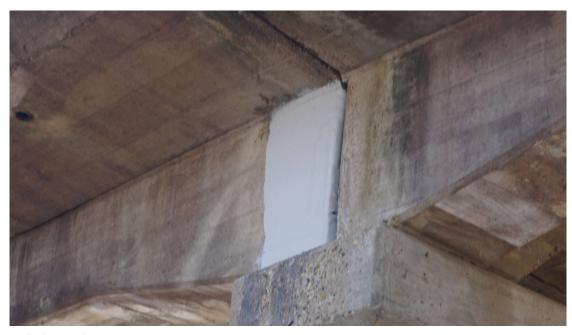
PHOTO 4 Superstructure

Description BEAM END REPAIR B-2

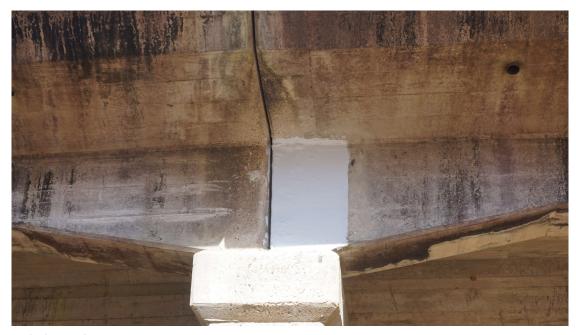
PHOTO 5 Superstructure

Description BEAM END REPAIR B-4

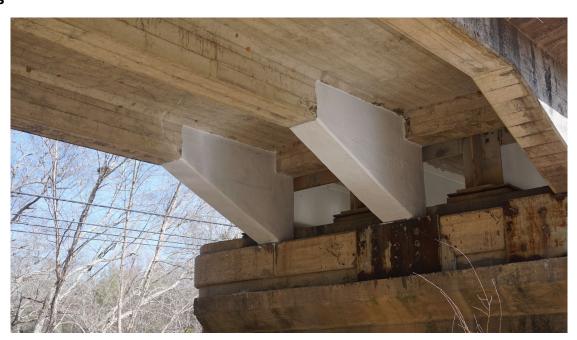
PHOTO 6 Superstructure

Description B-8 SPAN 8 BEAM 1 AND 2 REPAIRED

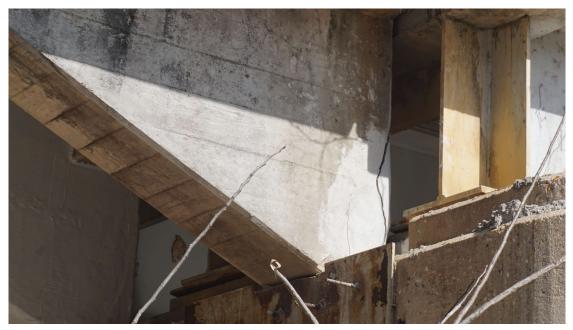
PHOTO 7 Superstructure

Description B-8 SPAN 8 BEAM 3 NOT REPAIRED, CRACK.

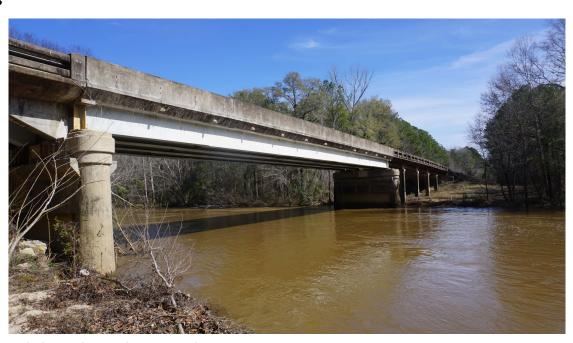
PHOTO 8 General, Substructure, Channel

Description DS

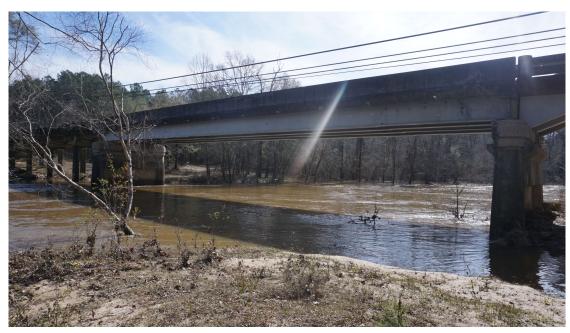
PHOTO 9 General, Substructure, Channel

Description US

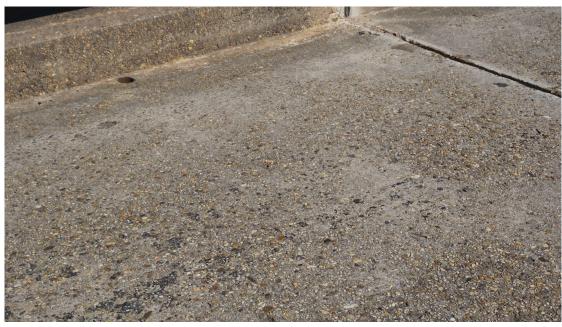
PHOTO 10 Deck

2.MOD. DECK CRACKING.

Description MOD. DECK CRACKING.

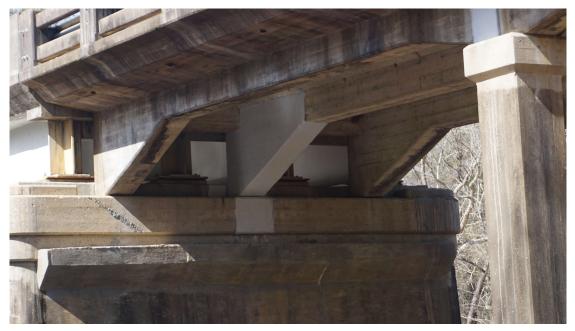
PHOTO 11 Superstructure

6.BEAM 2 AT **BENT 10, SPAN 10** HAS 3' HORZ./SHEAR CRACK, APPEARS TO GO ALL THE WAY THROUGH.

Description BEAM REPAIR. BENT 10
