**APPENDIX A**  
**LIT VOR SITE SURVEY REPORT**

**LIT VOR SITING REPORT  
LITTLE ROCK,  
ARKANSAS**

**PREPARED BY: SHELBY BOHMFALK  
(NAVAIDS LEAD ENGINEER)**

**TECH OPS – NAVAIDS DESIGN GROUP  
(08/24/2018)**

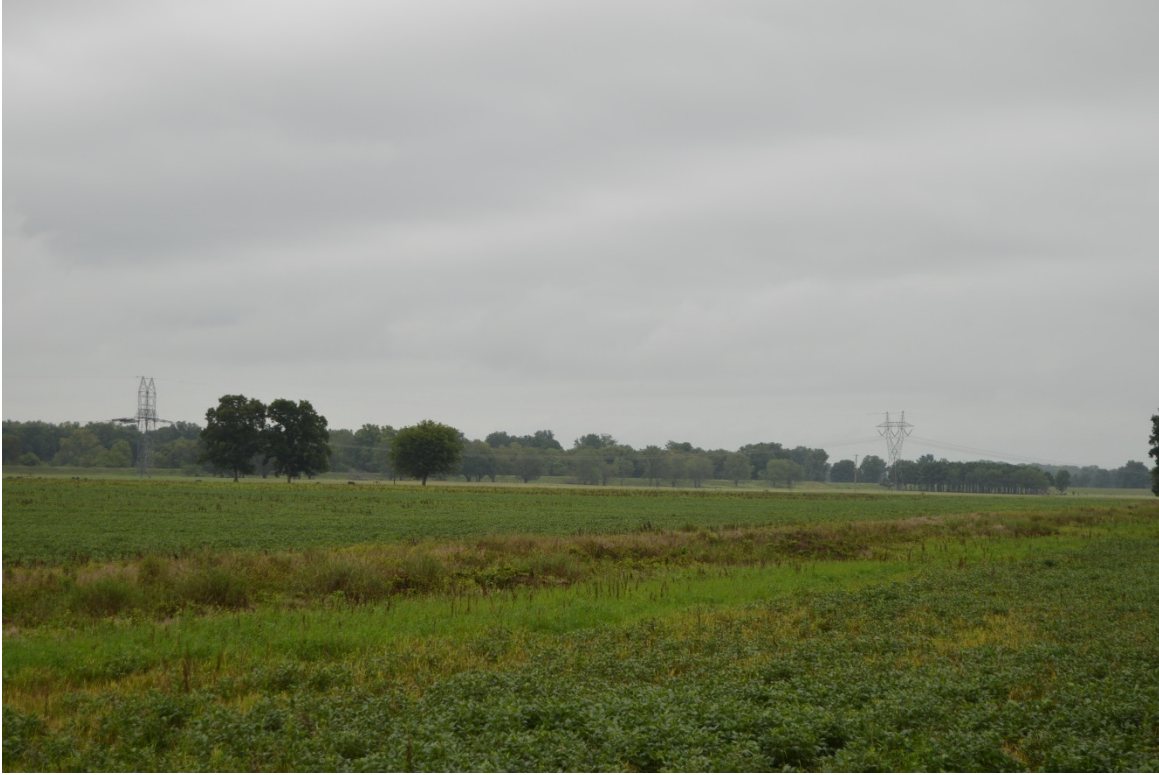
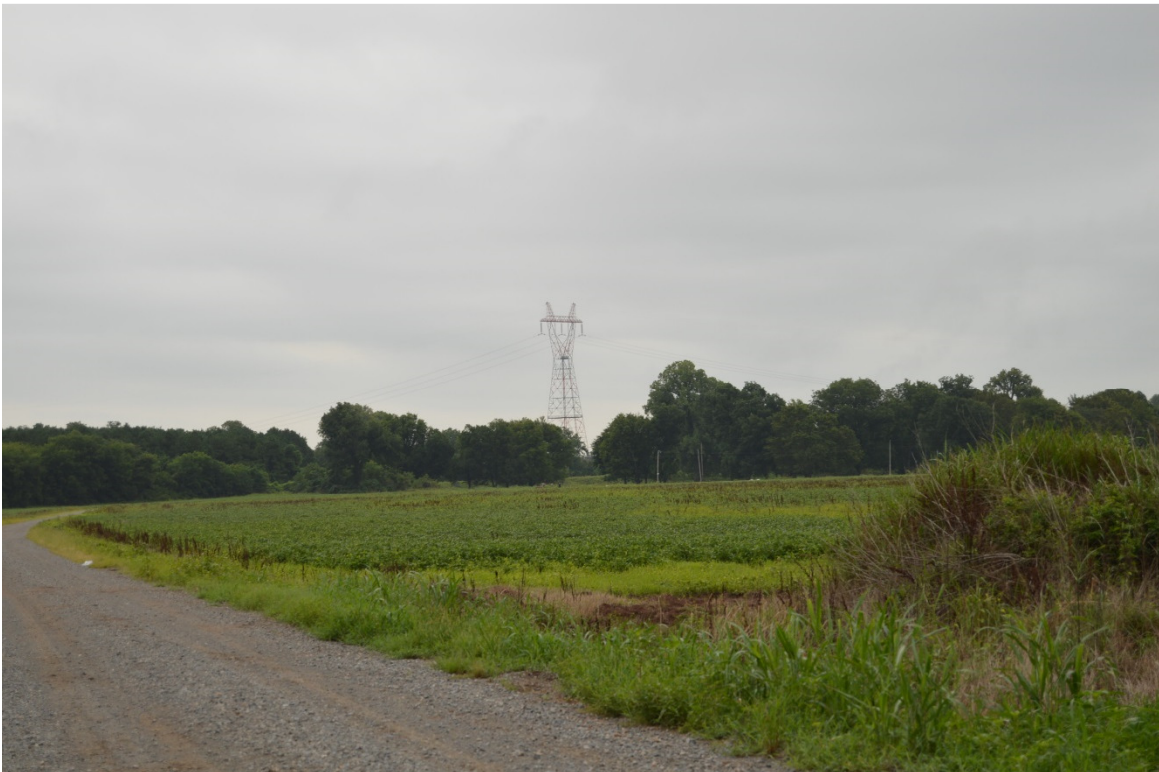
## Thomas Site

- To the North of the proposed location, the tree line penetrates the 2.0° angle specified in item I of the Condensed VOR Siting Criteria (referred to hereafter as CVSC). The tree line is thick enough to be considered impervious to the RF signal.
- From N to SE of the proposed location, the tree line is approximately 3.0° above horizontal, penetrating the 2.5° angle specified in item N of the CVSC.
- The tree line is approximately 2.5° above horizontal from a bearing of 274° to 350°, at times penetrating the 2.5° angle specified in item N of the CVSC.

- The tallest transmission tower extends to an approximate angle of 3°45' above horizontal as seen from the proposed VOR Site, penetrating the angles specified in items F, J, and M of the CVSC.

- The second transmission tower extends above an approximate angle of 1.5° from horizontal as seen from the proposed VOR Site, penetrating the angles specified in items F and J of the CVSC.

- The third transmission tower clears the 1.5° angle specified in item F of the CVSC by approximately 10 feet. Despite this tower slightly clearing the requirement of the order, there will likely be an impact to the RF signal.

- High voltage transmission lines become a penetration to the angles specified in items F, J and M of the CVSC from an approximate bearing of 128°30' from North through 145°10'.

- Transmission tower guy wires become a penetration to the angles specified in items F, J and M of the CVSC from an approximate bearing of 117°41' from North through 161°08'.

- The irrigation channel through the property appears to have been treated with herbicides and/or pesticides. Soil testing will need to be performed to identify potential contamination. Civil work needed to fill the irrigation channel will likely require coordination with USACE due to proximity to levee. Potential tree topping or removal will require coordination with USFWS regarding impact to wildlife.

- There are large metal towers connected with high tension power lines that disqualify this site. No math modeling should be performed on this site.

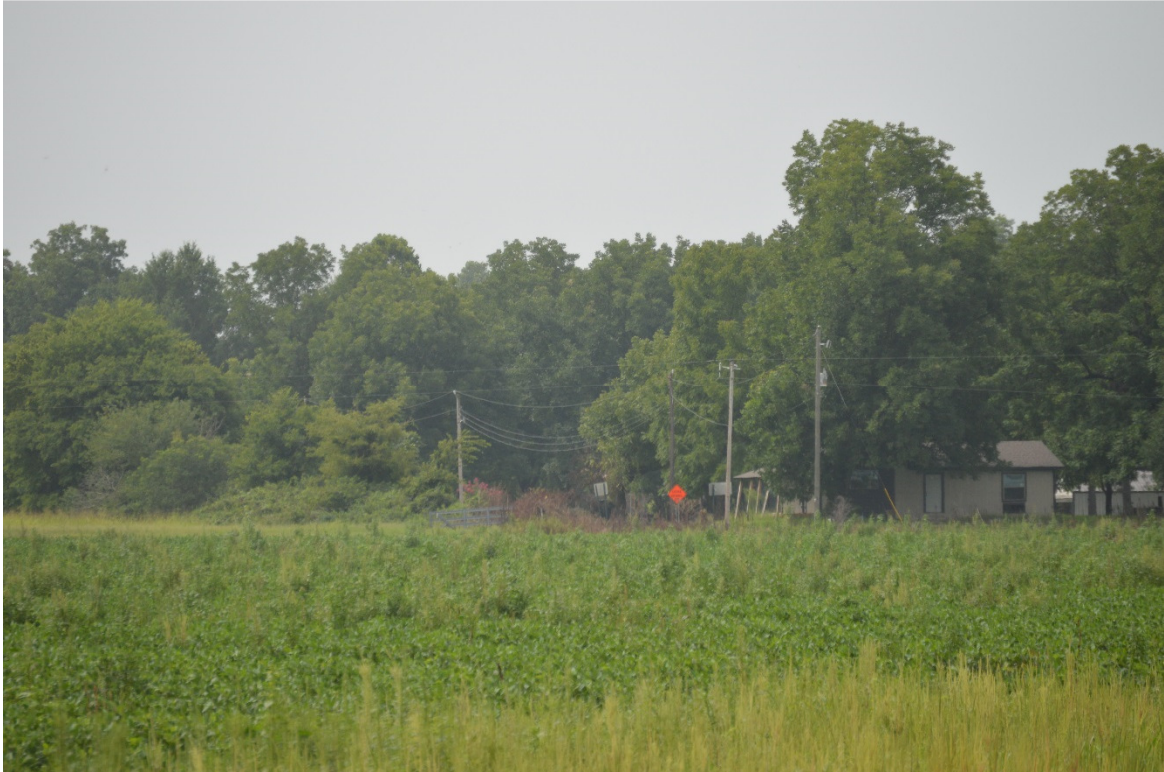
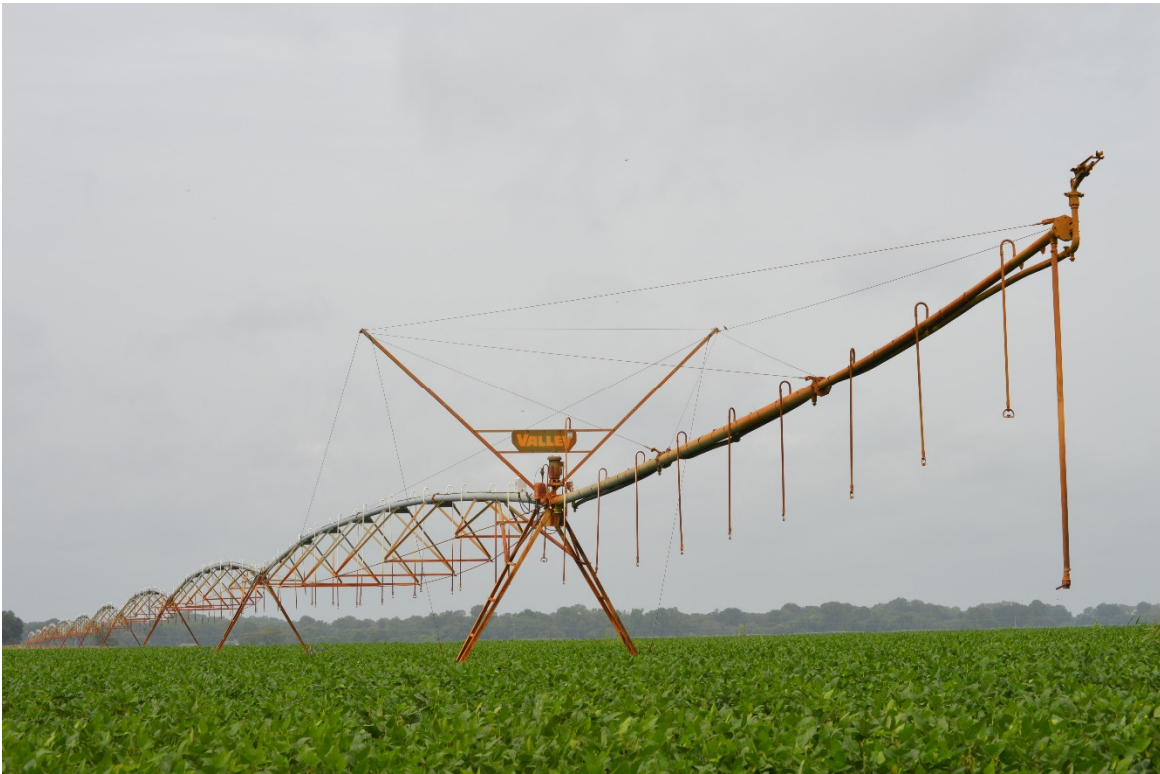
# Ginhouse Lake Site

- There is solid tree cover penetrating the 2° angle specified in item I of the CVSC from an approximate bearing of 53°30' to 152°05' and from 214°30' to 235°55'. The tallest tree is at an angle of 3°10' from horizontal measured from the proposed VOR site. These trees may need to be cut back if they negatively impact the mobile VOR test. We do not anticipate them having significant impact on the operation of the end state Doppler VOR.

- Within 1,200 feet of the proposed VOR site there are power lines overhead running tangent to the edge of the VOR critical area. Per items E and J of the CVSC, these overhead power lines will need to be relocated below grade. The closest power pole is at 1,148 feet from the proposed VOR Plot.

- The rotating Irrigation pivot on the adjoining field is 1,634 feet from the VOR Antenna location. The entire horizontal span of the pivot is within the 0.5° angle specified in item J of the CVSC from an approximate bearing of 295°25' through 328°20'. The irrigation pivot may be problematic for the mobile VOR test, but should be negated by the Doppler conversion and elevated counterpoise in the end-state VOR configuration. We recommend the irrigation pivot be oriented perpendicularly for the mobile VOR test in order to capture the worst case scenario impacts on VOR performance and potential restrictions.

- A sheen was noted on the water on the west portion of the property. This property will likely require discussion with USACE due to proximity to waterway; USFWS for potential impact to wildlife as a result of tree trimming and/or removal; USDA as this property is currently farmland; SHPO for potential historical impacts due to proximity to Civil War Historical Sites; THPO for tribal historical impacts due to proximity to burial mounds.
- This property is recommended for Math Modeling and Mobile VOR Testing. If testing is to move forward on this property, it is requested that a preliminary Phase 1 ESA/EDDA and an archeological survey be performed.

- There are aerial power lines along the entrance to the property that penetrate the restriction of 1200 feet and will have to be relocated underground. There is an irrigation pivot approximately 1600 feet from the proposed VORTAC plot that may restrict portions of the VOR signal, this is anticipated to mostly impact the mobile VOR test trailer. Math modeling should be performed at this location to include the irrigation system. This is the best candidate site of all properties we evaluated from an operational perspective.

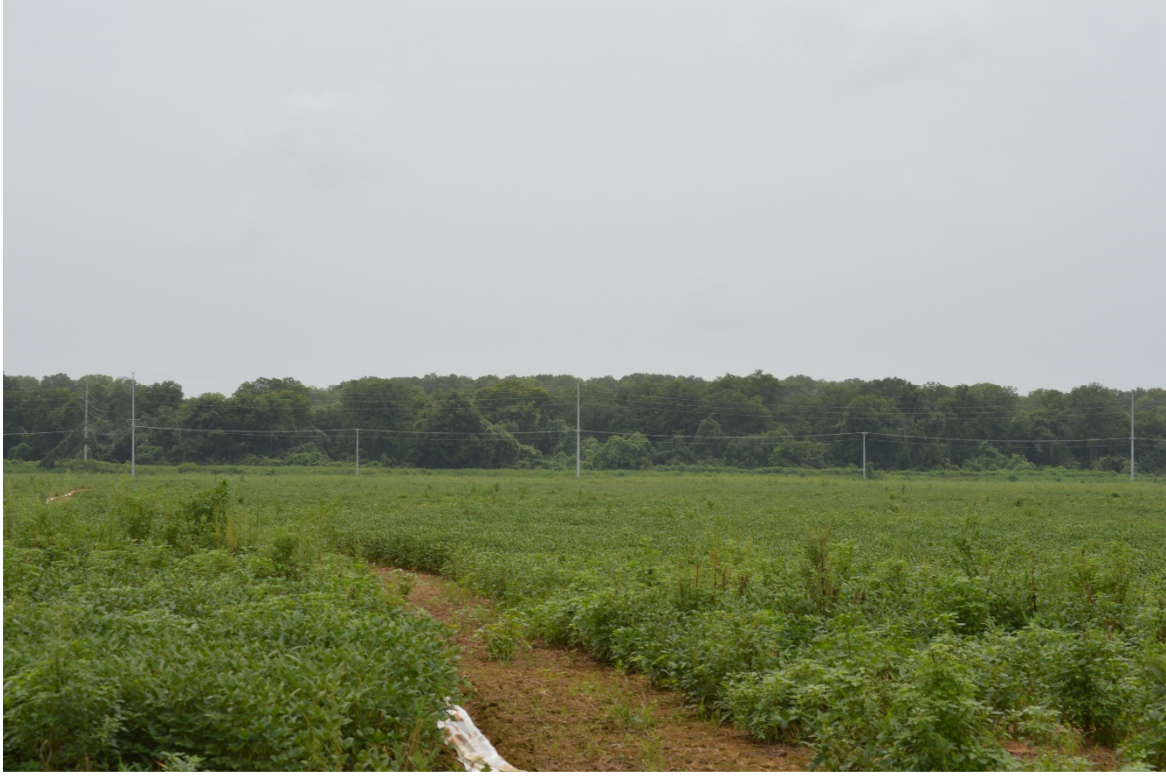
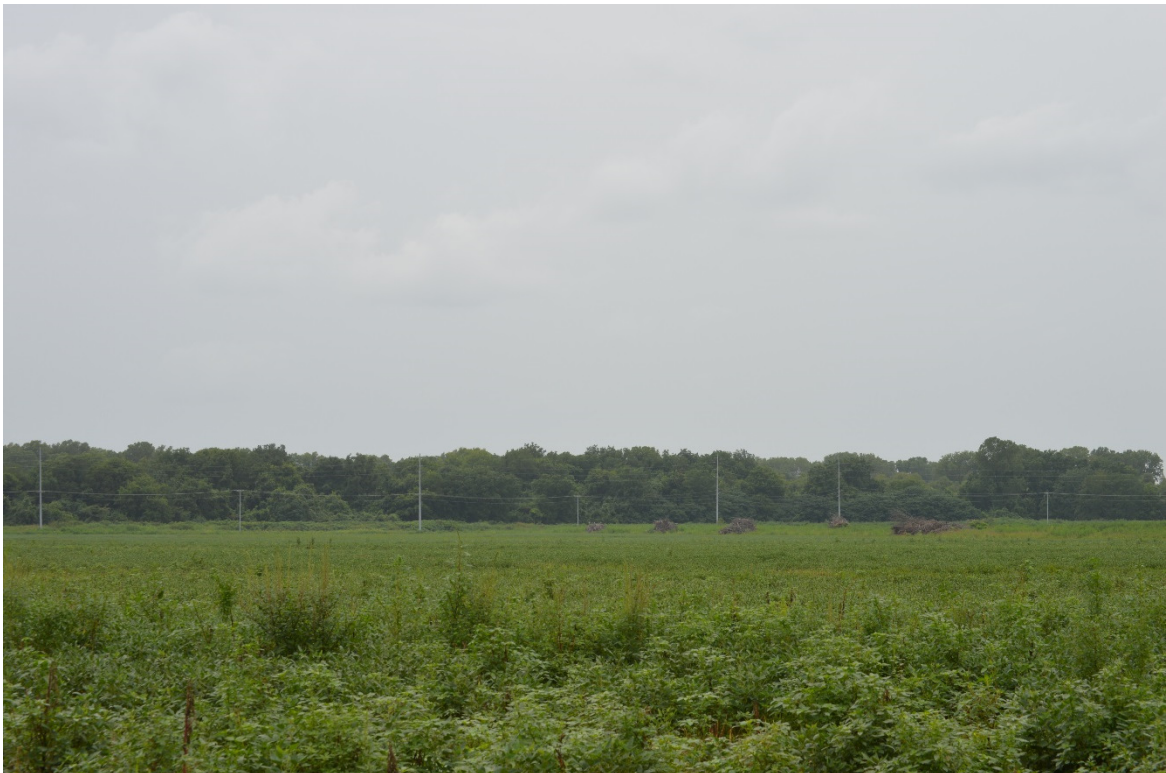
# Fulkerson Site

2. **High voltage transmission lines and towers**
  - Transmission towers and high tension power lines span the entire western boundary of this property. Overhead power and possible telephone lines span the entire eastern boundary of this property. Both sets of overhead lines likely conflict with items E, F, J, M and N of the CVSC.

3. **Tree line**
  - Trees appear to pose an issue to this site. The tree line extends above the western high voltage transmission lines, likely in conflict with items H and I of the CVSC.

6. **Electronics evaluation**
  - There are tall large metal towers with high tension power lines that disqualify this site. No math modeling should be performed on this site.

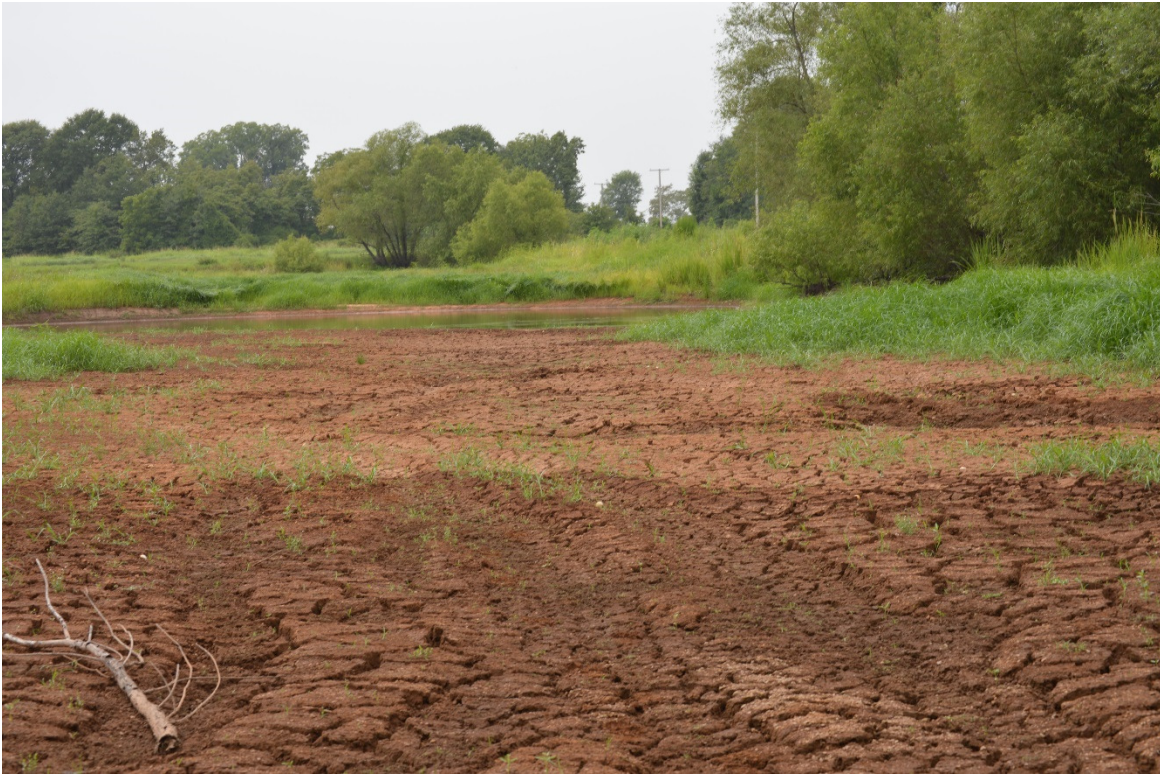
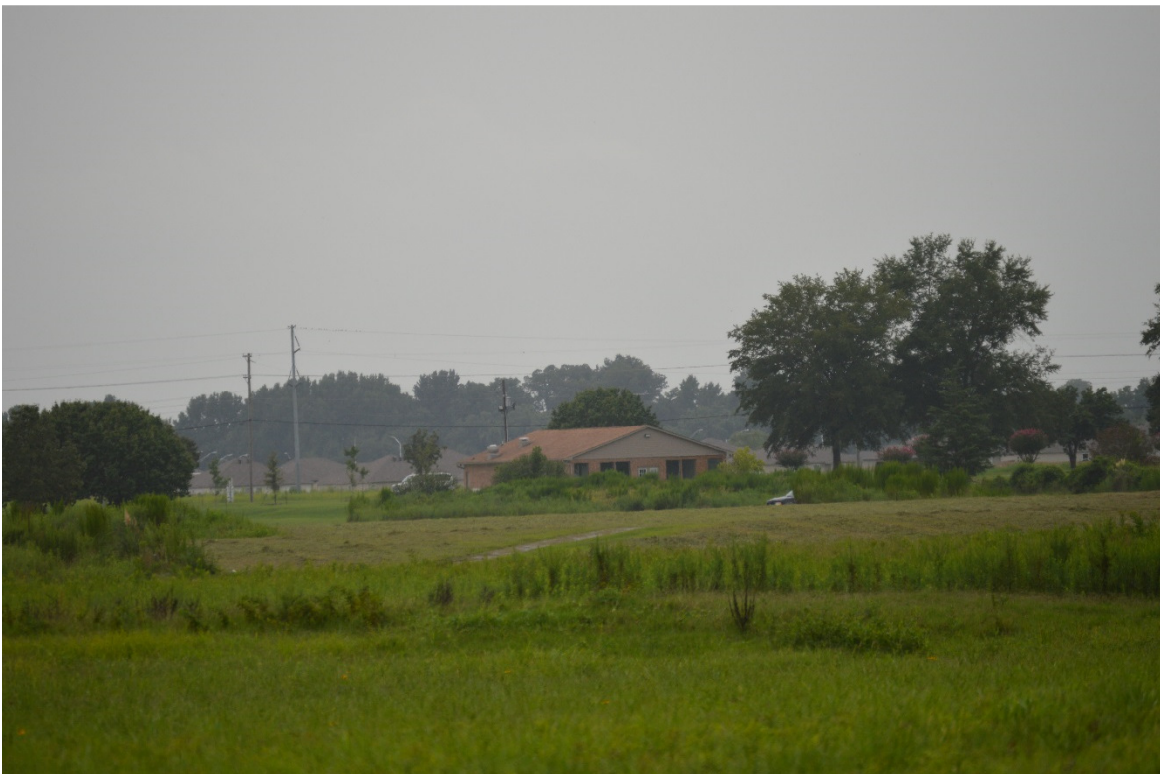
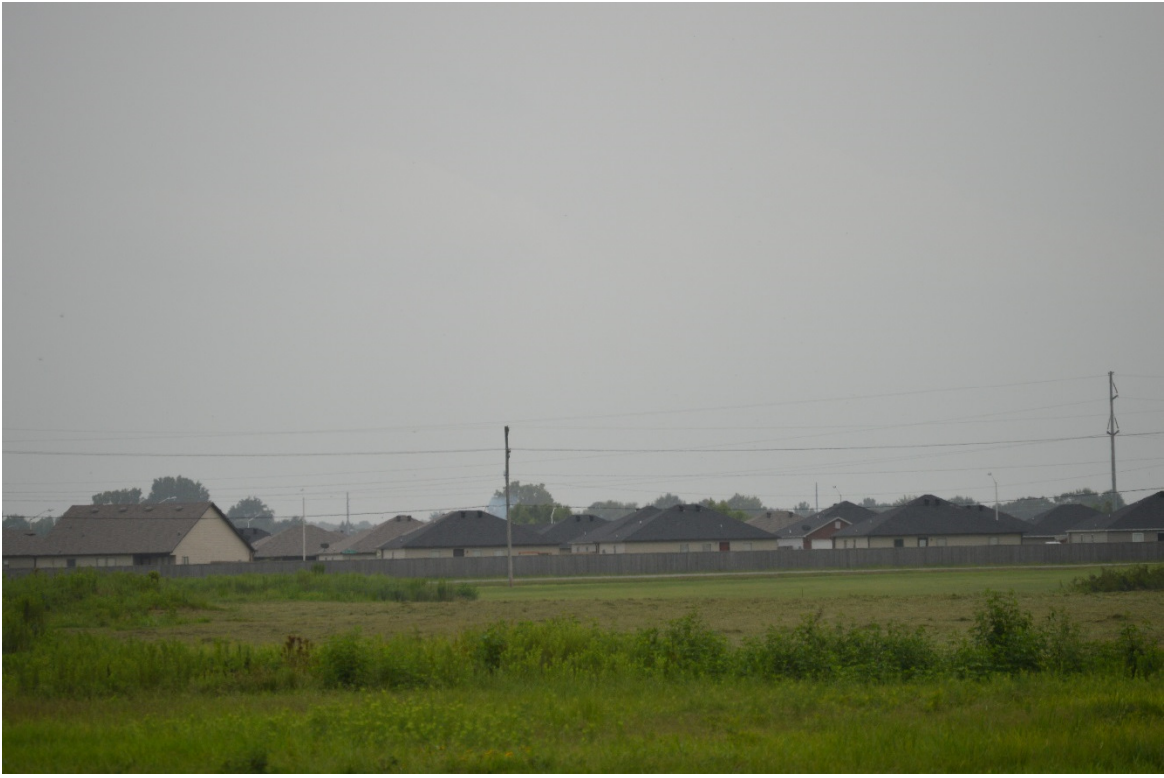
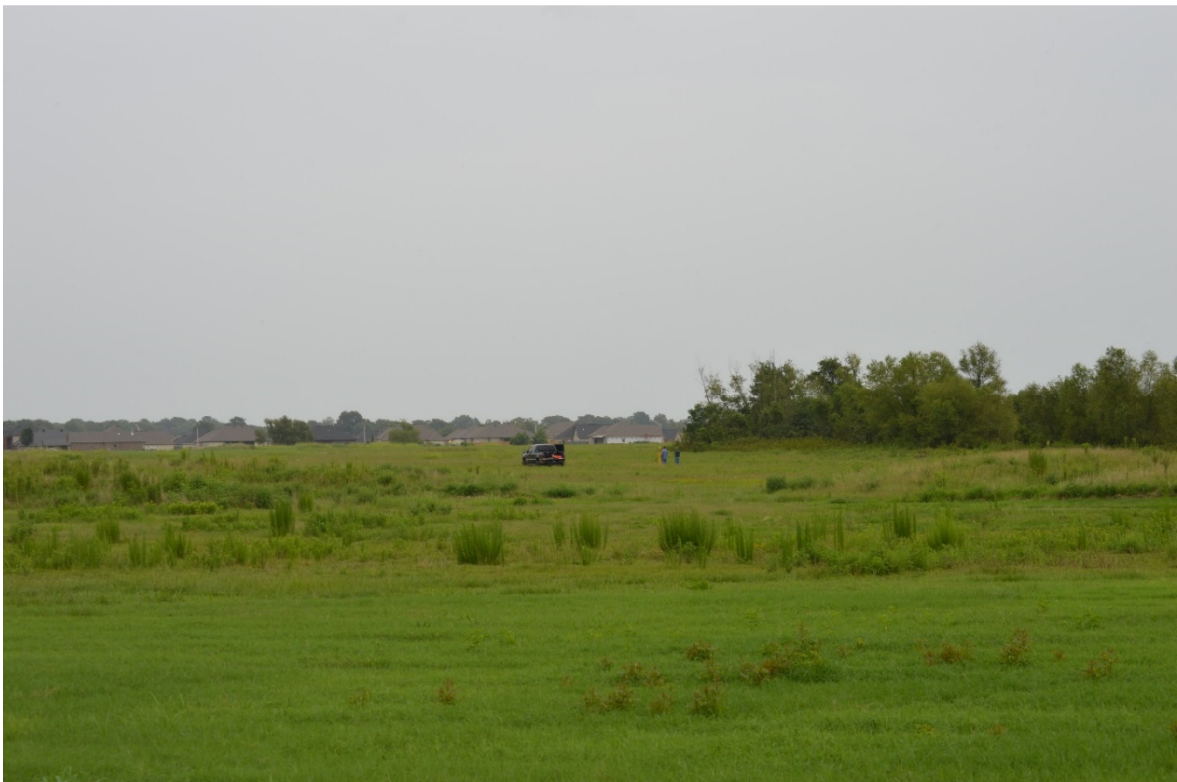
## Salmon Property - Stonelinks Site

- Overhead power lines and poles adjacent to the proposed VOR Antenna location penetrate the 1.5° angle specified in item F of the CVSC. The proximity of the lines conflict with items D, E, J, L, M and N of the CVSC. These lines would need to be removed or buried prior to mobile VOR testing.
- There are high voltage transmission lines to the South of the proposed VOR Plot, across Faulkner Lake Road. Due to the terrain surrounding the VOR Antenna location, these lines could not be surveyed at the 0.5° angle specified in item J of the CVSC, however they are anticipated to significantly impact the operation of the VOR.

- A 360° obstruction survey was performed at 2.5° per item N and I of the CVSC. Individual tree penetrations were observed at approximate bearings of 261°45', 271°50', 285°51', 293°20', 301°20', 307°23'. Groups of trees penetrated the 2.5° vertical angle at approximate bearings of 311°18', 321°35', 325°30' and 328°28'.

- There is a group of trees at approximate bearing of 57°20' from the proposed VOR Antenna location that is within the 1000 foot requirement specified in item H of the CVSC. These trees would need to be removed prior to mobile VOR testing.

- There is a large group of trees surrounding the pond adjacent to the South side of the proposed VOR Plot. These trees would need to be removed prior to mobile VOR testing.

- There are additional trees within the 1000 foot radius of the VOR Antenna location that will most likely need to be removed, mostly to the South of the proposed location. Many of these are obscured by the terrain and tree line surrounding the pond to the South.

- Significant portion of the Northeastern quadrant of the property is inside Zone A of the floodplain, very close in proximity to the proposed VOR Plot. Significant fill work may need to take place to ensure the site cannot be flooded and all-weather access guaranteed to maintenance personnel.

- Large pond adjacent to South side of proposed VOR Plot would need to be filled in and terrain smoothed out prior to mobile VOR testing. The slope of this pond would likely block southward RF signal from the mobile VOR.

- Second large pond further to the south of the proposed VOR Plot would need to be filled in and terrain smoothed out prior to mobile VOR testing. This pond holds significant water, which will have negative impacts on VOR performance and reliability. Terrain slopes down to the North of the proposed VOR Plot. This is not a disqualifier, however this will have a negative impact on VOR performance.

- Multiple elevated moguls or tee boxes from the golf course are located within the critical area of the proposed VOR Plot. All of these features would need to be removed prior to mobile VOR testing.

- The area has a gentle slope overall but has moguls left over from the golf course which will need to be leveled. The dried up water hazards will need to be filled in. There is a concern for vandalism due to the proximity to the housing editions. We do not recommend that math modeling be performed at this site. If the modeling is performed, all obstructions should be included in the model, including the irrigation system and nearby transmission lines. There are high voltage transmission lines to the South of the property which will likely have a significant impact to the operation of the VOR.

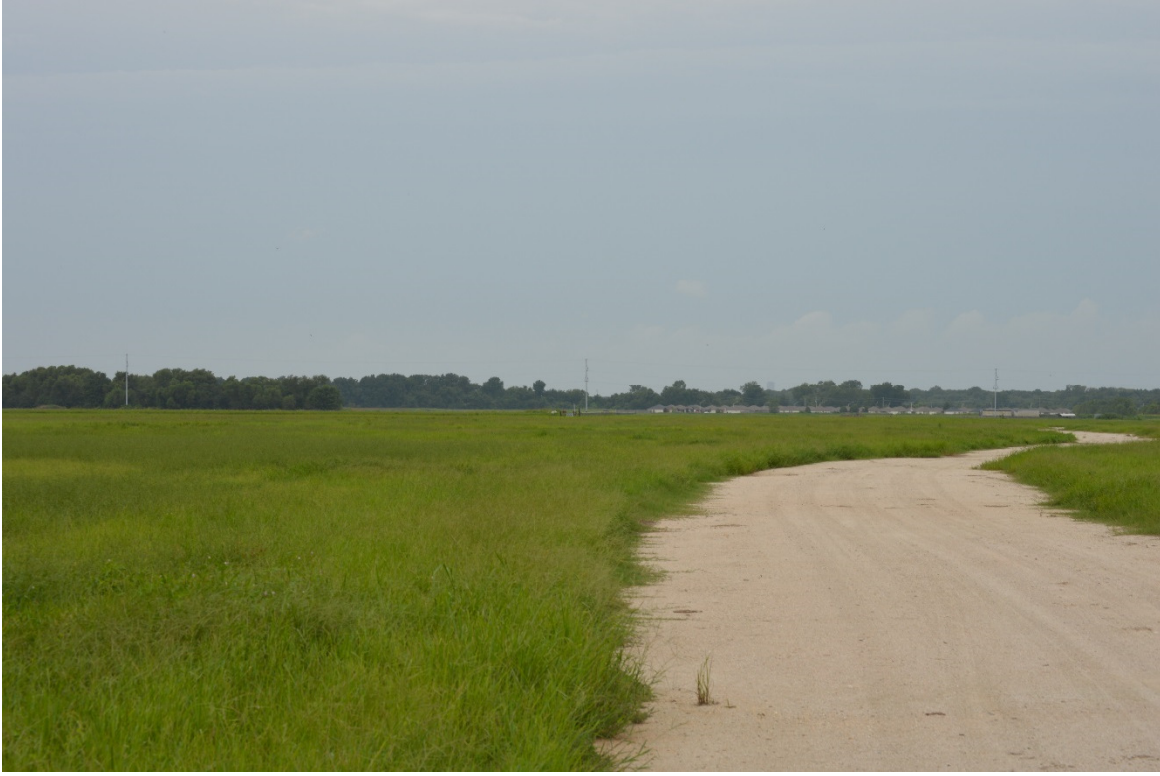
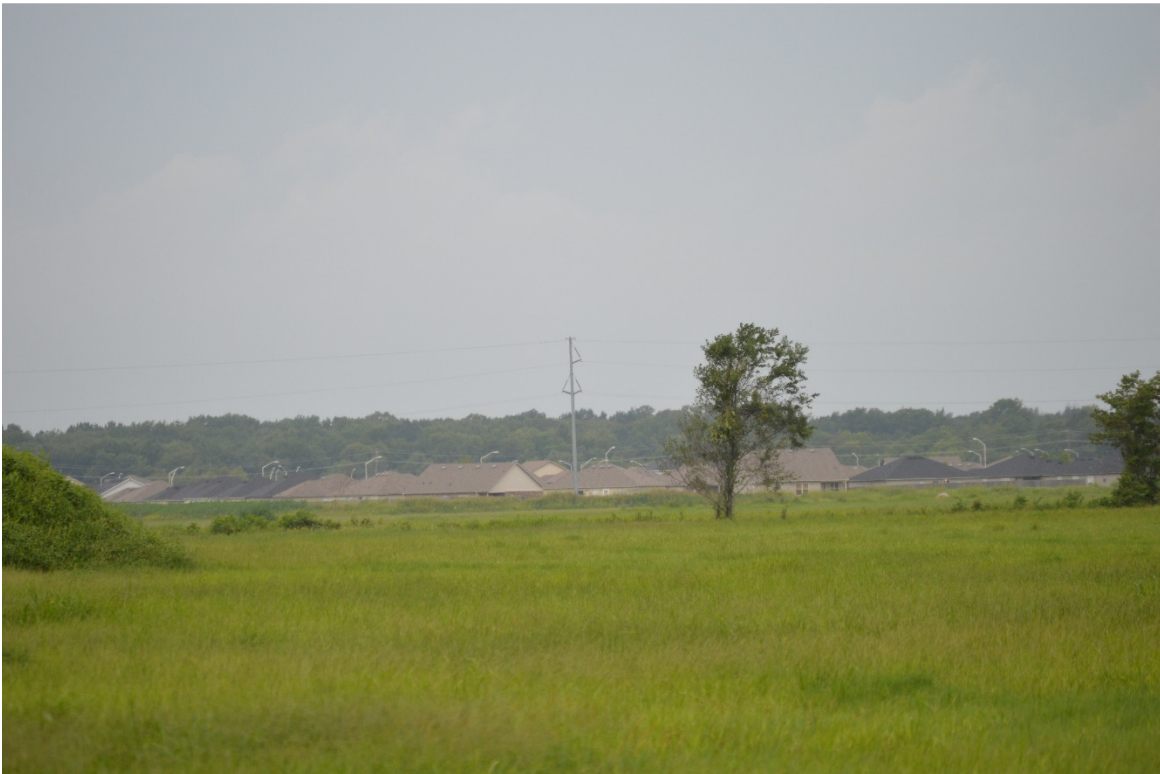
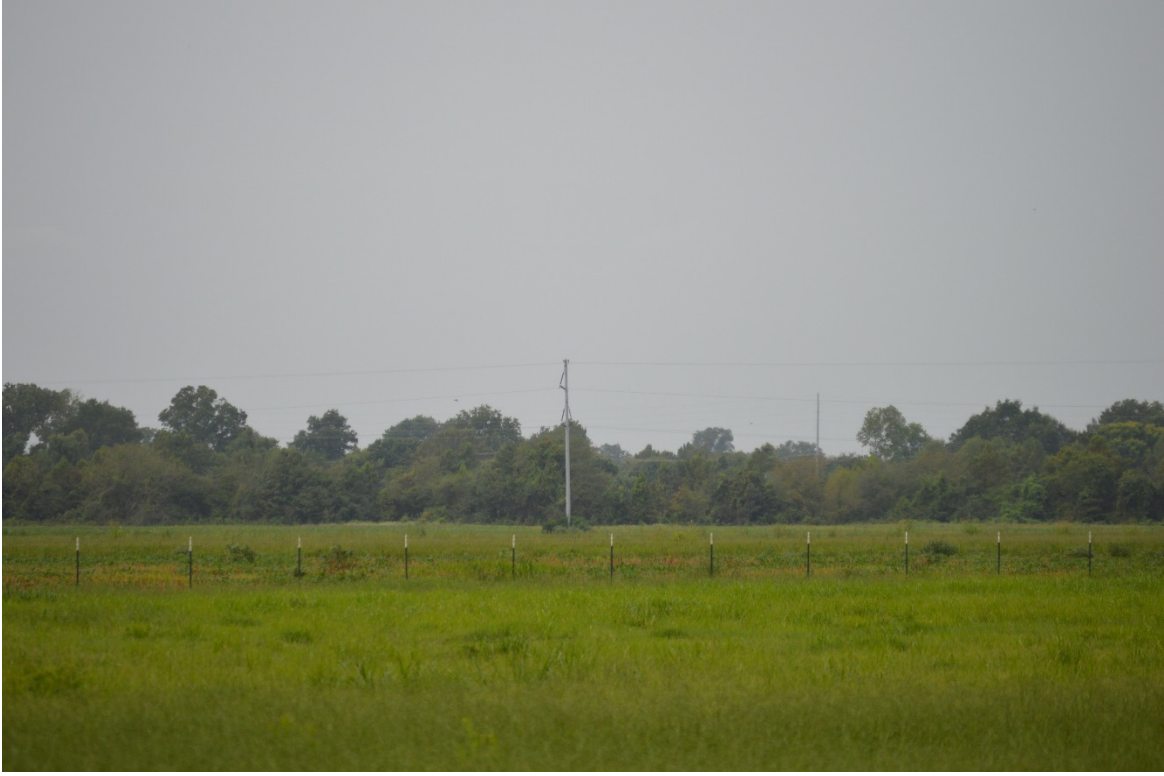
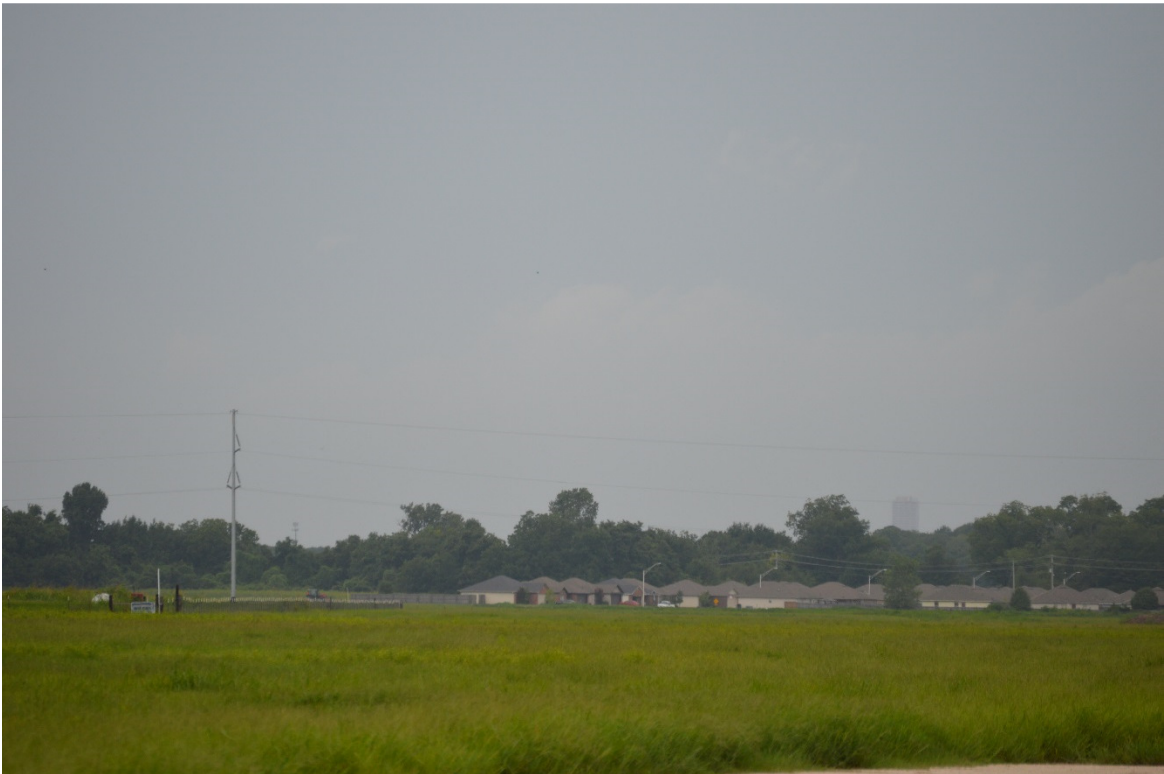
## Theo Road Site

- High voltage transmission lines observed to the West of the proposed VOR Plot. These transmission lines extend above approximately 1° above horizontal to the Southwest of the property, are approximately 1°10' above horizontal to the West of the property, and are approximately 49' above horizontal to the Northwest of the property. The transmission lines are visible from an approximate bearing of 217°34' through 290°29'. These transmission lines penetrate the angle specified in item J of the CVSC.

- Tree line observed to the North of the proposed VOR Plot, ranging from approximate vertical angle of 4°24' above horizontal to 4°33' above horizontal when panning from Northwest to Northeast. These trees penetrate the angle specified in item I of the CVSC. Distance to tree line when measured was 949.5 feet, conflicting with item H of the CVSC.
- A second group of trees is located a distance of 733 feet from the proposed VOR Antenna Location. The trees surround an intermittent stream that feeds into a creek on the north side of the property. This group of trees also conflicts with Item H of the CVSC.

- Storage silos observed to the Northwest of the proposed VOR Site. These silos would likely result in radial restrictions to the VOR, penetrating the angle specified in items J and M of the CVSC.

- Fill dirt mounds observed along the gravel access road to the site. These mounds would need to be removed prior to mobile VOR testing.
- Signs of potential flood issues observed for road into and out of the facility when entering from Theo Road. Exit to Faulkner Lake Road is through an active construction site, which may complicate access and egress.

- Quarry located to the Northwest of the proposed VOR Plot holds water. This may have significant impact to operation and reliability of the VOR.
- Proximity to and visibility from nearby residential neighborhood raises concerns of vandalism. This is an unmanned facility with potential to broadcast Hazardous Misleading Information in the event of vandalism.

- Due to the tall power lines to the West of the VOR Plot and proximity to the houses this site should not be considered. No math modeling should be performed for this site.

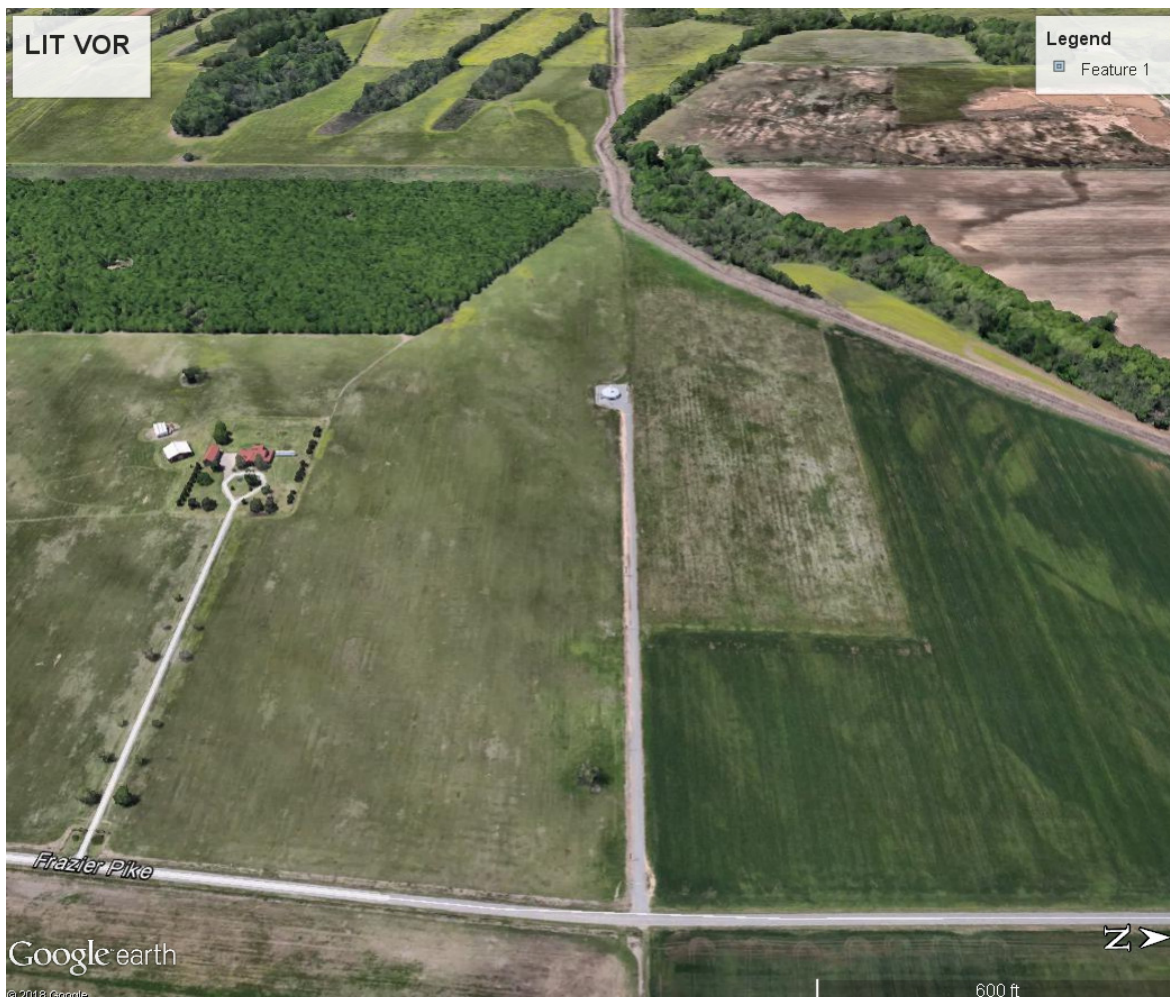
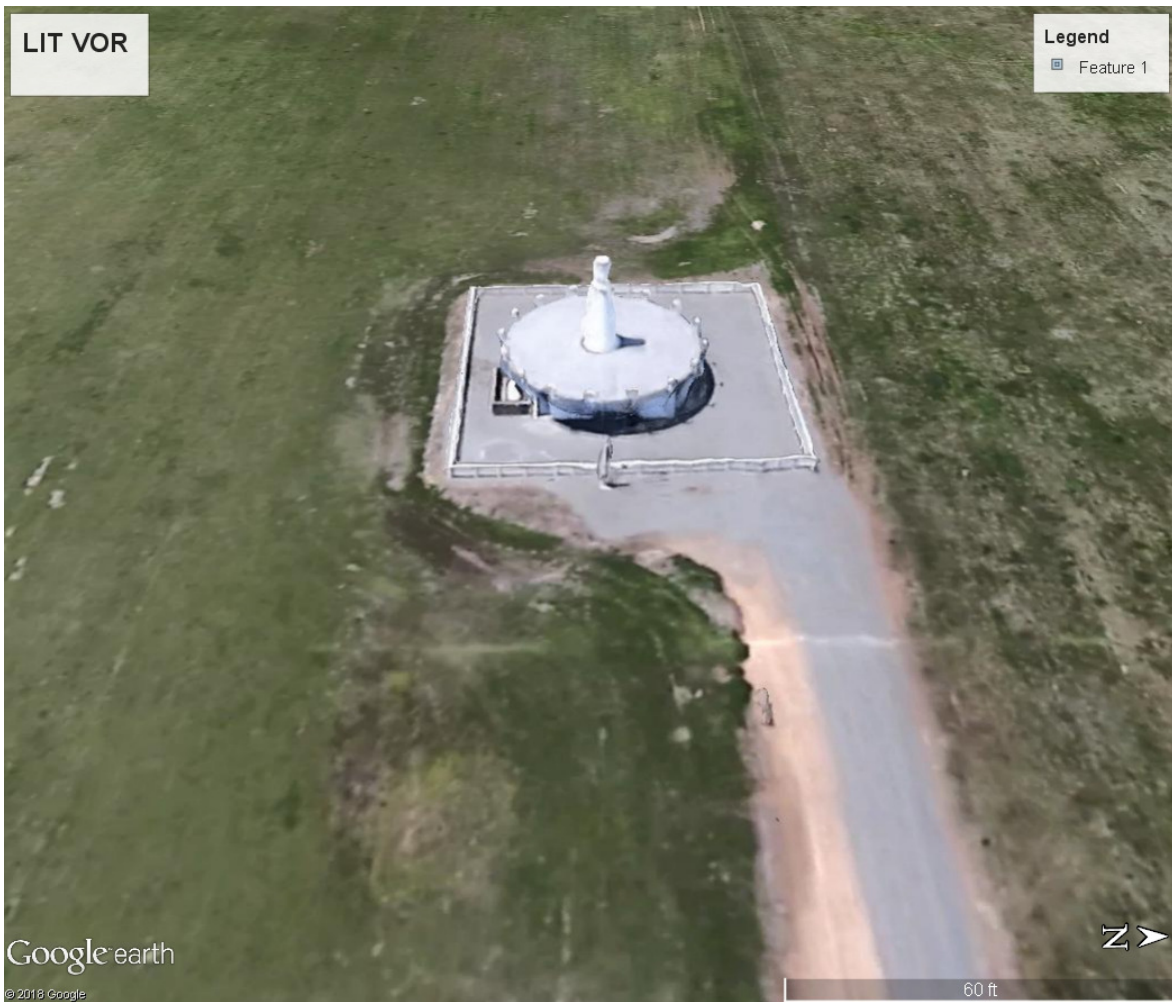
## EXISTING VORTAC

- Existing Propane tank for the engine generator is required to be removed and disposed of properly.
- The existing building is from the 40's/50's and will require coordination with the SHPO before any type of demolition can occur.
- Building has asbestos and lead-based paint (LBP). FAA will review the records of the existing HAZMAT analysis and will suggest a thorough hazmat survey be completed at this site including any TCLP testing for the LBP.
- A field visit may be required from personnel from the SHPO office. A submittal will need to be completed outlining the following:
  - a. Why this project is occurring.
  - b. The history and purpose of the building.
  - c. Photographs of the building.
  - d. The location of the new VORTAC facility.
