**APPENDIX A**  
**LIT VOR SITE SURVEY REPORT**

**LIT VOR SITING REPORT  
LITTLE ROCK,  
ARKANSAS**

**PREPARED BY: SHELBY BOHMFALK  
(NAVAIDS LEAD ENGINEER)**

**TECH OPS – NAVAIDS DESIGN GROUP  
(08/24/2018)**

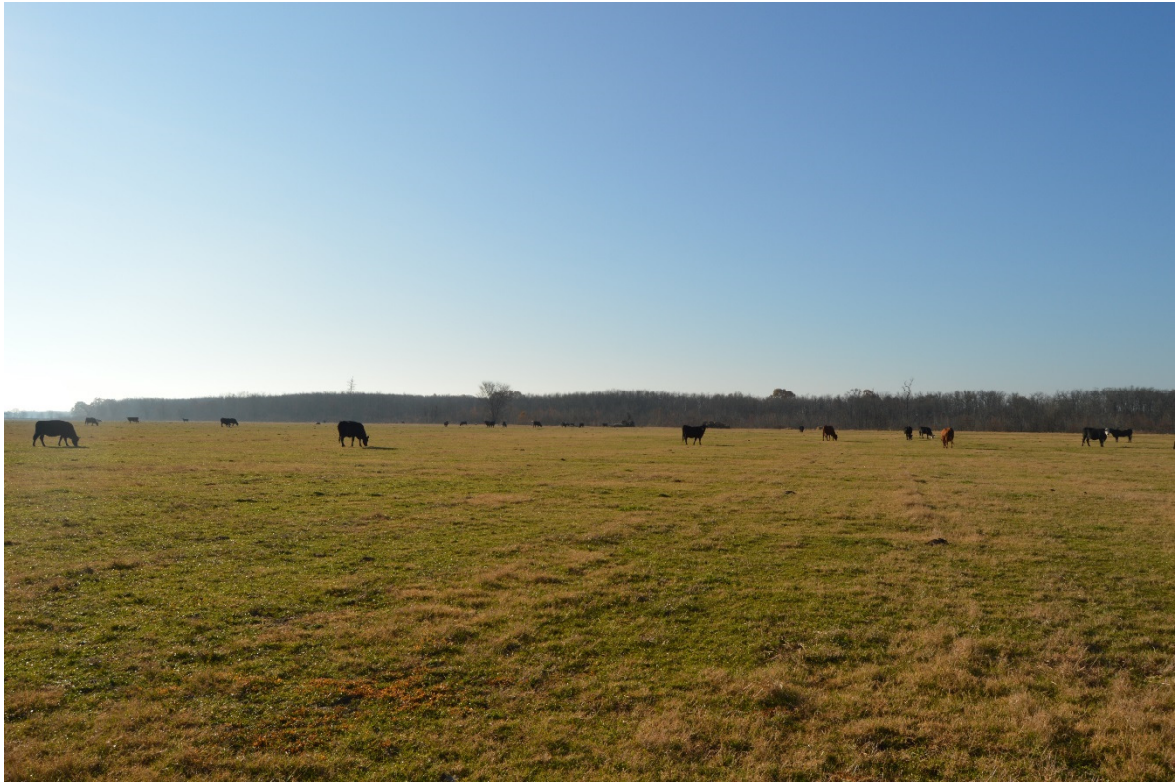
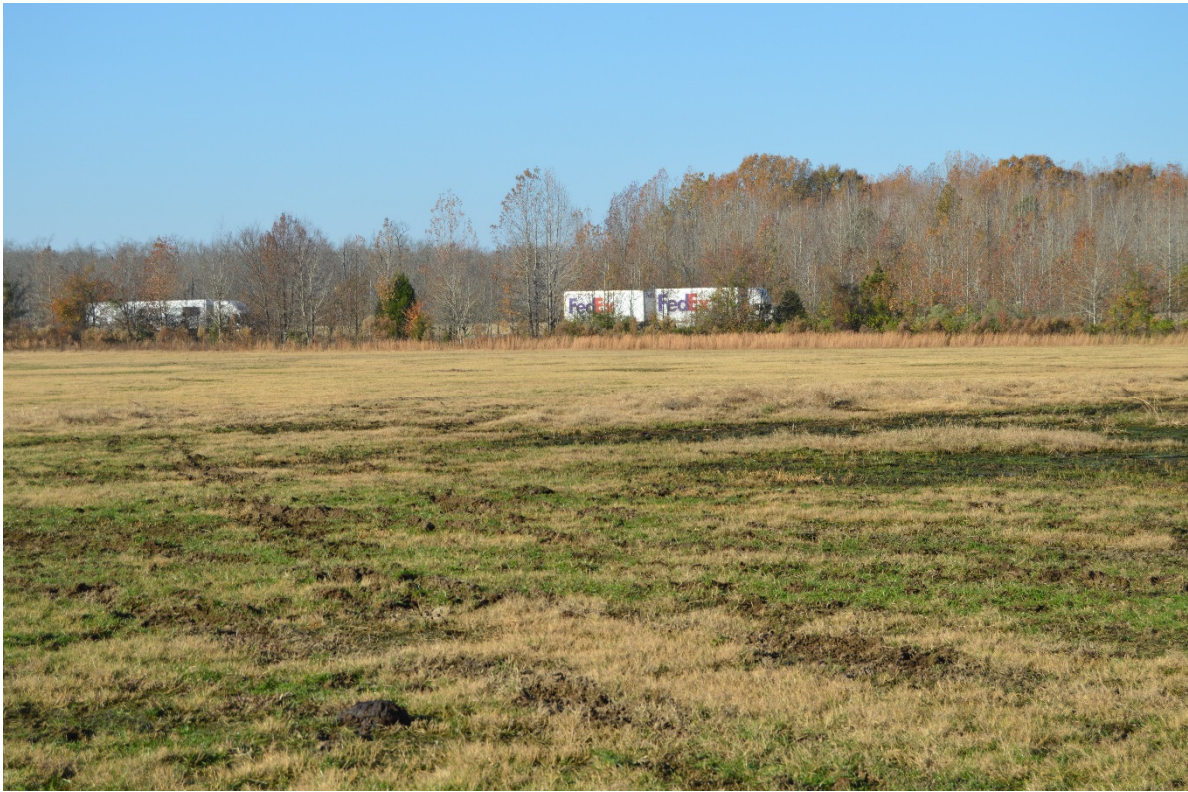
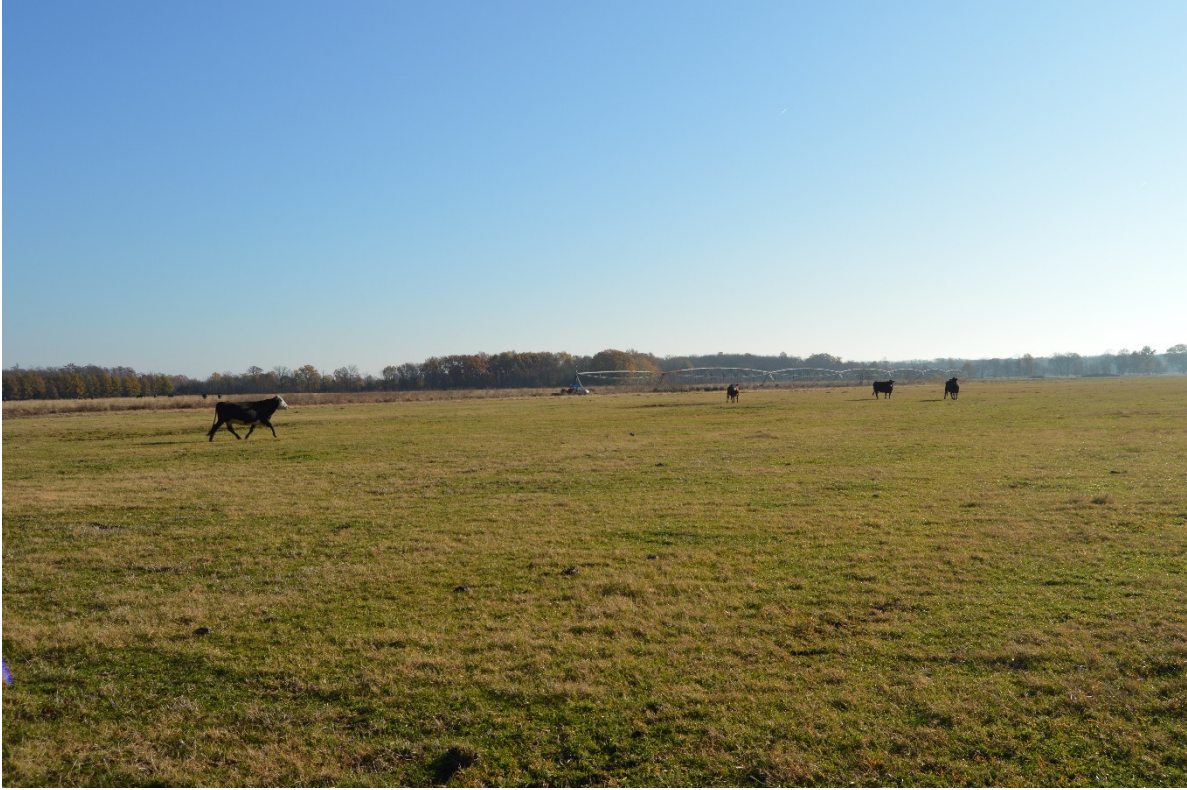
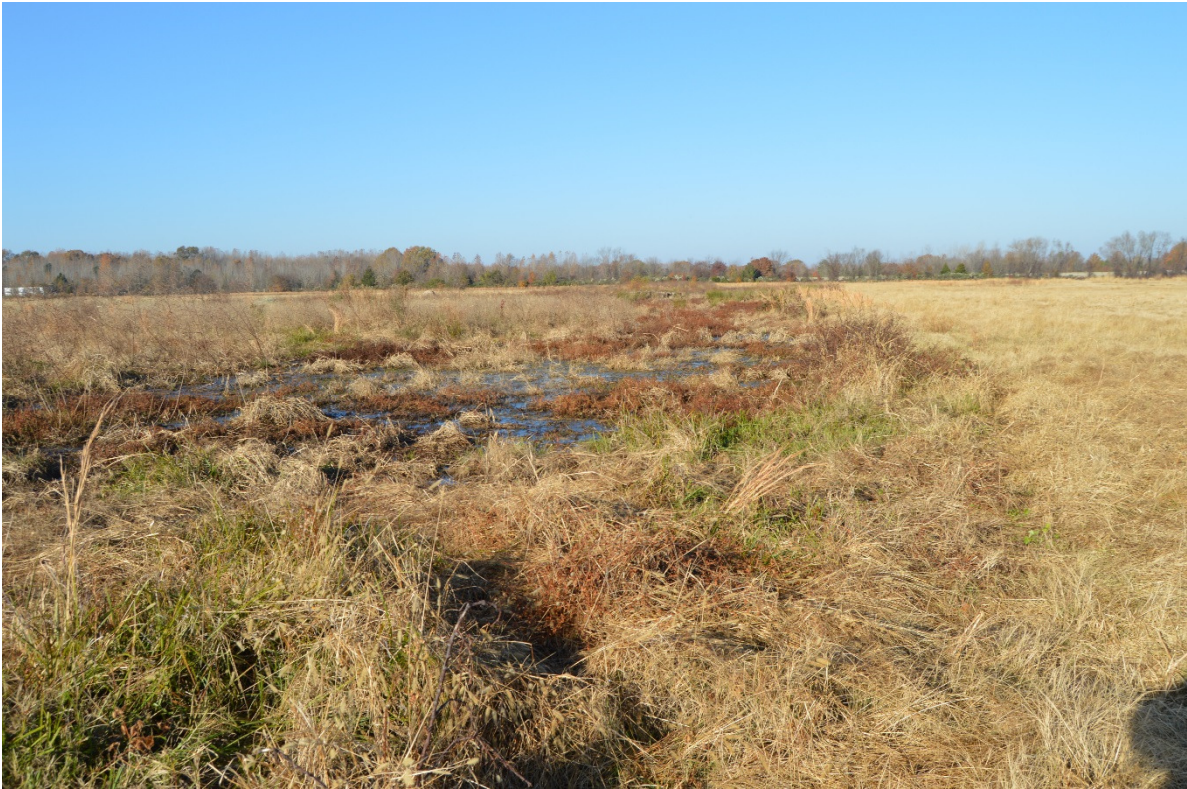
# Davidson Property

- The proposed VOR site and 1000 foot radius around the site are all within the 500 year floodplain. Some parts of the adjacent property to the East of the proposed VOR site are within the 100 year floodplain. Coordination will be required with USACE and likely USFWS if this site is selected.

- The site was muddy and required a four wheel drive vehicle to access the plot. Two areas within the 1000 foot radius held a few inches of water at the time of the site visit.

- To the Southeast of the proposed location there is a large metallic grain silo. The Silo is located at a bearing of  $158^{\circ} 15'$  from North as observed from the proposed VOR location. The silo is located approximately 4,450 feet from the proposed VOR location.
- As observed from the proposed VOR location, the silo subtends a vertical angle of  $0.5^{\circ}$  above horizontal. This is well clear of the  $1.2^{\circ}$  limit defined in item M of the Condensed VOR Siting Criteria (referred to hereafter as CVSC.)

- To the East of the proposed VOR location there is an irrigation pivot that is used to irrigate the grass used for cattle grazing. The irrigation pivot extends from a bearing of  $129^{\circ} 27'$  to  $134^{\circ} 29'$  from North as observed from the proposed VOR location. The pivot is 741 feet from the proposed VOR site, encroaching the 1000 foot structure clearance requirement specified in item L of the CVSC.
- As observed from the proposed VOR location, the irrigation pivot subtends a vertical angle of  $0^{\circ} 33'$  above horizontal. This is well clear of the  $1.2^{\circ}$  limit defined in item M of the CVSC.

- There are small groups of trees that penetrate the  $2^{\circ}$  angle specified in item I of the CVSC. These trees are located at bearings of  $14^{\circ} 36'$ ,  $290^{\circ} 28'$ ,  $315^{\circ} 42'$ , and  $321^{\circ} 37'$  from North as observed from the proposed VOR location. These trees are approximately 1600 feet from the proposed VOR site.
- A group of trees penetrate the  $2^{\circ}$  angle specified in item I of the CVSC from a bearing of  $258^{\circ} 27'$  to  $282^{\circ} 30'$  from North. The high point of this group of trees subtends a vertical angle of  $2^{\circ} 38'$  above horizontal. This group of trees is located off of the Davidson property, across highway 440.

- A diesel engine and above ground fuel storage tank (AST) are located adjacent to the irrigation pivot. Several fuel and oil filters were observed on the ground near the AST. No sheen was observed around the AST, indicating that the soil is not likely to be contaminated.

- The Davidson property is a prime location for a VOR facility in comparison with most of the other properties we have evaluated.
- The irrigation pivot may have an effect on the performance of the Mobile VOR Test Trailer. We would recommend that the pivot be oriented broadside to the VOR trailer during testing to identify the worst case impact to VOR performance. The irrigation pivot is not anticipated to impact the performance of the end-state Doppler VOR system.

- The slight ponding on the site should not impact the VOR performance.
- An elevated landfill is visible to the North of the Davidson property. The results of Mobile VOR Test will determine if this landfill will impact the operation of the facility or cause excessive radial restrictions. Initial impression is that the landfill will not be of significant impact.

- Muddy conditions and rough rutted terrain in route to the proposed VOR location may be problematic for the Mobile VOR Test Trailer as bouncing the equipment around may cause parts to fail. It is recommended that some sort of gravel access road be built to the proposed VOR site to minimize potential bouncing and damage of equipment. The recommended road will need to support a light duty truck and an approximately 10,000 lb trailer.

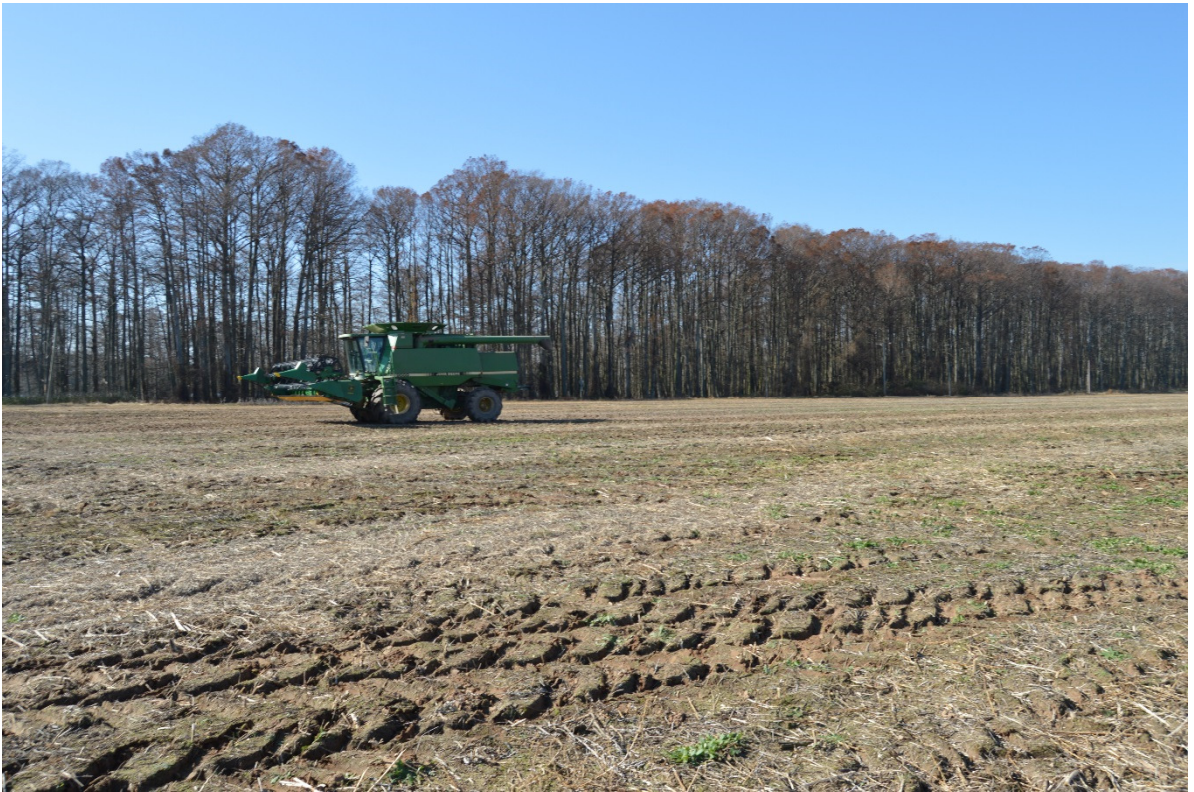
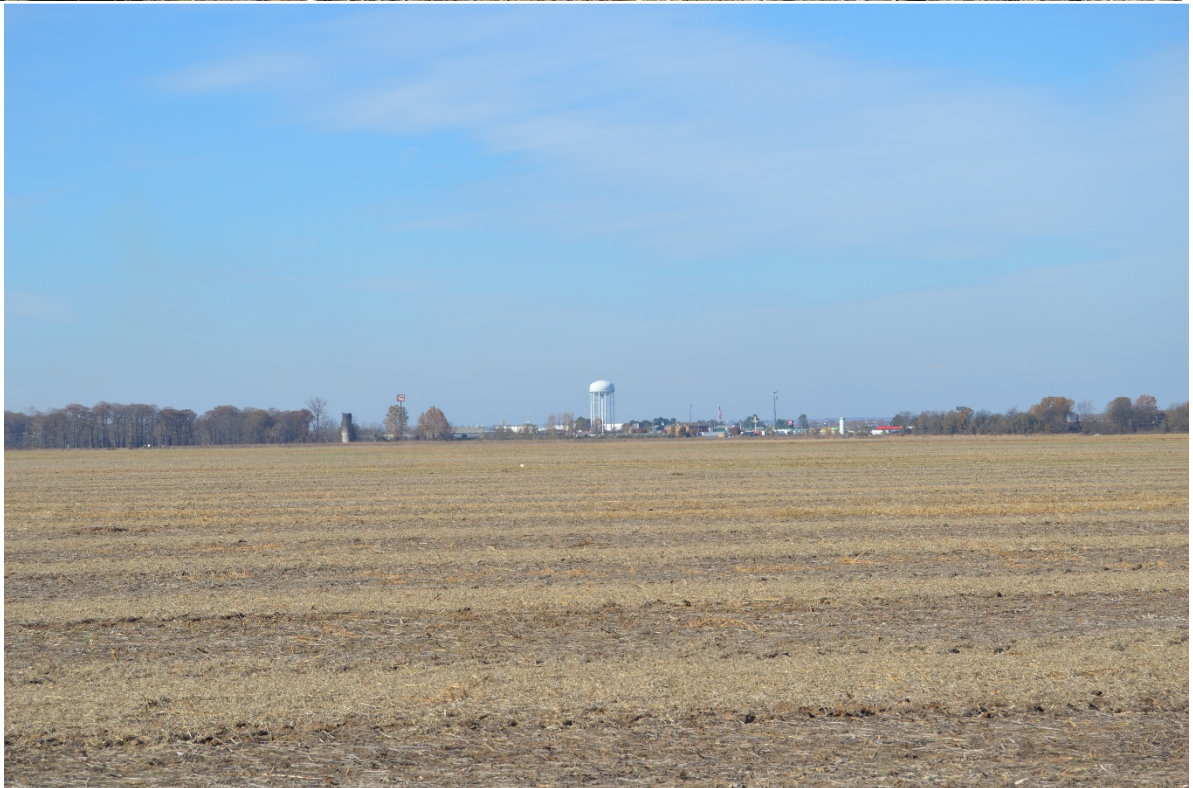
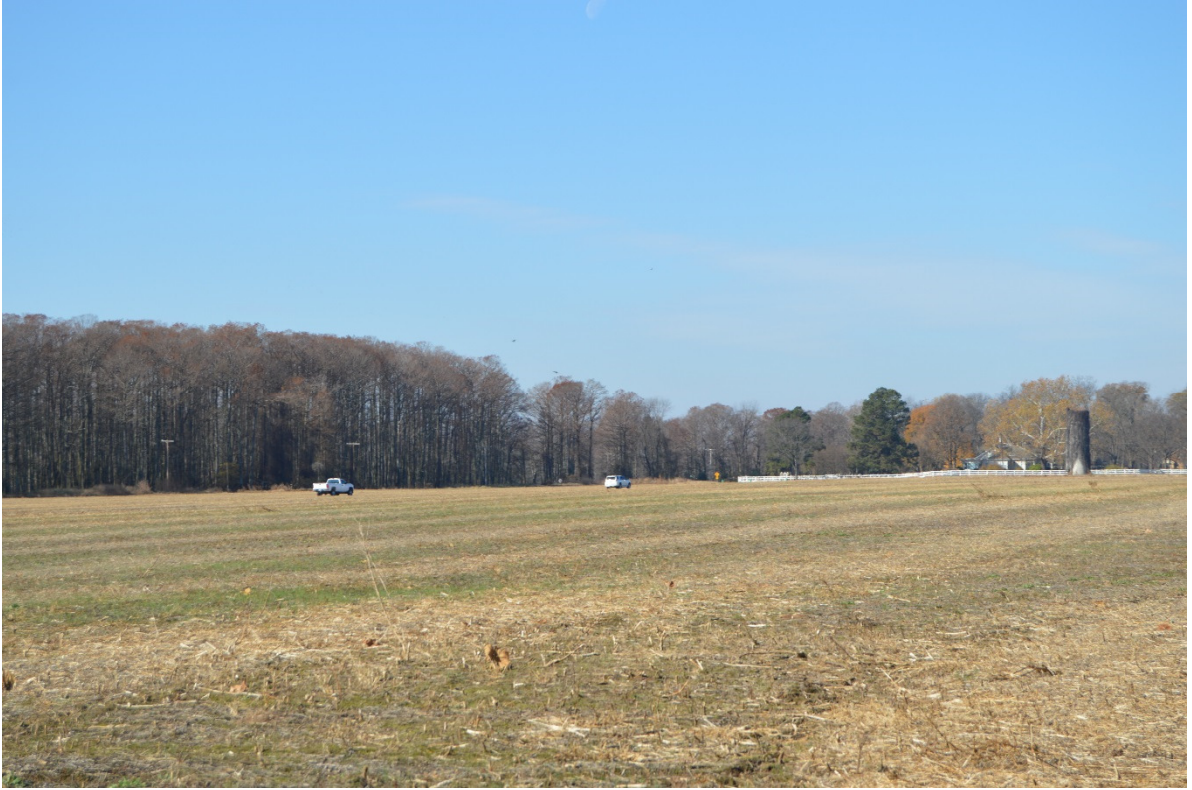
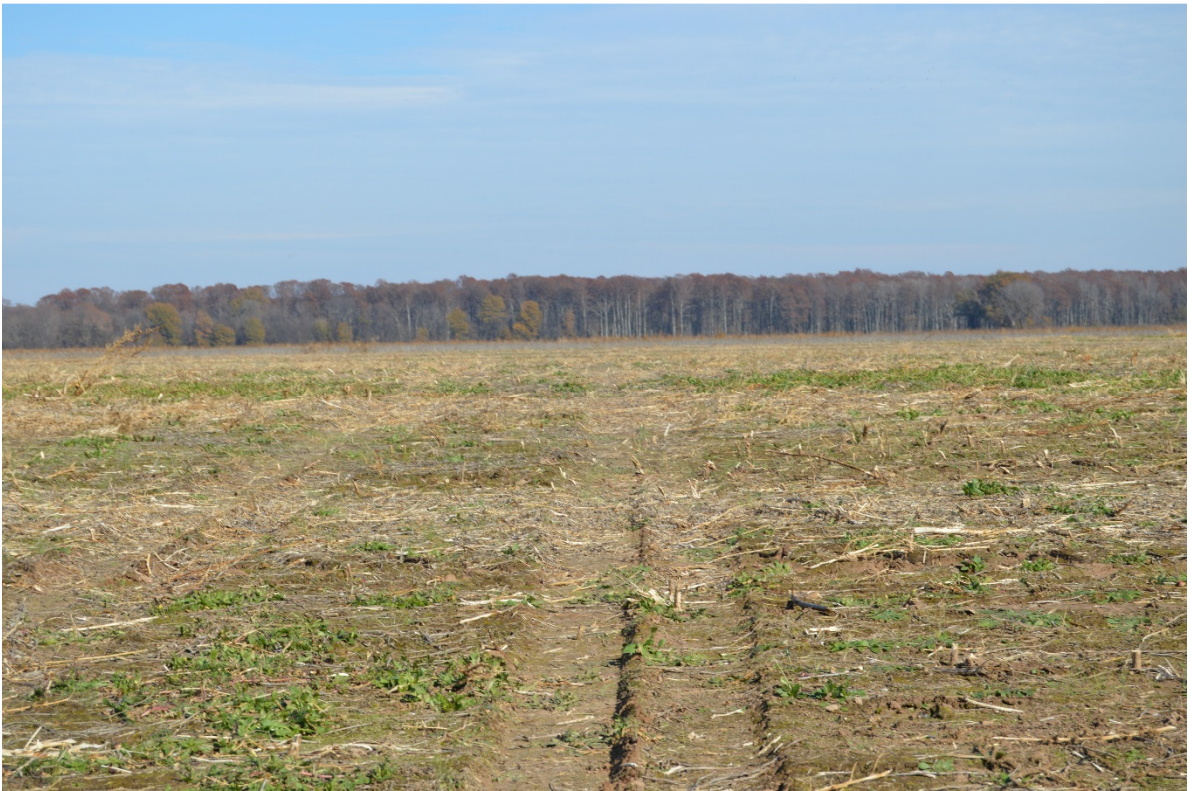
# Tulip Property

- There is a large water tower approximately 8,500 feet to the West of the proposed VOR location. The water tower is located at a bearing  $292^{\circ} 27'$  from the proposed VOR site. The water tower subtends a vertical angle of  $1^{\circ} 14'$  from horizontal as observed from the VOR site, slightly penetrating the  $1.2^{\circ}$  angle specified in item M of the CVSC. The height and width of the water tower may impact the performance of the VOR. If this site is selected for Mobile VOR testing, the results will determine if this water tower will significantly impact the operation of the facility and identify the extent of potential radial restrictions. It is recommended that this water tower be included in any math-modeling performed for this site.

- Two concrete silos are visible from the proposed VOR location. The first concrete silo is located at a bearing of  $245^{\circ} 30'$  from North as observed from the proposed VOR site, subtending a vertical angle of  $1^{\circ} 10'$  above horizontal. This silo is just under the  $1^{\circ}$  angle specified in item M of the CVSC.
- The second concrete silo is located at a bearing of  $287^{\circ} 04'$  from North as observed from the VOR site, subtending an angle of  $0^{\circ} 36'$  above horizontal. This silo is located approximately 1700 feet from the proposed VOR site and does not violate any criteria of the CVSC.

- Billboards and Cell towers were observed at approximate bearings of  $288^{\circ} 15'$ ,  $296^{\circ} 03'$  and  $108^{\circ} 26'$  from North as measured from the proposed VOR site. The tallest of these structures subtended a vertical angle of  $1^{\circ} 0'$  above horizontal. None of these structures violate any criteria of the CVSC, however they have potential to slightly impact the evaluation of the site during the Mobile VOR Test due to their orientation relative to the VOR site.

- A significant treeline penetrates the  $2^{\circ}$  angle specified in item I of the CVSC from a bearing of  $348^{\circ} 48'$  through  $61^{\circ} 43'$  from North as observed from the proposed VOR location. The largest vertical penetration was  $3^{\circ} 12'$  above horizontal, and was located approximately 1278 feet from the VOR location.
- A second treeline penetrates the  $2^{\circ}$  angle specified in item I of the CVSC from a bearing of  $198^{\circ} 34'$  through  $236^{\circ} 11'$  from North as observed from the proposed VOR location. The largest vertical penetration was  $2^{\circ} 23'$  above horizontal.

- The Tulip site is relatively flat. There was no irrigation pivot on the property at the time of the site visit, however the property is set up for one. 3-Phase power and Telco are available near the site. There is a water tower that slightly penetrates the obstruction angle and may block the signal when evaluated for radial coverage. This may impose restrictions on the new facility but the Mobile VOR Test will identify if any of the coverage orbit will be restricted. Initial impression is that only missed approach procedures to small airports in the area may be affected.
