Bridge Inspection Report

SR 42

BOGUE HOMA CREEK

- INSPECTION DATE
06/29/2023
- STRUCTURE NUMBER
310004205607620
- BRIDGE ID
13920

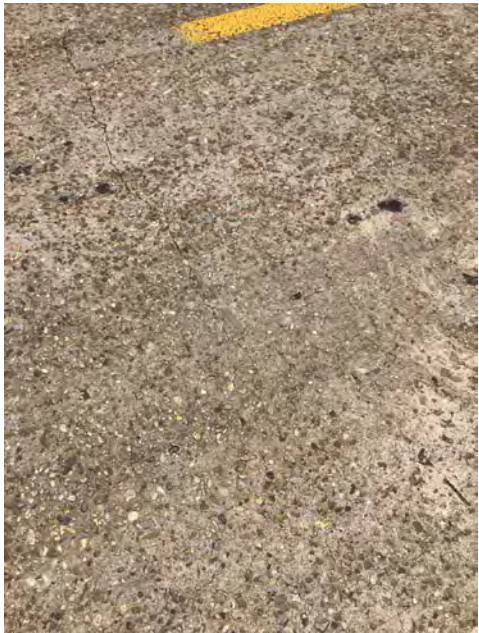
PHOTO 4

Deck cracking

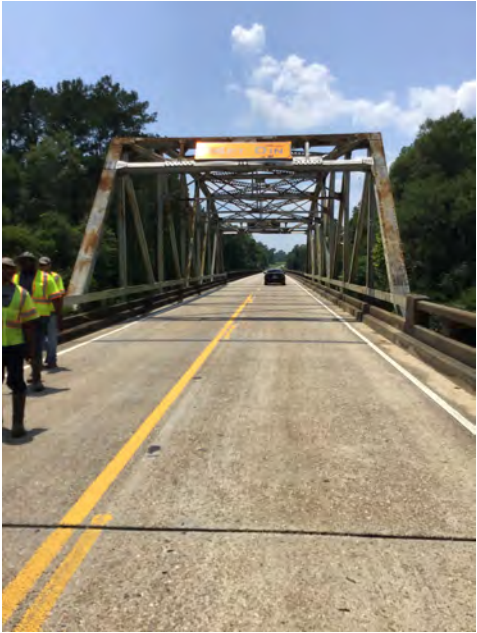
Portals-The bottom member of both portals has been replaced in the past, as evident of bolted connections. Both the East and West portal show signs of damage from over-height impact. The bottom member of the East and West portal over the West bound lane is severely bent and damaged in places. The damage appears to be the same since the last inspection. Surface rust is on the top portion of portals with overall condition being fair.

PHOTO 26 Truss
Description East portal

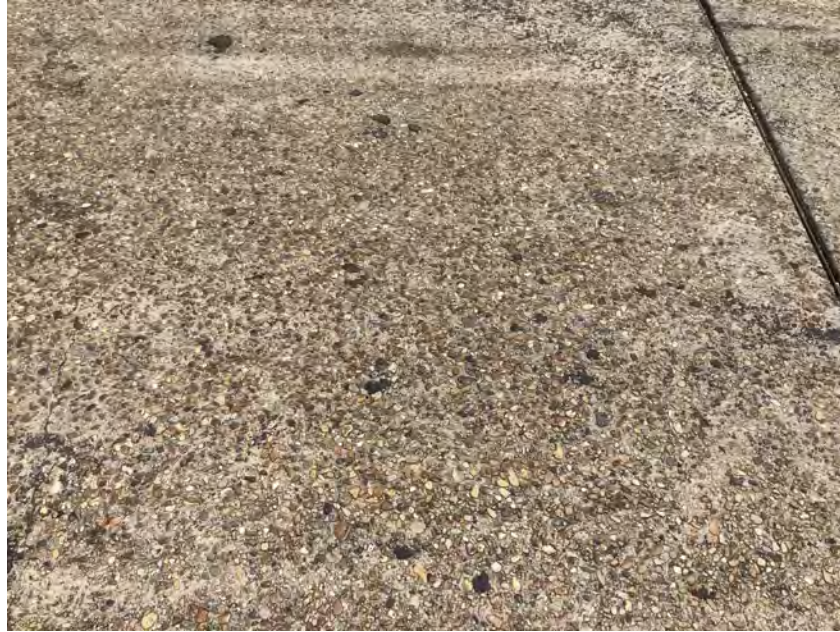
PHOTO 29 Deck

Description Typical wear in riding surface

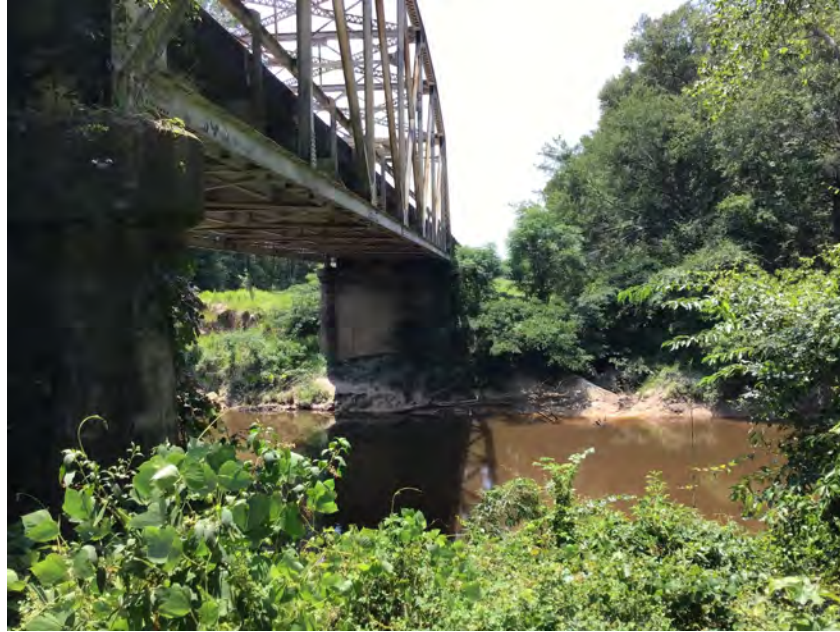
DESIGN MAIN CHANNEL SPAN	CURRENT MAIN CHANNEL SPAN
BANK CONDITION-UPSTREAM Good	
BANK CONDITION-SITE Good	Light
BANK CONDITION-DOWNSTREAM Good	
SCOUR COUNTERMEASURES Good	Rip rap as been added to West abutment due to bank erosion.

Description West bank

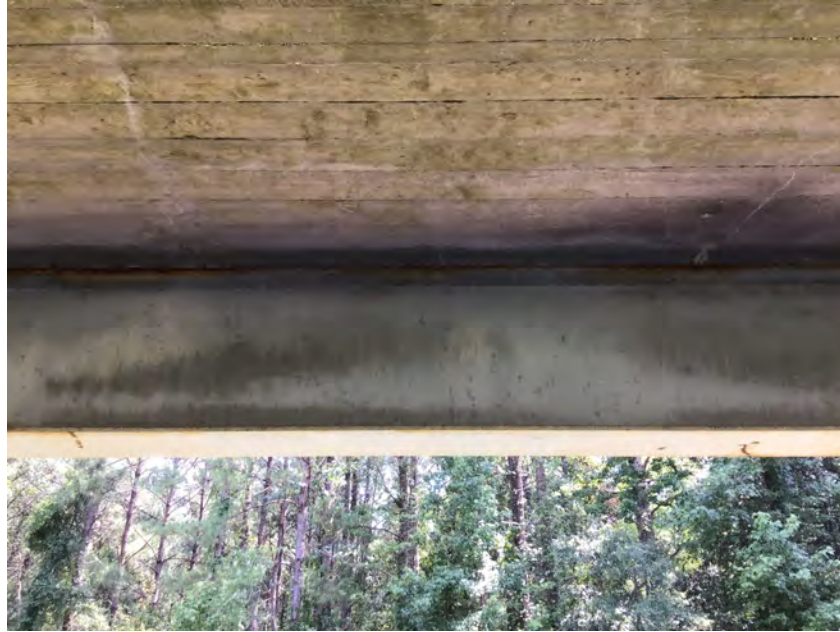
PHOTO 37 Superstructure

Description Typical paint losing its effectiveness on steel girders.

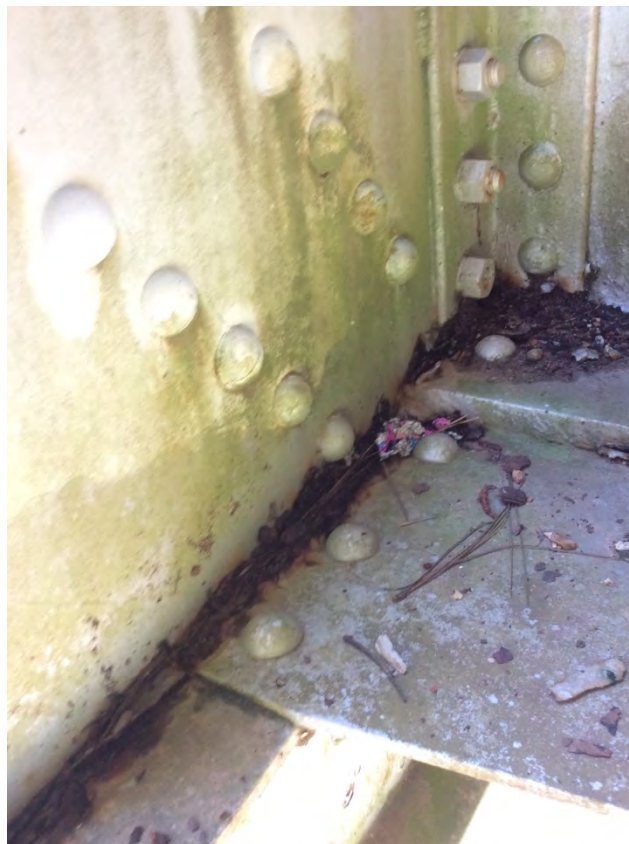
The lower panel points where the lateral bracing is connected to the floor beams and lower chord by a horizontal gusset plate are prone to collecting debris and water. Debris and moisture collect in a gap between the vertical gusset plates and the bottom flange of the floor beams causing pack rust. All of the vertical gusset plates have section loss ranging from 1/16" to 1/8" with gusset plate thickness being 3/8". See notes for locations and measurements on section loss in gusset plates. The areas of section loss were somewhat cleaned and spot painted with RUSTGRIP paint since the last inspection. The spot painted areas are beginning to show signs of rust or the paint is flaking off in some locations.

Left Truss Panel Point at L3

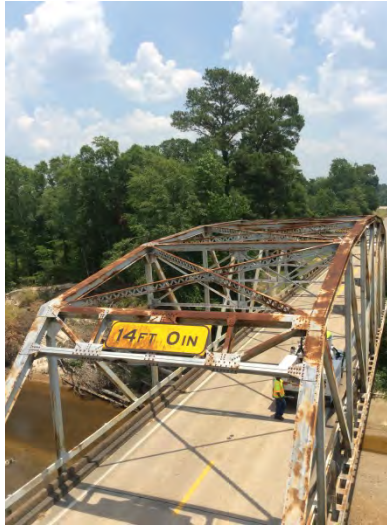
The upper chord is constructed of two (2) C-sections connected with rivets by a solid plate on top and intermittent batten plates and lattice members on bottom to form a box section. The top plate of the chord contains minor surface rust throughout the whole length. No loose rivets were discovered. No deviation in alignment or distortion in member was evident. Overall the upper chord is in good condition.

Top of Truss Upper Chord Viewing West

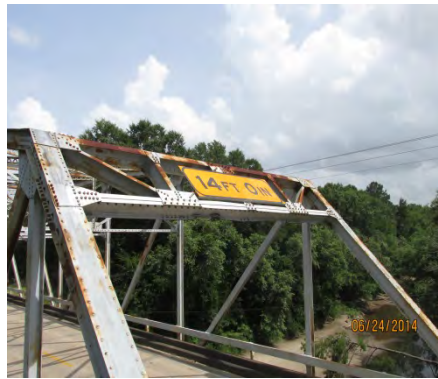
West Portal

The bottom member of both portals has been replaced in the past, as evident of bolted connections. Both the East and West portal show signs of damage from over-height impact. The bottom member of the East and West portal over the West bound lane is severely bent and damaged in places. The damage appears to be the same since the last inspection. Surface rust is on the top portion of portals with overall condition being fair.
