Bridge Inspection Report

US 51

TILDA BOGUE CREEK

- INSPECTION DATE
04/12/2022
- STRUCTURE NUMBER
210005104512470
- BRIDGE ID
13013

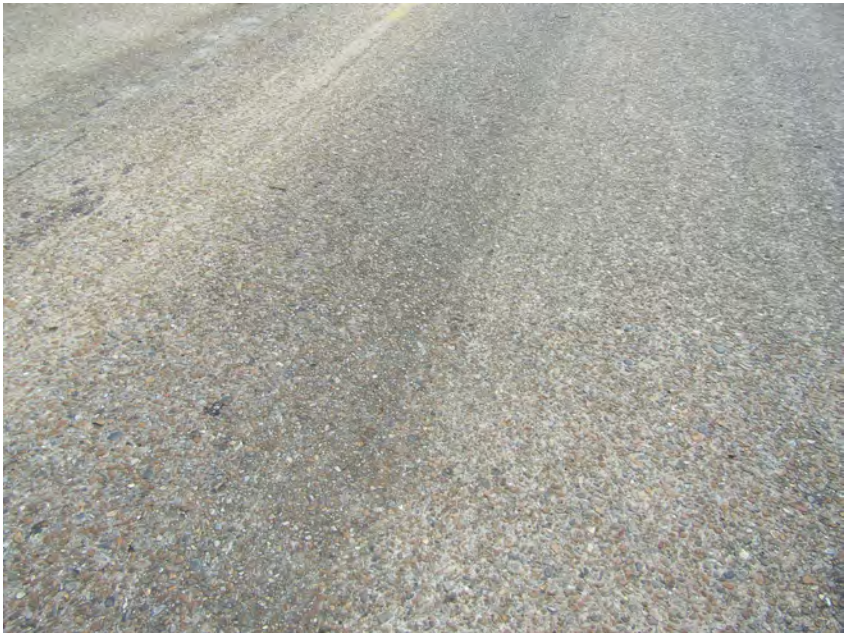
2.LIGHT DECK SCALING AT ALL SPANS.

PHOTO 4 General
Description LIGHT DECK SCALING

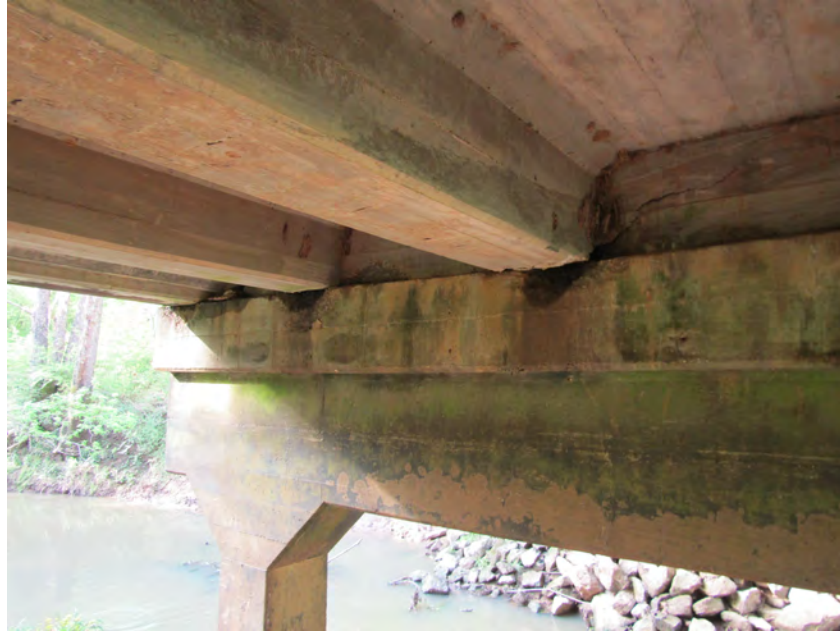
- 10.BENT 5, SPAN 4 DELAMS UNDER BEAMS 1,2,3,4,5 WITH EXP. REBAR AT FACE OF CAP
- 11.BENT 5, SPAN 5, SPALL AT FACE OF CAP UNDER BEAMS 3,4,5.
- 12.4' CRACK AT TOP OF WING WALL AT NE CORNER AT TOP AND BOTTOM.

PHOTO 7 General
Description BENT 5 SPAN 5 SPALL TO FACE OF CAP UNDER BEAMS 3,4,5

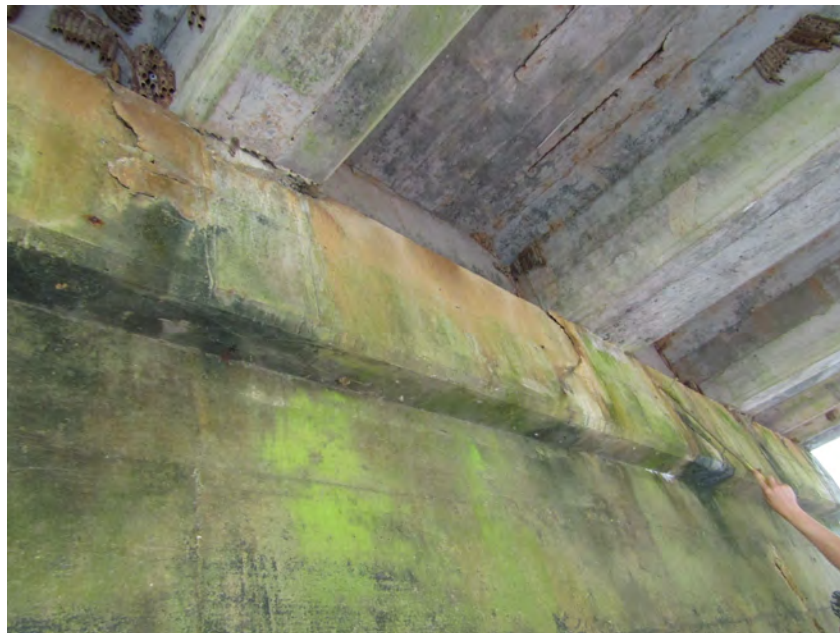
PHOTO 8 General
Description BENT 5 SPAN 4 DELAMS FACE OF CAP

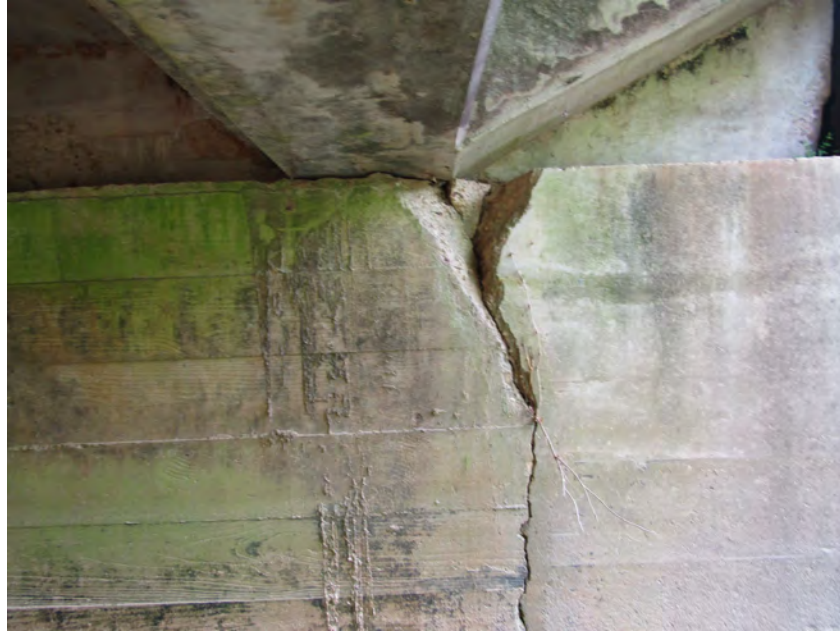
- 1.3 VC'S AT ABUTMENT WALL AT BENT 1.
- 2.SPALL AT TO OF ABUTMENT WALL UNDER BEAM 5, 2' X 2' B-1.
- 3.TOP OF WING DAMAGED AT SE CORNER, HANGING IN PLACE.

- 13.3 VC'S AT ABUTMENT WALL AT BENT 6, 2 ARE HEAVY
- 14.SPALL AT FACE OF CAP UNDER BEAMS 1 AND 3 AT BENT 4, SPAN 4, 3'.
- 15.EXP. REBAR AT FACE OF CAP AT BENT 4, SPAN 3, 3' X 4'.

PHOTO 9 General
Description VC'S IN ABUTMENT WALL

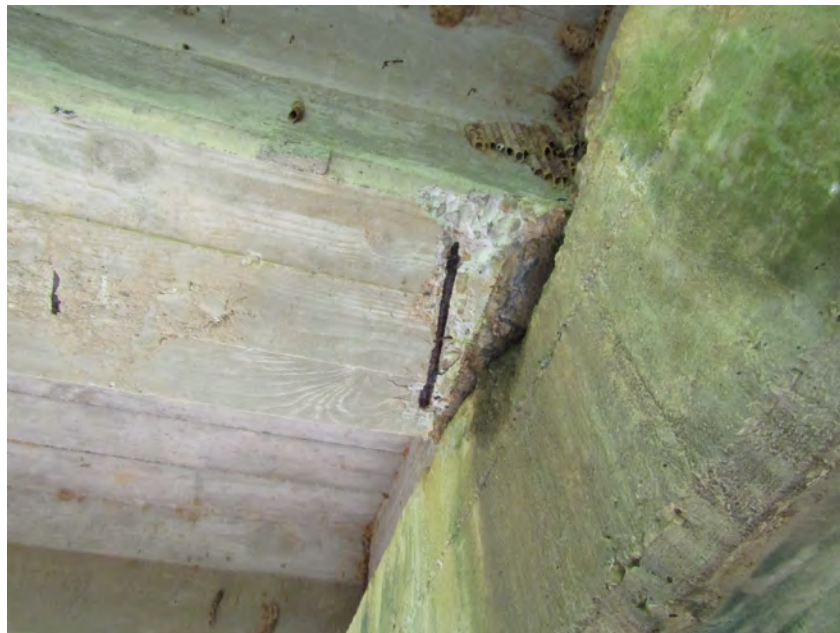
- 1.BEAM 3 AT BENT 3, SPAN 3 LIGHT SPALL AT BEAM END.
- 2.B-3 SPAN 3 BEAM 3 EXP REBAR AT BEAM ENDS.
- 3.DIA. SPALLED AT BAYS 2,3,4 AT BENT 5, SPAN 5.
- 4.REBAR EXP AT BOTTOM OF BEAM 1 AT 3 LOCATIONS AT BENT 4, SPAN 4.
- 5.REINF EXP. AT BEAM 3, AT BENT 5, SPAN 5, 10'
- 6.DIA 1 AT BENT 6, SPALLED AT BAYS 1 AND 4. 3' X 2'.
- 7.LIGHT VC'S AT ALL GIRDERS.
- 8.DIA. AT BENT 1 SPALLED AT BAYS 1 THRU 4.
- 9 B-5 SPAN 5 BEAMS 2AND 3 HAVE 1'X1' SPALL UNDER BEAM 5.

PHOTO 10 General
Description B-3 BEAM 3 SPAN 3 EXP REBAR IN BEAM END

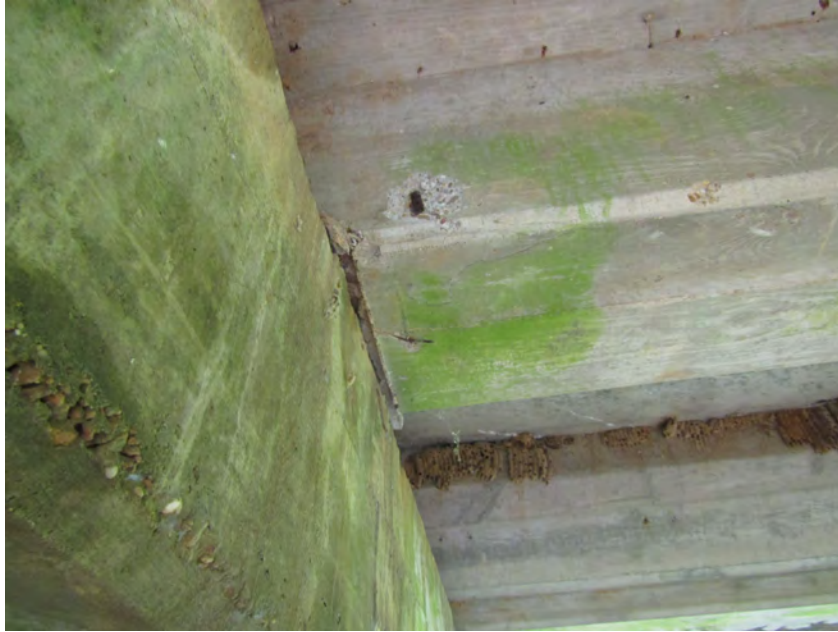
PHOTO 11 General
Description BEAM SPALLED BENT 3

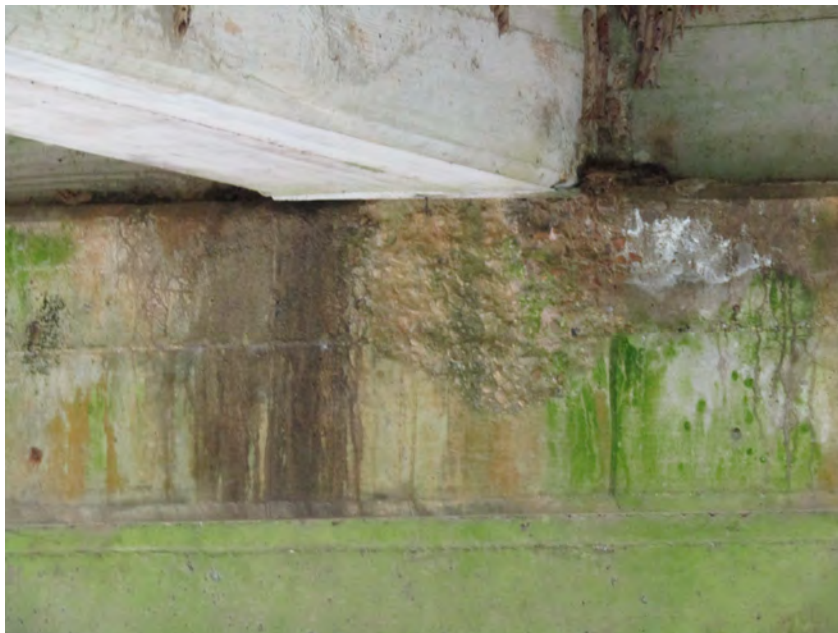
PHOTO 12 General
Description CAP SPALLED UNDER BEAMS 1 AND 3 BENT 4

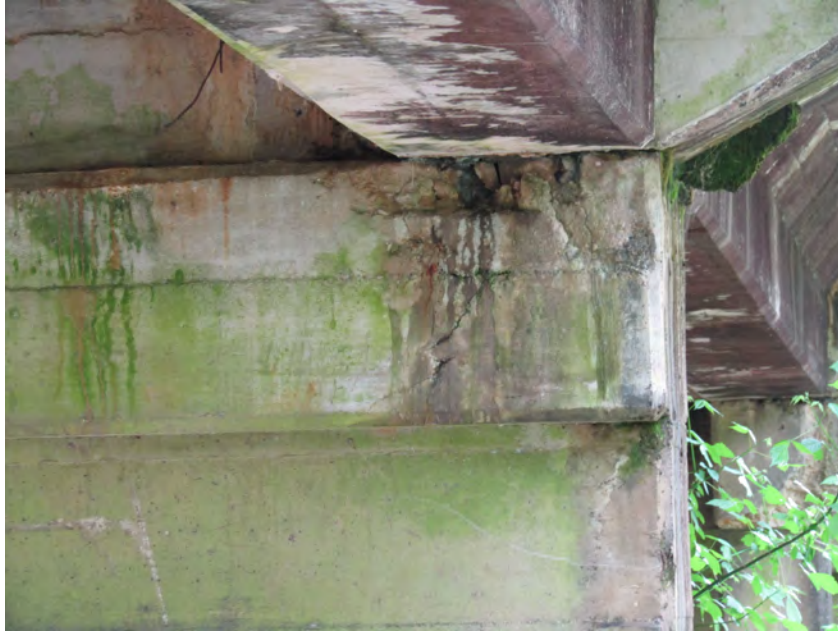
PHOTO 13 General

Description CAP SPALL BENT 4 BEAM 1

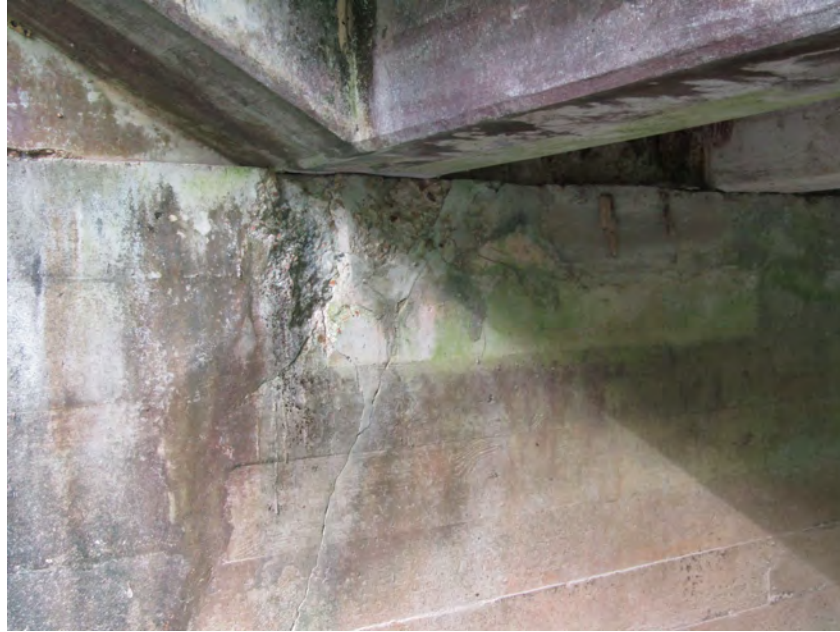
PHOTO 15 General

Description SPALL TOP OF ABUNTMENT WALL UNDER BEAM 5 2'X2' B-1

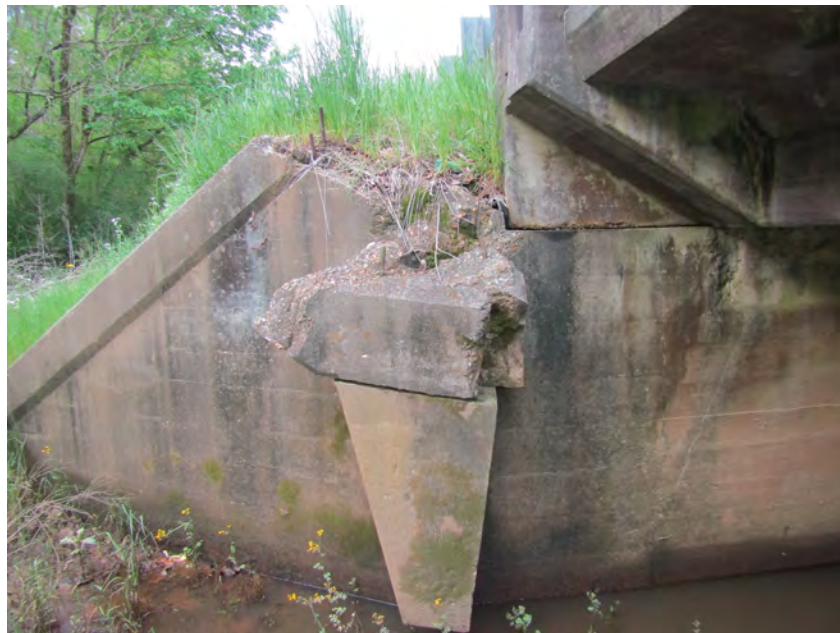
PHOTO 16 General

Description WINGWALL BROKE HANGING IN PLACE

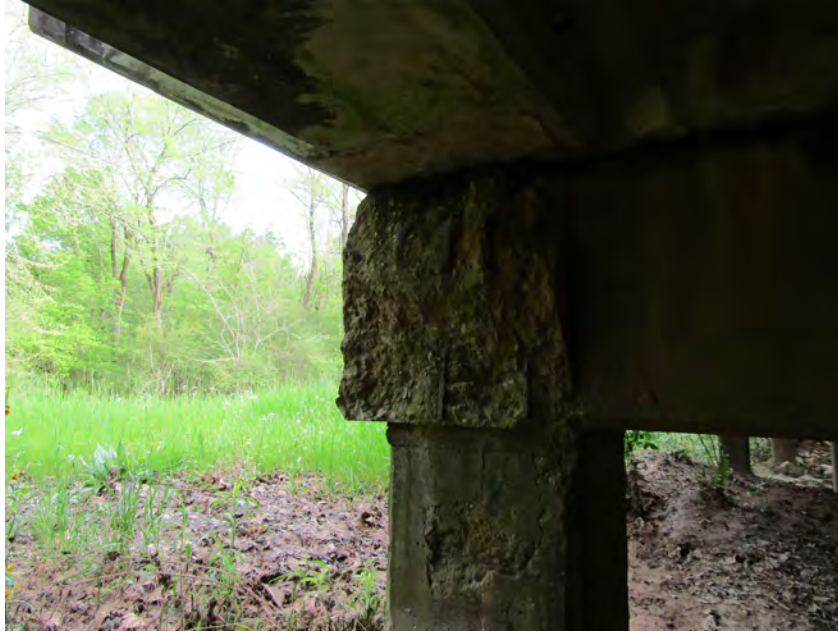
- 4.CAP SPALLED AT BENT 2, SPAN 1, 2'X 1'UNDER BEAM 1, EXP REBAR.
- 5.EXP. REINF AT ALL 5 PILES AT BENT 2.
- 6.DELAM AT CAP UNDER BEAMS 3 AND 4, SPALL IN FACE OF CAP BETWEEN PILES 3 AND 4, 3' X 1'AT B-2,SPAN 2 DUE TO EXPANSION.

PHOTO 17 General
Description CAP SPALLED AT BENT 2 SPAN 1 2'X1' UNDER BEAM 1

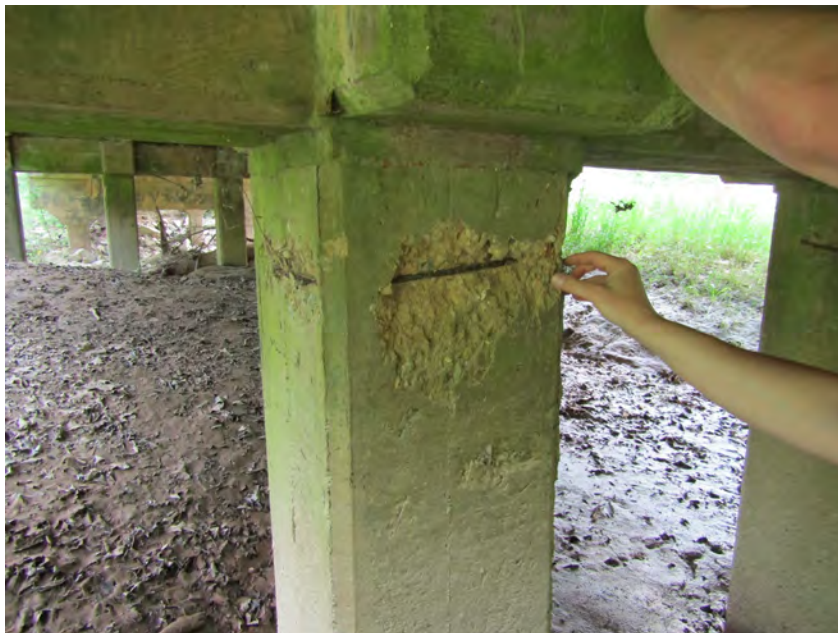
PHOTO 18 General
Description EXP REINFORCEMENT AT ALL PILES BENT 2

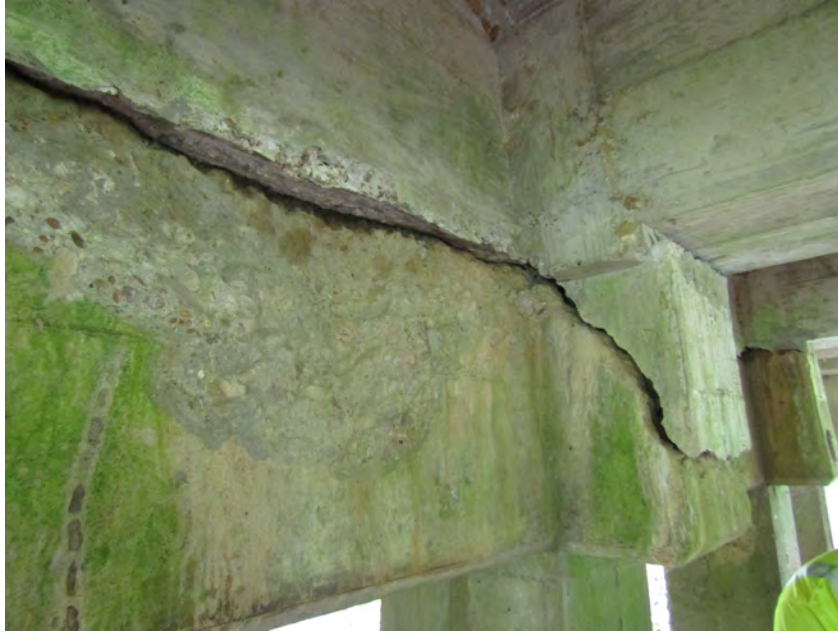
PHOTO 19 General
Description DELAM ON CAP UNDER BEAMS 3 AND 4 BENT 2

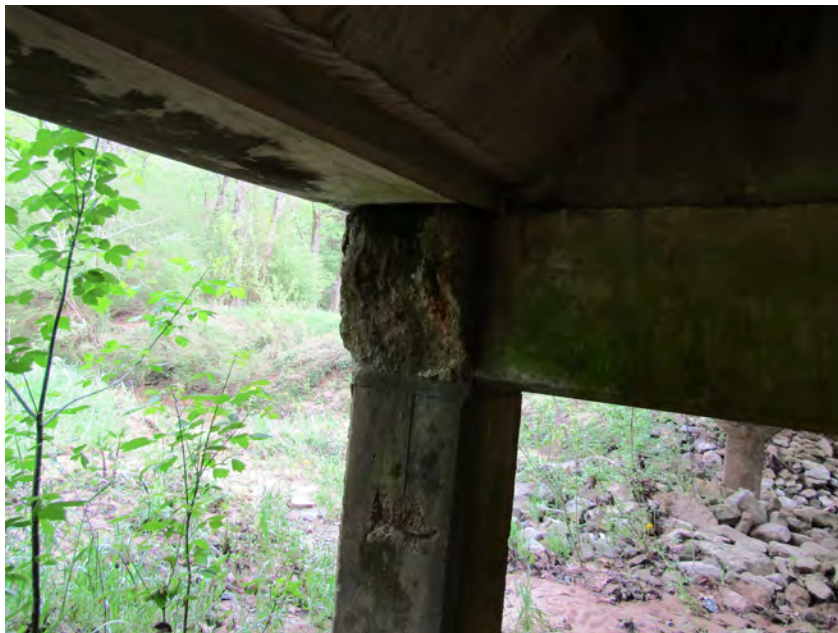
- 7.CAP SPALLED AT BENT 3, SPAN 2, 5' TOTAL.
- 8.CAP SPALLED AT BENT 3, SPAN 3 UNDER BEAMS 1,3,5, 3' X 1'.
- 9.SPALL TO PILE 2 AT BENT 3, EXP. REINF, LIGHT CRACKS TO PILE 3.

PHOTO 20 General
Description CAP SPALLED AT BENT 3 SPAN 2

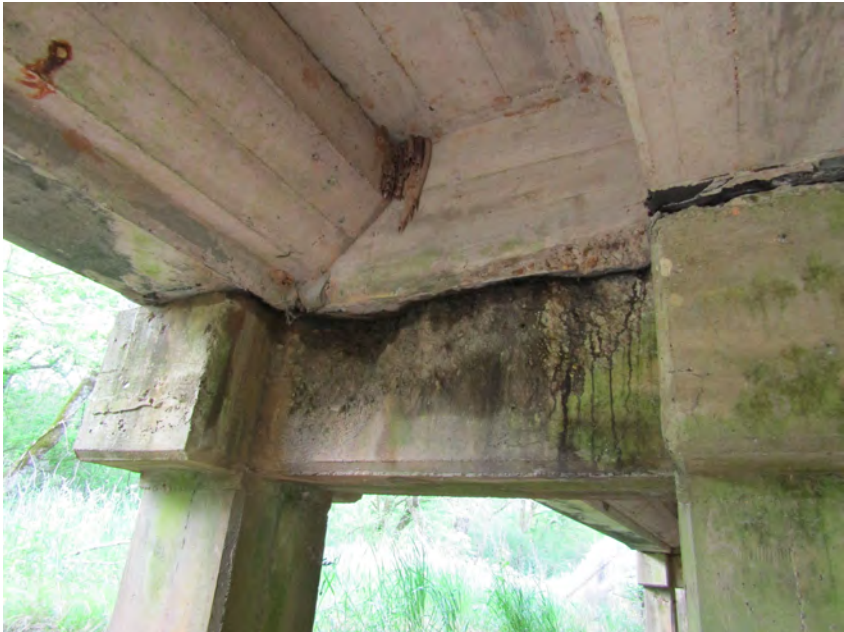
PHOTO 21 General
Description CAP SPALLED AT BENT 3 SPAN 4

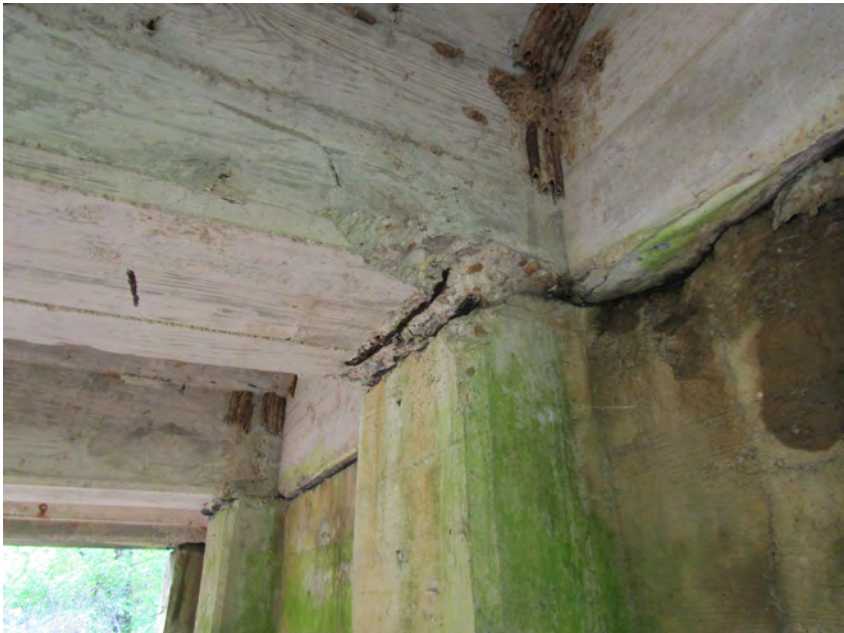
PHOTO 22 General
Description BEAM 3 SPAN 3 EXP REBAR

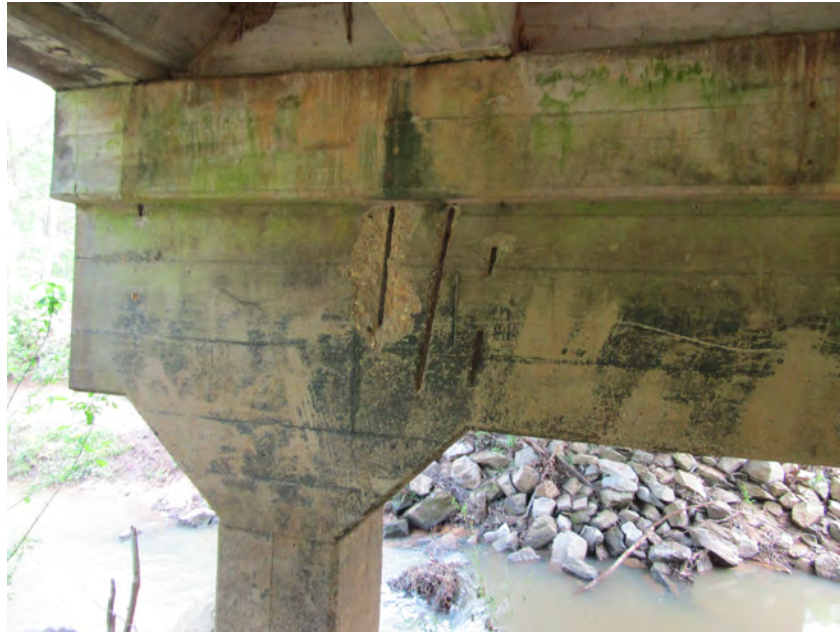
PHOTO 23 General
Description EXP REBAR FACE OF CAP BENT 4
