# Bridge Inspection Report

US 80

SLOUGH

- INSPECTION DATE  
04/20/2023
- STRUCTURE NUMBER  
210008003812310
- BRIDGE ID  
12376

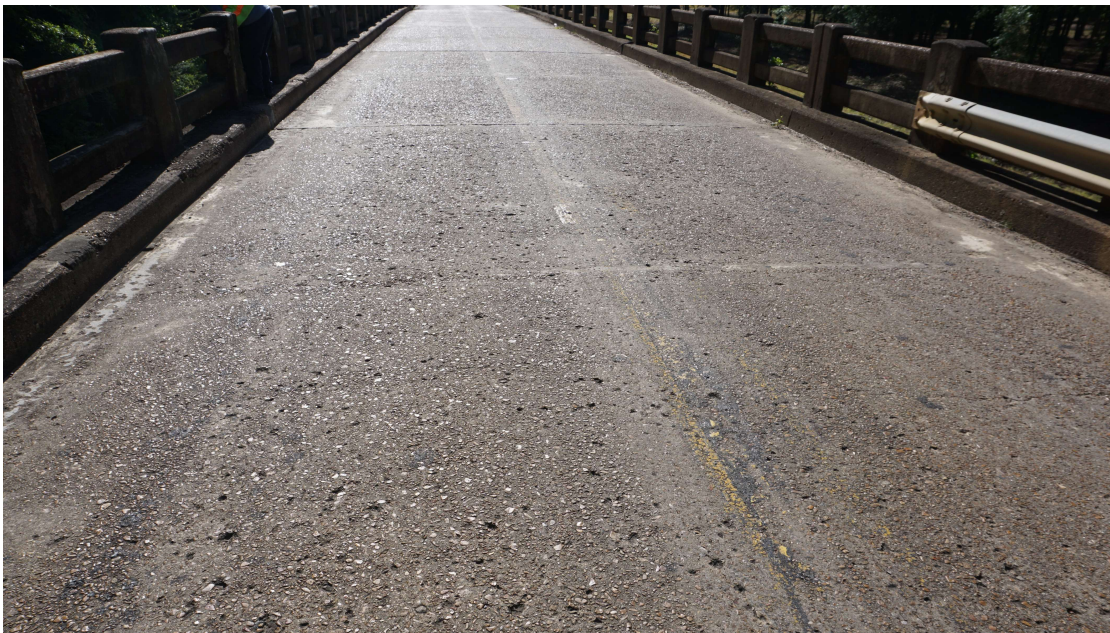
PHOTO 3 Deck

DECK IS IN FAIR CONDITION,RATED 5, WITH MOD. DECK SCALING AND DECK SPALLS.

Description DECK SCALINNG

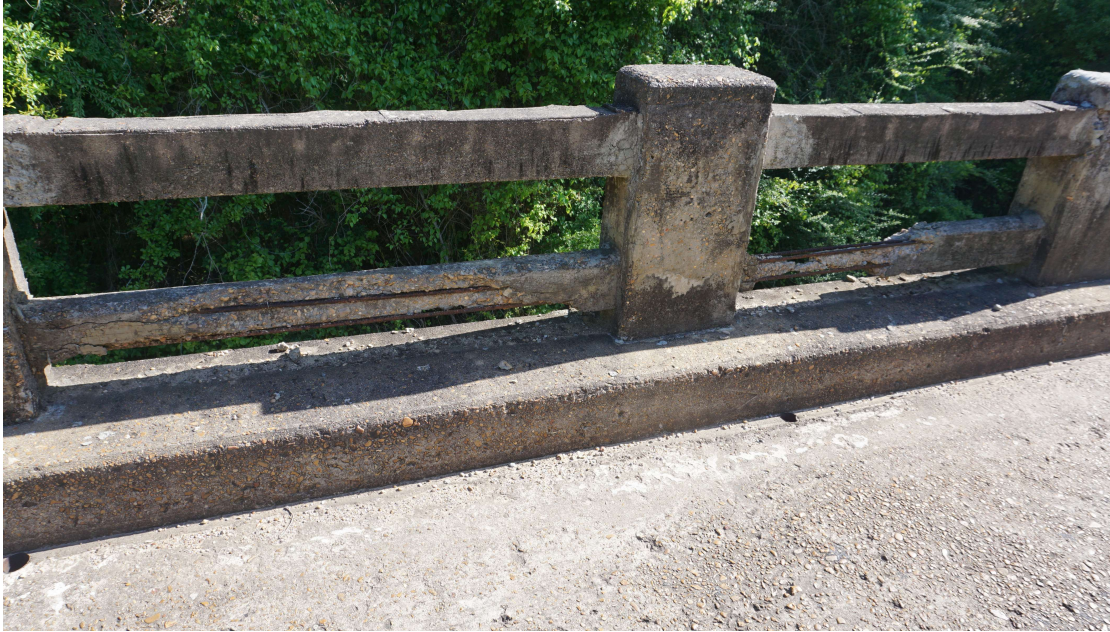
PHOTO 4 Deck

<u>Condition</u>	<u>Notes</u>
Structure:	Fair	MOD. DECK SCALING, DECK SPALL, SPAN 5, WEST BOUND LANE 2'X2.
Wearing Surface:	Poor	
Curbs:	NA	
Median:	NA	
Sidewalk:	NA	
Joints:	Poor	
Railing:	Fair	SPALL AND EXPOSED REBAR IN BRIDGERAIL, SPAN 3 NORTH SIDE 21.5'.
Drainage:	Good	
Lighting:	NA	
Utilities:	NA	
Overlay Thickness:	in

Description SPALL AND EXPOSED REBAR IN BRIDGERAIL SPAN 3.

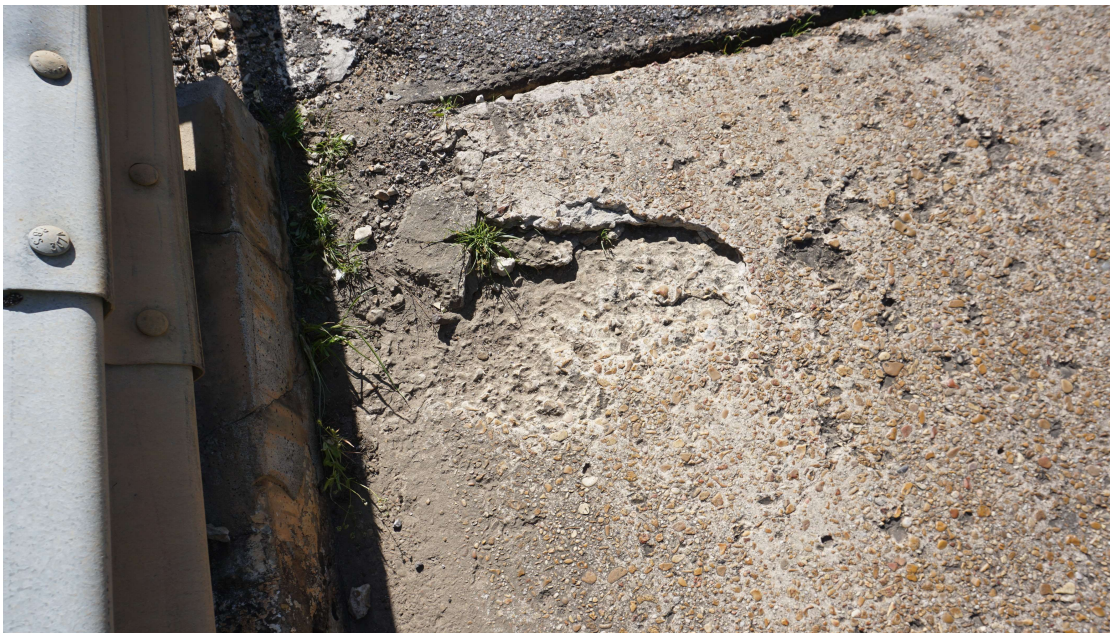
PHOTO 5 Deck

Description DECK SPALL, SPAN 5, WEST BOUND LANE 2'X2.

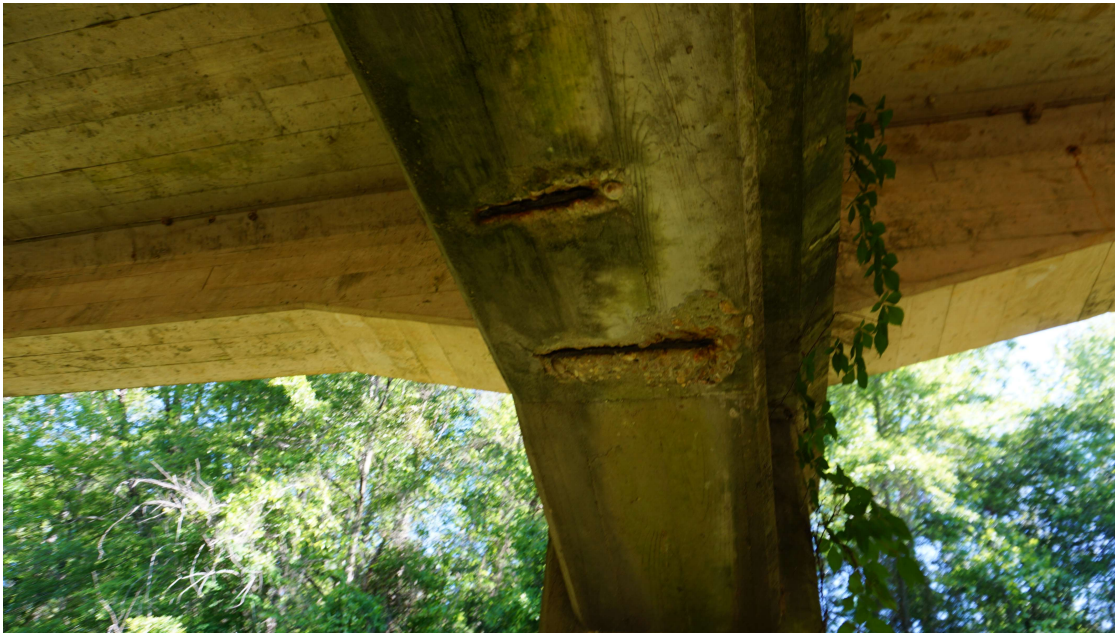
<u>Condition</u>	<u>Notes</u>
Backwall:	Good	
Bulkhead:	NA	
Wing Walls:	Good	
Cap:	Fair	DELAM AT FACE OF CAP AT BENT 2, UNDER BEAM 2, 2' X 3'. REBAR EXP. AT BOTTOM OF CAP AT BENT 4, 2'X2'. 3' X 6" SPALL/DELAM BOTTOM OF CAP BENT 2. LIGHT SPALL FACE OF CAP BENT 2 SPAN 2 BEAM 2, 1'X6".
Footings:	NA	
Piles:	NA	
Embankment:	Good	
Slope Paving:	NA

PHOTO 7    Substructure  
Description    REBAR EXP. AT BOTTOMOF CAP AT BENT 4, 2' X 2'.

1. REPAIR BEAM ENDS.
2. REPAIR CAP SPALLING.

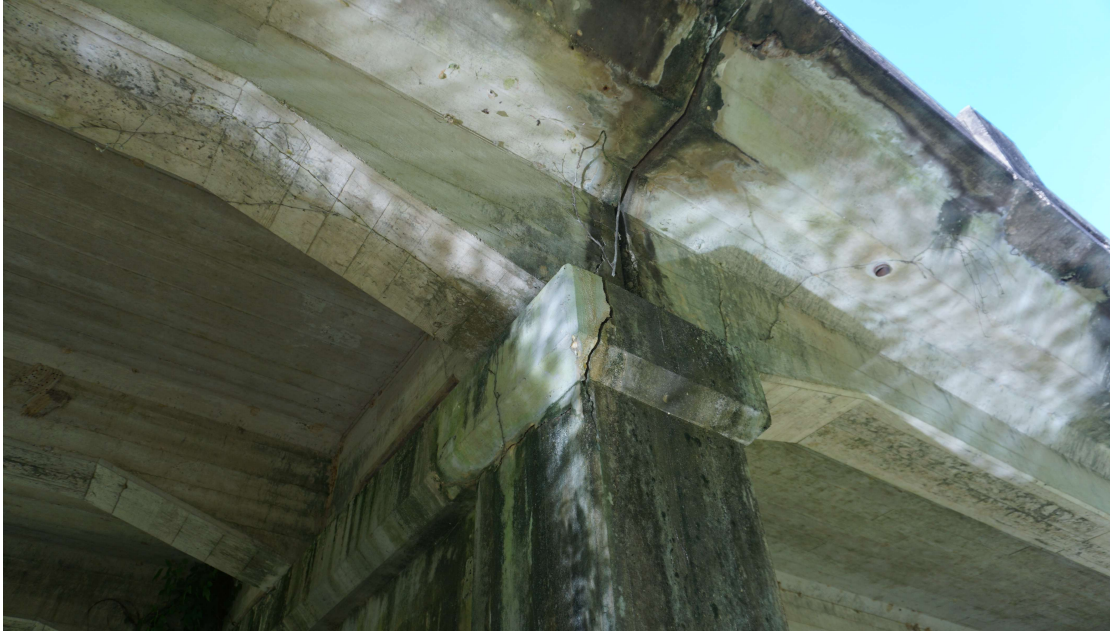
PHOTO 10 Substructure

Description SPALL BOTOM OF CAP BENT 2.

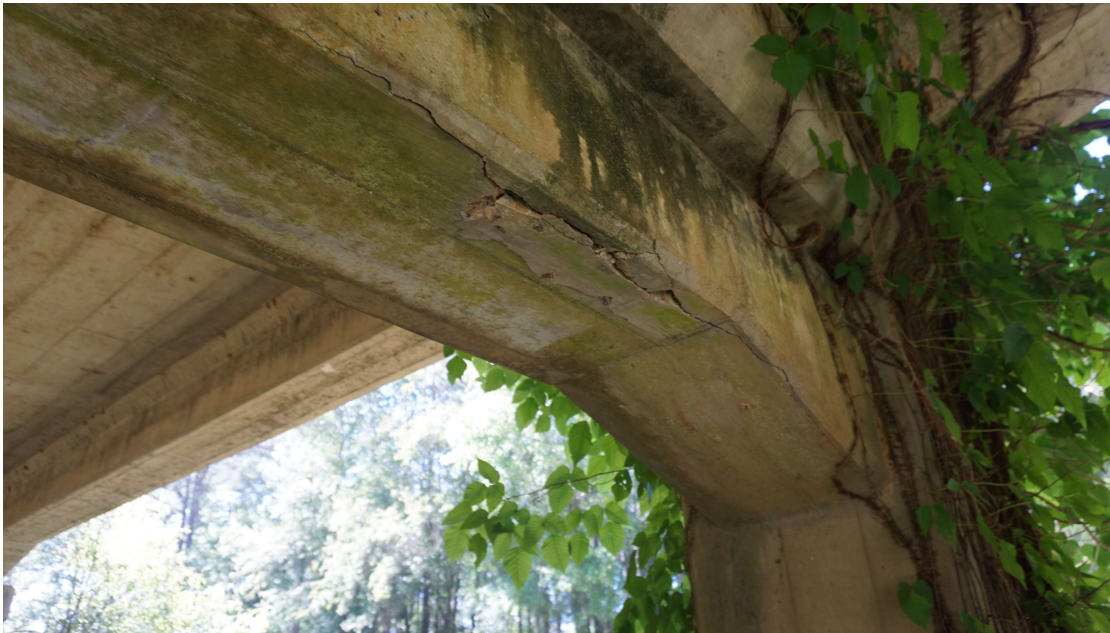
PHOTO 11 Substructure

Description DELAM AT FACE OF CAP AT BENT 2.
