# Bridge Inspection Report

US 80

SLOUGH

- INSPECTION DATE  
04/20/2023
- STRUCTURE NUMBER  
210008003812350
- BRIDGE ID  
12378

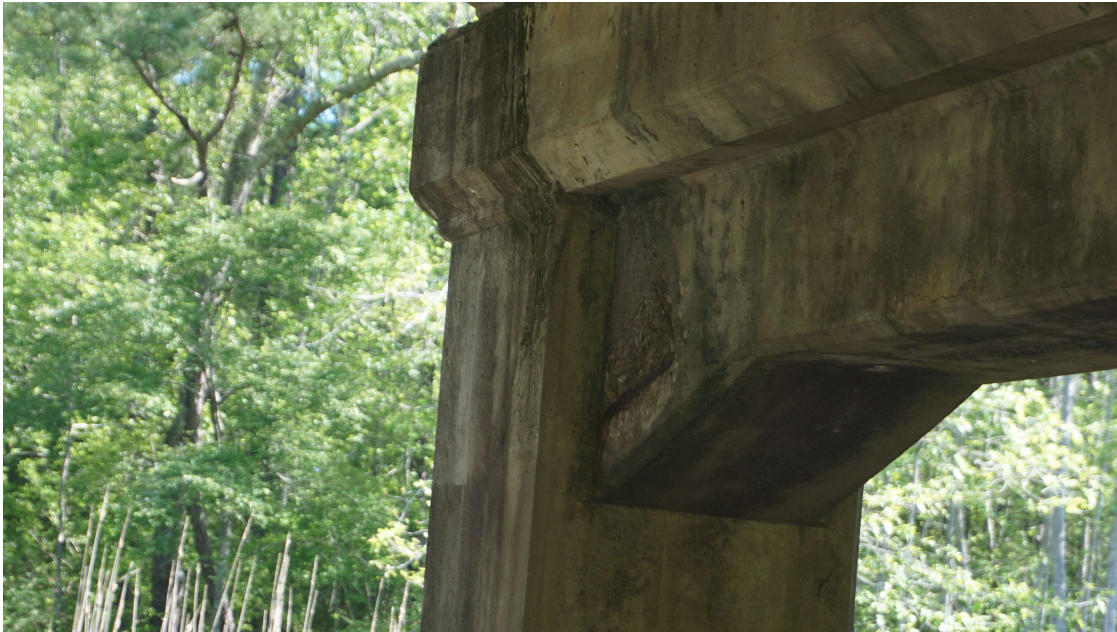
PHOTO 5      Substructure

<u>Condition</u>	<u>Notes</u>
Backwall:	Good	
Bulkhead:	NA	
Wing Walls:	Good	
Cap:	Fair	B-2, SPAN 1, SPALL WITH EXP. REBAR 1'X1' FACE OF CAP. B-3 SPAN 2 SPALLS WITH EXP REBAR AT WEST SIDE OF CAP, 3'.
Footings:	NA	
Piles:	NA	
Embankment:	Good	
Slope Paving:	NA

Description      B-2 SPAN 1, SPALL WITH EXP. REBAR 1' X1' FACE OF CAP

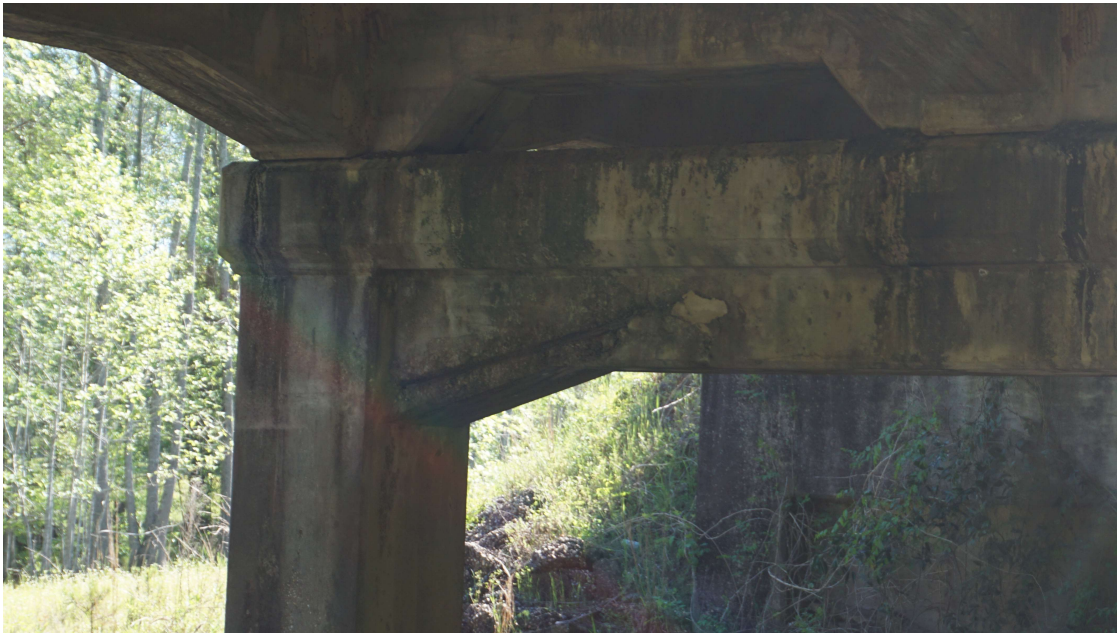
PHOTO 6      Substructure

Description      B-3 SPAN 2, SPALLS IN CAP.

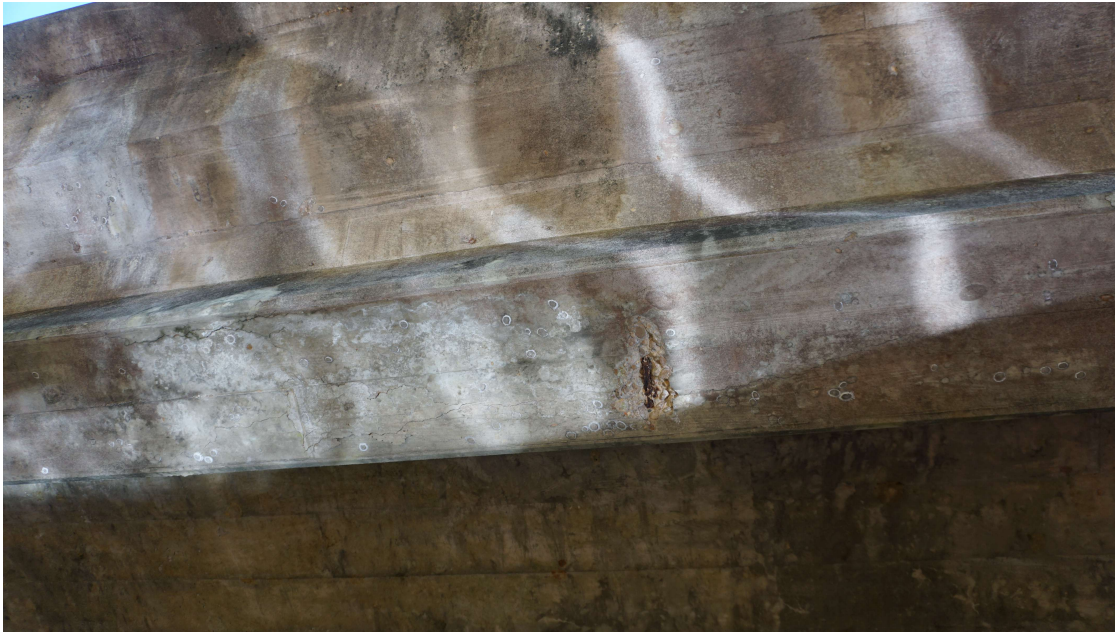
PHOTO 7     Superstructure

SUPERSTRUCTURE IS IN FAIR CONDITION,RATED 5,WITH VERTICAL CRACKS BEAM ENDS AND EXPOSED REBAR.

<u>Condition</u>	<u>Notes</u>
Girders:	Fair	VERT. CRACKS AT CONC. BEAM ENDS OF SPAN 2, B-3, BEAM 3. VC'S AT R/C BEAMS, EXP. REBAR AT SPAN 2, BEAM 3, 1', 2'X1' REBAR AT SPAN 1, SPALL AND DELAM BEAM 3 SPAN 2 BOTTOM OF BEAM 4'X1'.
Floor Beams:	NA	
Stringers:	NA	
Steel Risers:	NA	
Bearings:	NA	
Hinge Pins/Hangers:	NA	
Diaphragms/Cross Frames:	Fair	CONC. DIA CRACKED AT B-4 AT ENDWALL.
Paint:	NA	
Collision Damage:	Good	
Deflection/Vibration:	Good	
Cap/Girder Debris:	Fair	
Navigation Lighting:	NA

Description     SPALL AND DELAM BEAM 3 SPAN 2 BOTTOM OF BEAM 4'X1'. VC'S AT R/C BEAMS

1. Repair Beam ends.
2. Clean and seal deck.

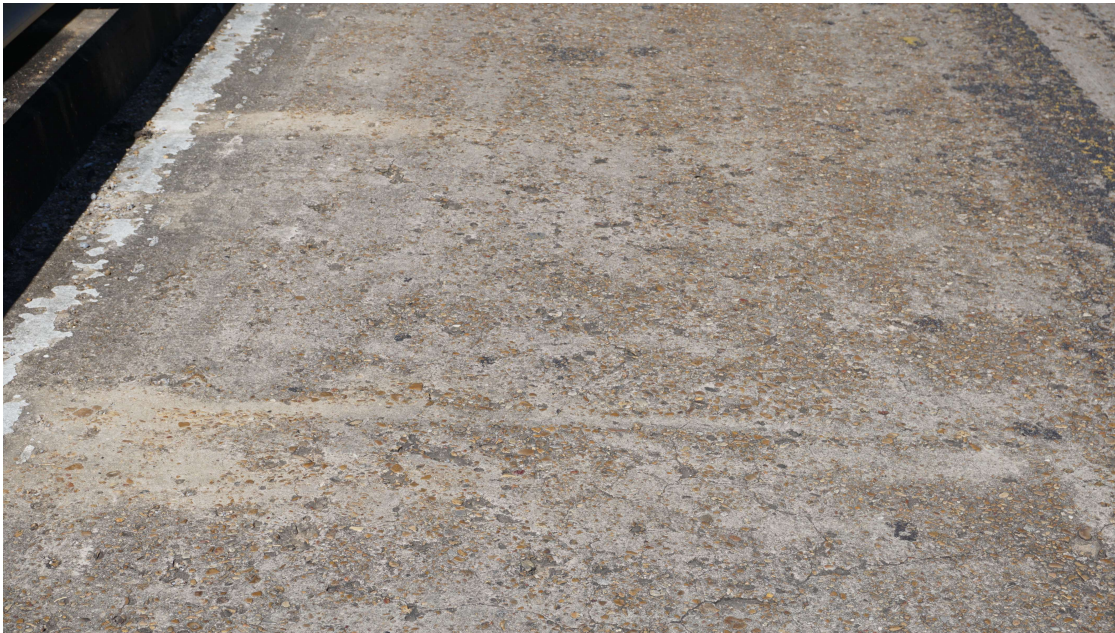
PHOTO 10    Deck  
Description    MOD. DECK SCALING. SEVERAL POP OUTS

DECK IS FAIR CONDITION,RATED 5,WITH MOD.SCALING AND POP OUTS,WITH EXPOSED REBAR IN THE SOFFITS.

<u>Condition</u>	<u>Notes</u>
Structure:	Fair	MOD. DECK SCALING, SEVERAL POP OUTS, REBAR EXP. AT BAY 1 AT SPAN 3, SOFFIT, EXP. REBAR AT SOFFIT AREA ALL 3 SPANS, SEVERAL LOCATIONS.
Wearing Surface:	Fair	
Curbs:	NA	
Median:	NA	
Sidewalk:	NA	
Joints:	Poor	
Railing:	Good	
Drainage:	Good	
Lighting:	NA	
Utilities:	NA	
Overlay Thickness:	in
