# Bridge Inspection Report

US 51

DOAKS CREEK  
MADISON County

- INSPECTION DATE  
04/12/2023
- STRUCTURE NUMBER  
210005104513010
- BRIDGE ID  
13024

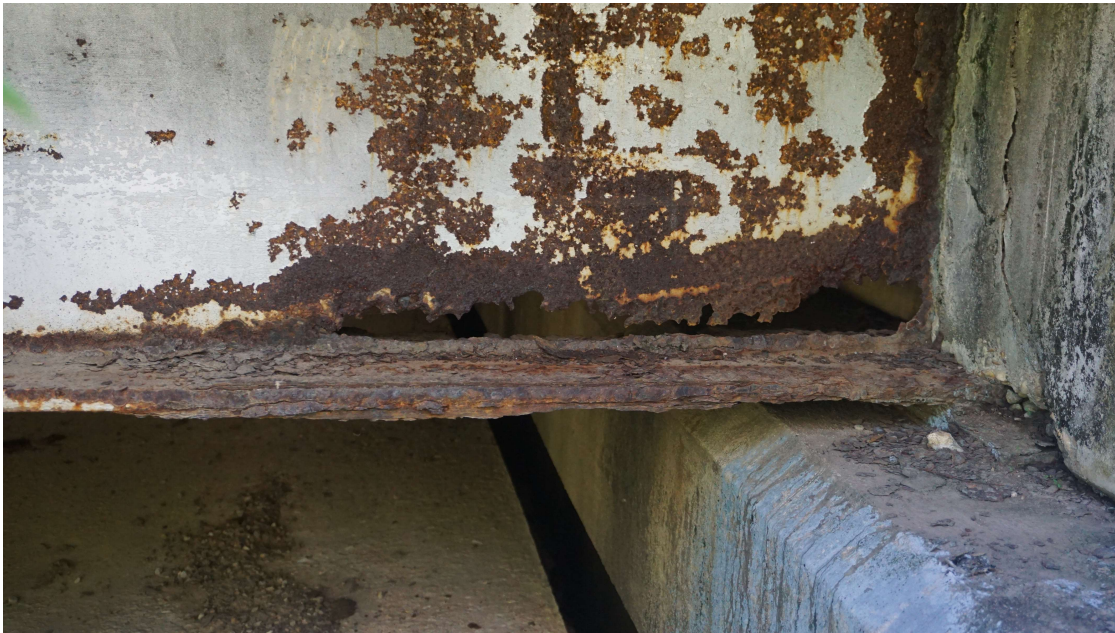
PHOTO 4     Superstructure  
Description     HIGH SECTION LOSS IN BEAM.

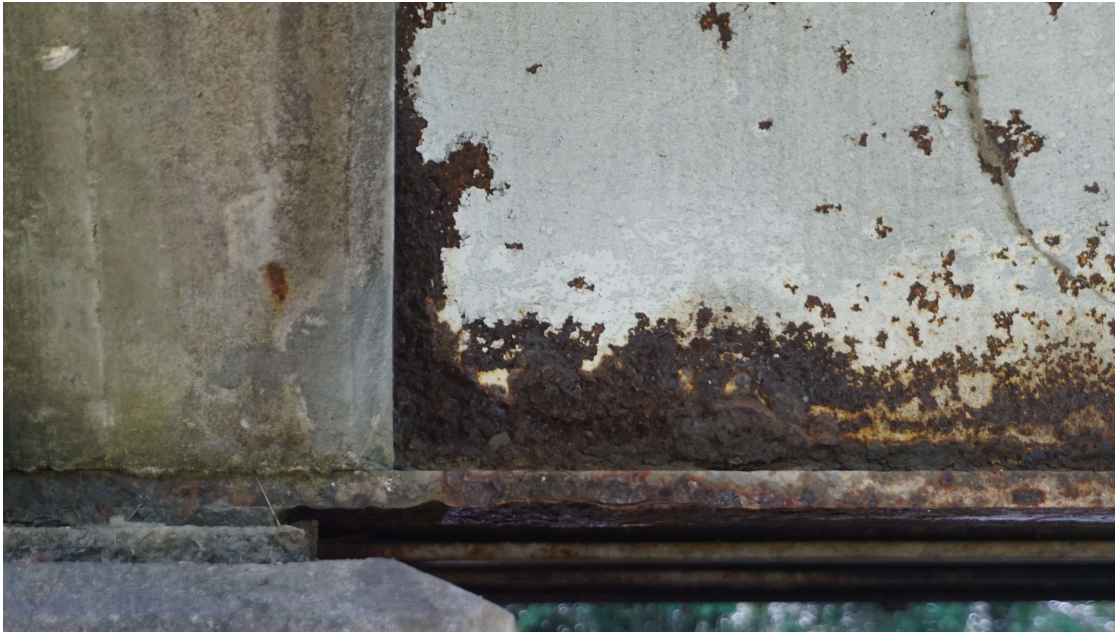
PHOTO 5     Superstructure  
Description     BEAM ENDS SEVER RUSTING.

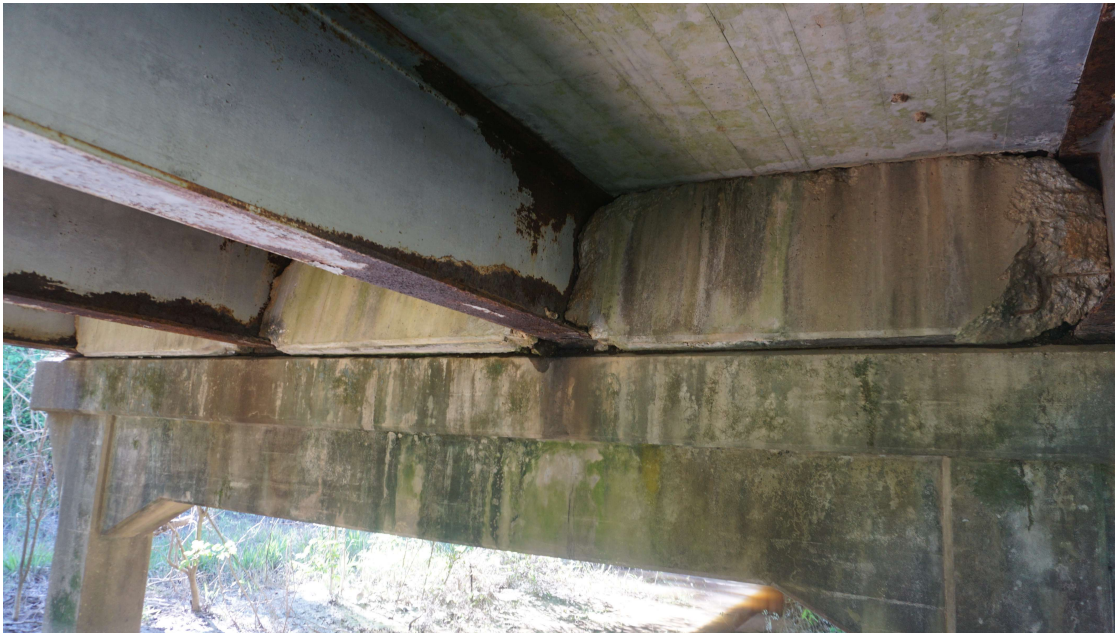
PHOTO 6     Superstructure  
Description     DIAPHRAGMS SPALLED ABOVE CAP.

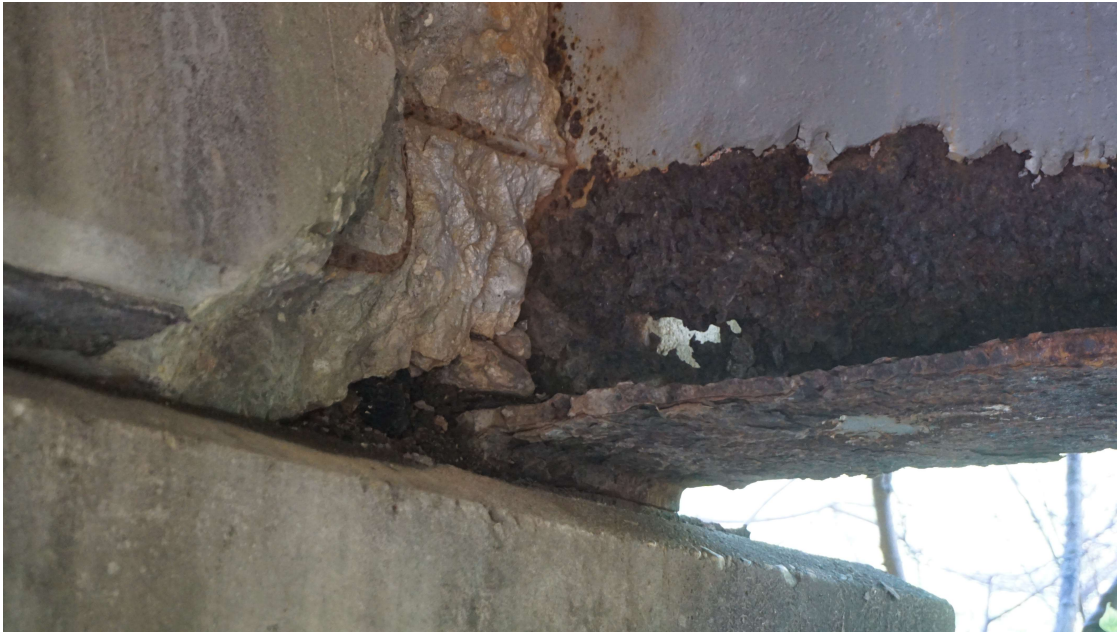
PHOTO 7     Superstructure  
Description     SECTION LOSS IN BEAM, WITH DIAPHRAM SPALLED.

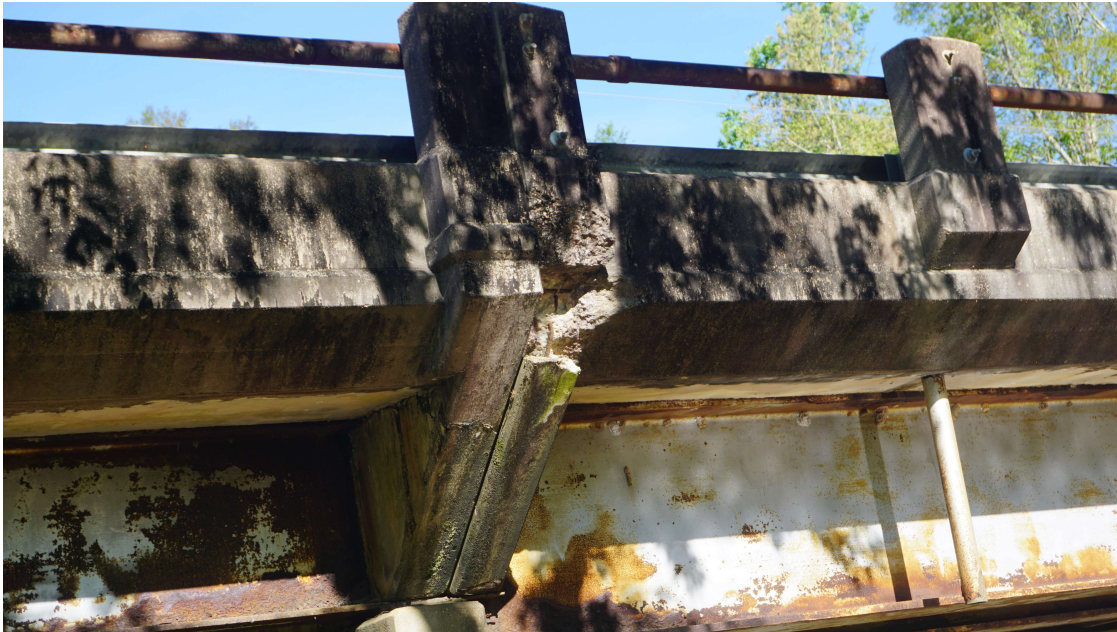
PHOTO 9     Deck  
Description     BRIDGE RAIL SPALLED.

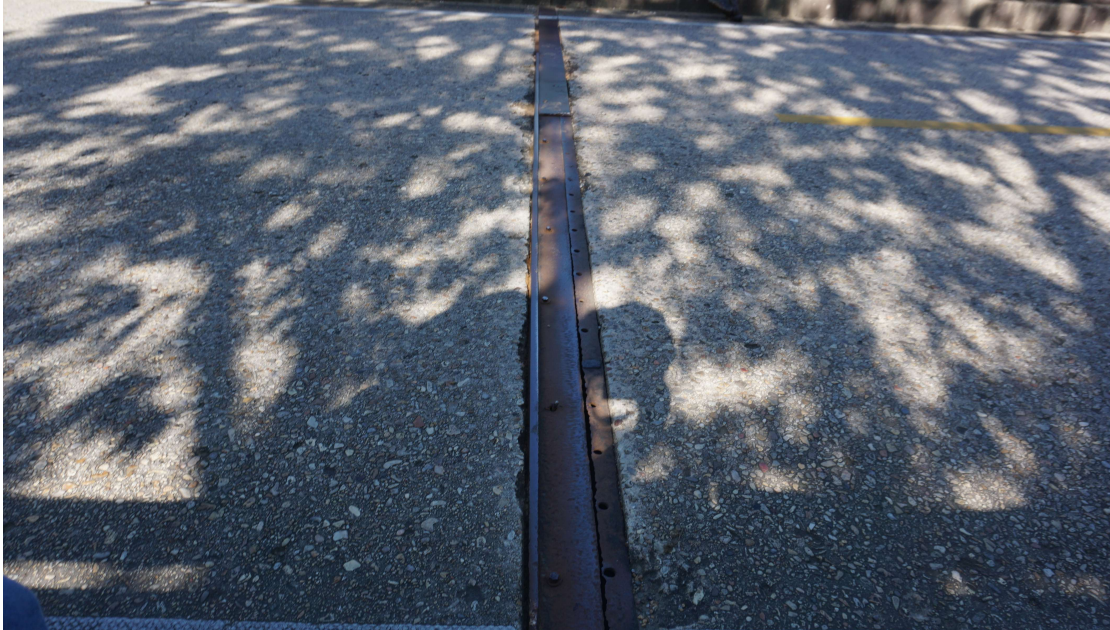
| | <u>Condition</u> | <u>Notes</u> |
|---|---|---|
| Joints: | Fair | JOINT ARMOR REMOVED B-4, NB LANE. LOOSE AT CENTER LINE. |

Description JOINT ARMOUR MISSING.

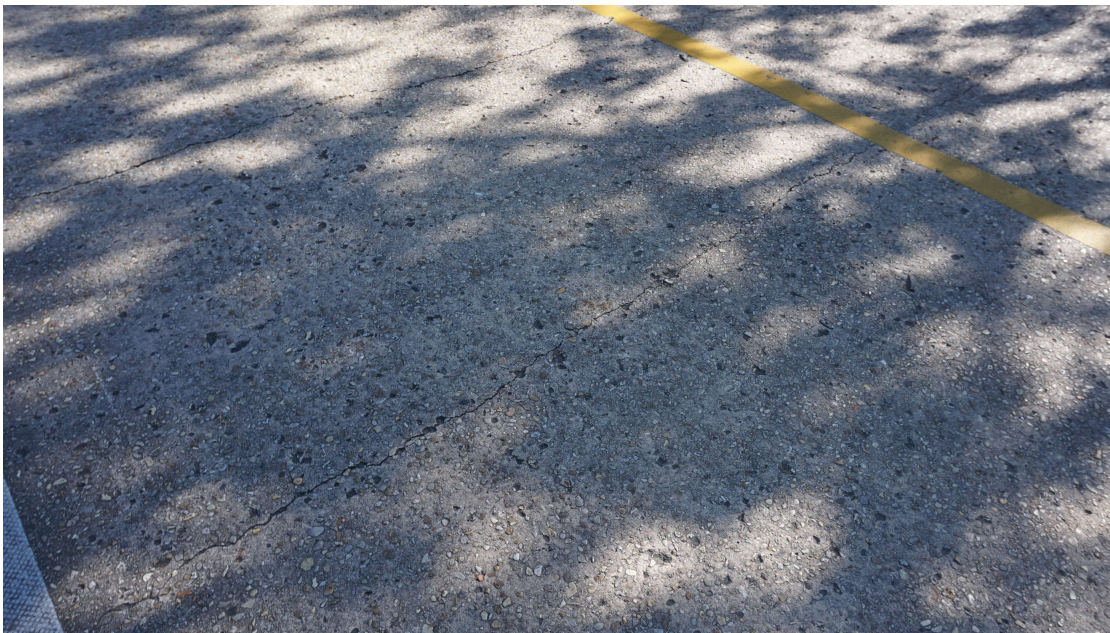
| | <u>Condition</u> | <u>Notes</u> |
|---|---|---|
| Structure: | Fair | HEAVY DECK CRACKING AT MID SPAN OF ALL SPANS EXTENDS TO SOFFIT, 1/8" PLUS. MOD. DECK SCALING AT ALL SPANS. |

Description DECK SCALING AND CRACKING.

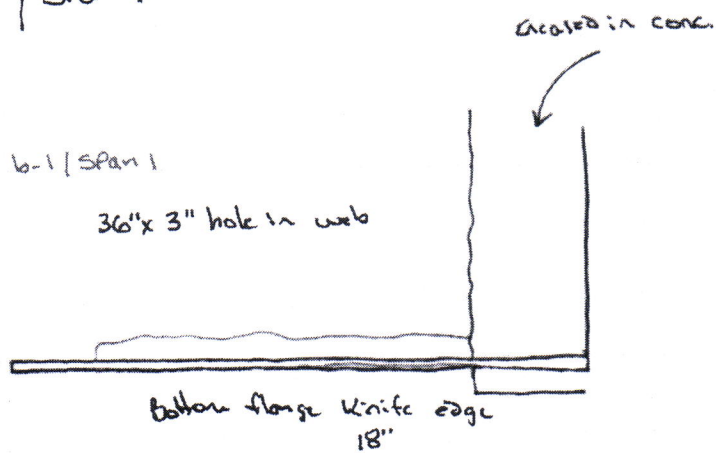
Beam 1 at b-1 / Span 1

36" x 3" hole in web

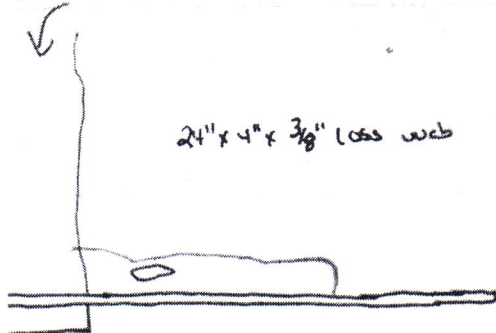
Bent 3 / Span 3

created in conc.

24" x 4" x 3/8" loss web

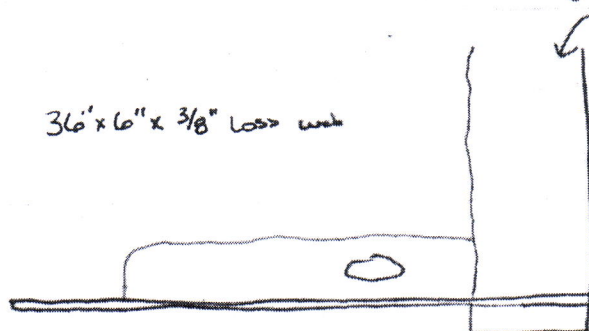
west side

created in conc.

36" x 6" x 3/8" loss web
