Bridge Inspection Report

US 80

BETHEL BRANCH

- INSPECTION DATE
02/09/2023
- STRUCTURE NUMBER
210008005111480
- BRIDGE ID
13535

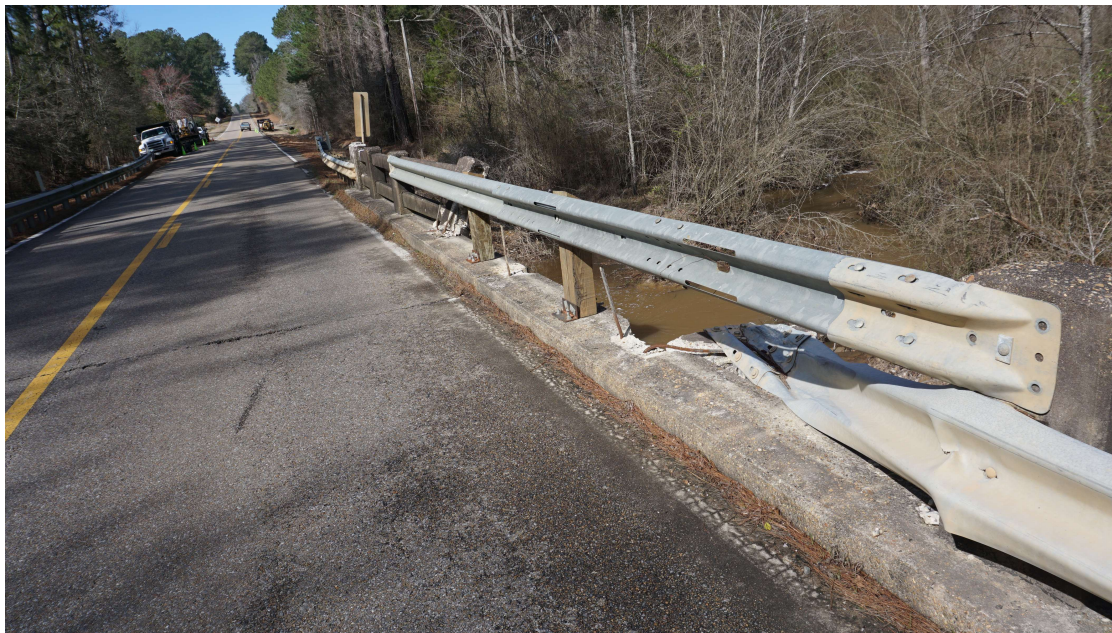
- 1.ASPHALT OVERLAY 2".
- 2.40' COL. DAMAGE TO WEST BOUND BRIDGE RAIL, 4 POST, SPANS 1 AND 2.

PHOTO 2 Deck
Description DAMAGE TO WEST BOUND RAIL

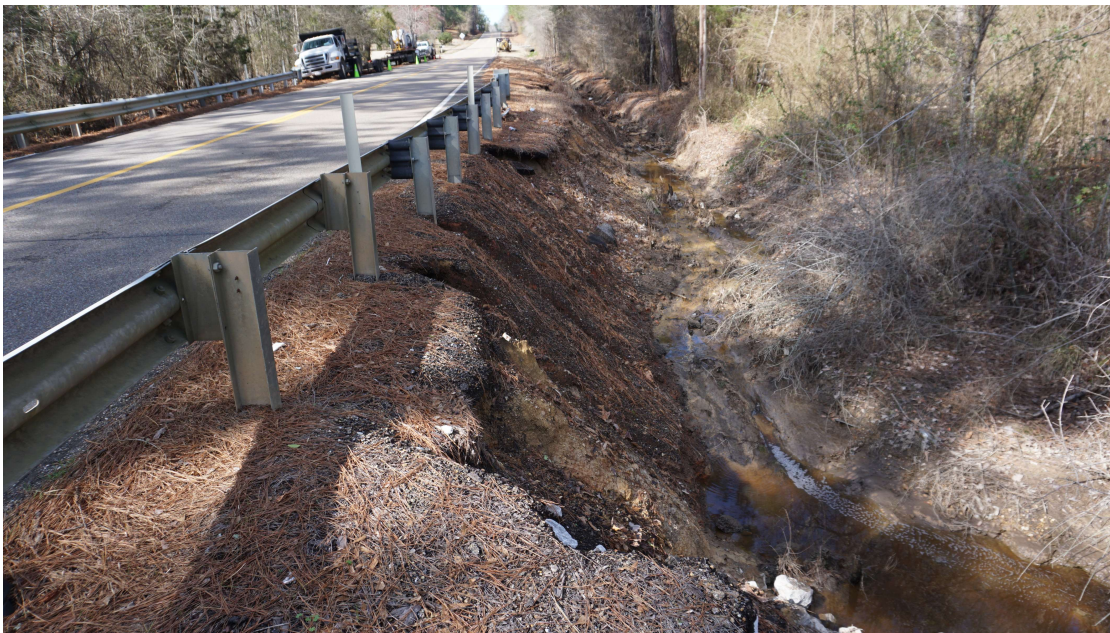
Description SHOULDER EROSION AT NW GUARDRAIL 20' X 10'.

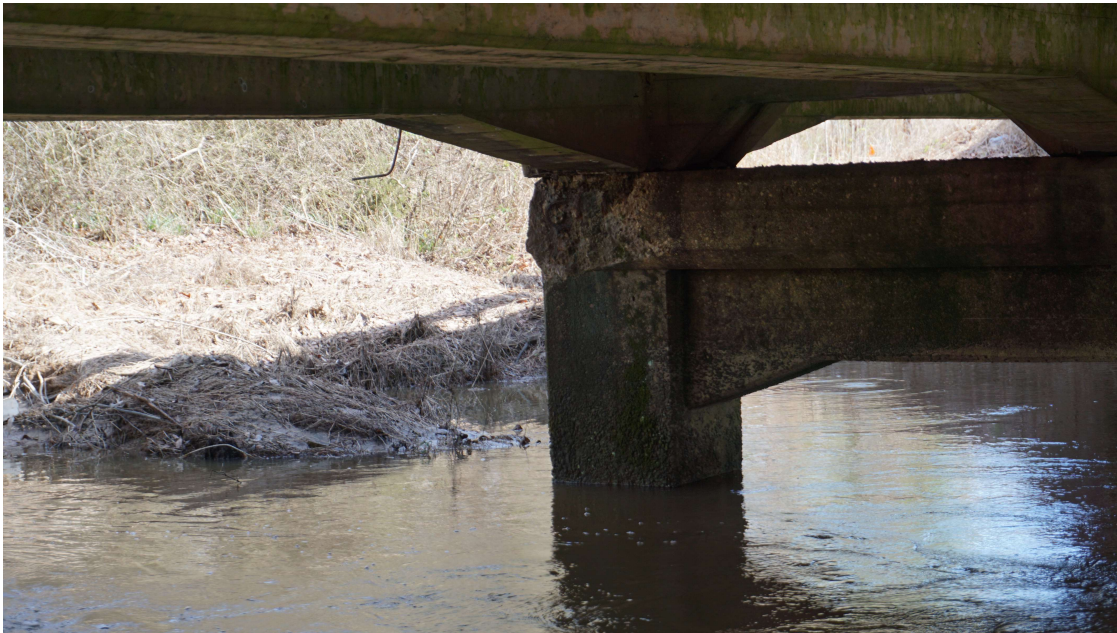
- 1.VC'S AT ABUTMENT ENDS, BENTS 1 AND 3, 2 EACH.
- 2.SPALL AT FACE OF CAP AT BENT 2, SPAN 1 UNDER BEAM 1, EXP REINF, 50% BEARING.
- 3.ABUTMENT AT B-3 HAS A SPALL AT NE CORNER, 1' X 1'.
- 4.HORIZONTAL CRACK AT FACE OF CAP AT BENT 2, LENGTH OF CAP.
- 5.SHOULDER EROSION AT NW GUARDRAIL 20'X10'.

PHOTO 8 Substructure
Description SPALL AT FACE OF CAP AT BENT 2, SPALL AT NE CORNER.

Monitor areas of potential bearing loss.

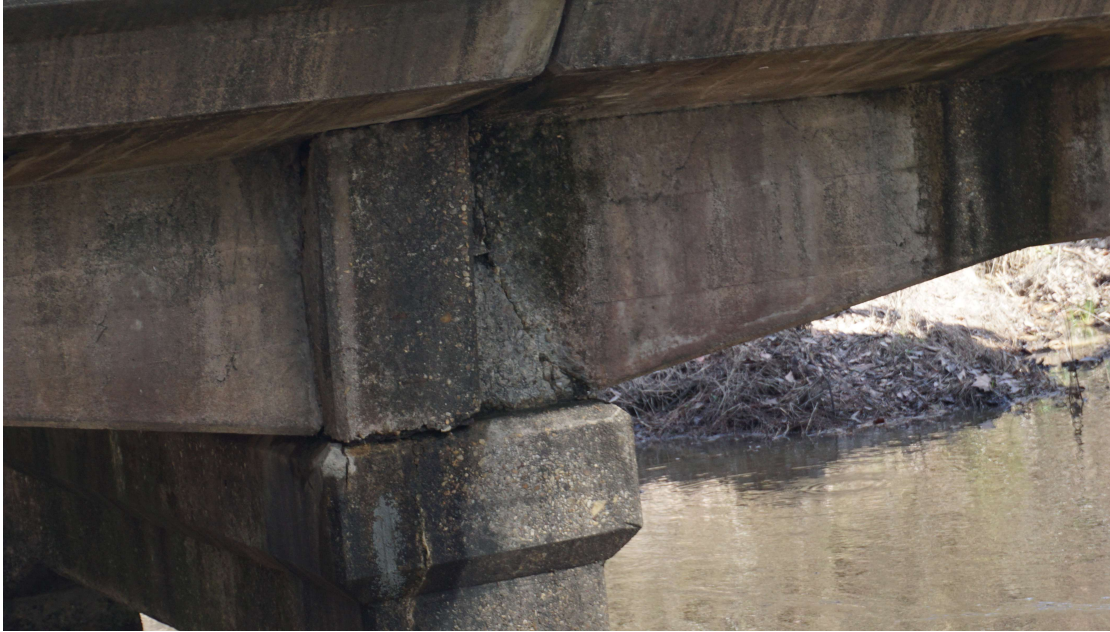
Description VC'S AT ABUTMENT ENDS, BENTS 1 AND 3.

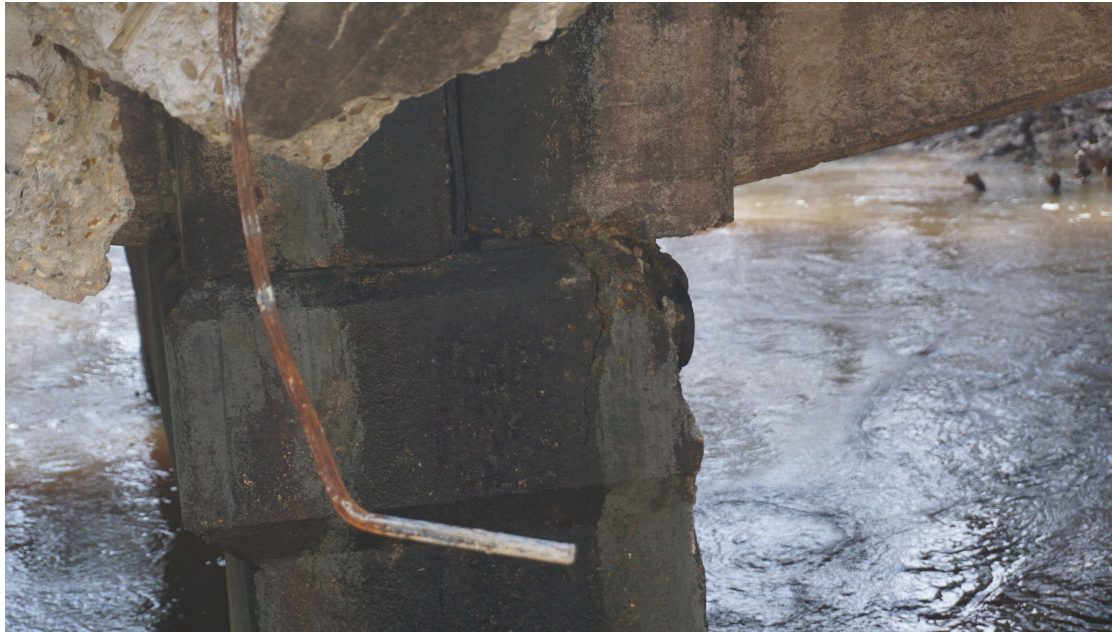
Description SPALL AT FACE OF CAP AT BENT 2, SPAN 1 UNDER BEAM 1.
