Bridge Inspection Report

US 80

TURKEY CREEK

- INSPECTION DATE
02/14/2023
- STRUCTURE NUMBER
210008005111170
- BRIDGE ID
13534

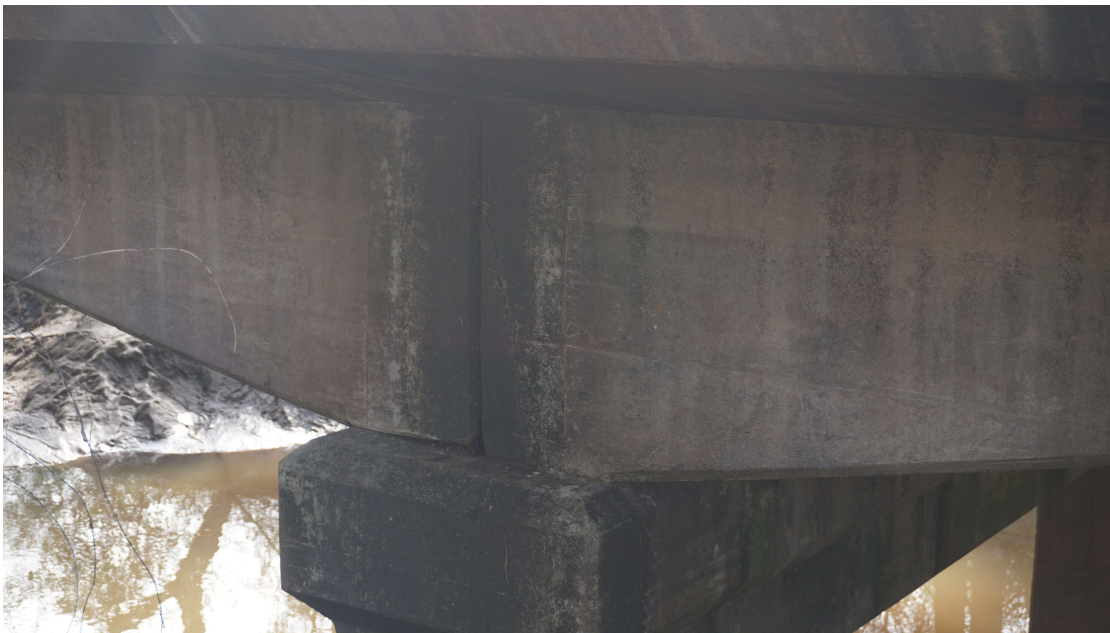
- 1.VC'S AT R/C BEAMS LIGHT
- 2.SPAN 1 BENT 2 BEAM 1 AND 3 VC AT THE BACK END OF BEAM,
- 3.SPAN 2 BENT 3 BEAM 1
- 4.SPAN 3 BENT 4 BEAM 1AND 2
- 5.SPAN 4 BENT 5 BEAM1 AND 2
- 6.SPAN 5 BENT 5 BEAM 1 AND 3
- 7.SPAN 6 BENT 7 BEAM 1
- 8.SPAN 6 BENT 6 BEAM 3
- 9SPAN 7 BENT 7 BEAM 3
- 19.B-7 SPAN 7 AT BEAM 1 2'X4" EXP REINF.

PHOTO 4 Superstructure

Description SPAN 1 BENT VC AT THE BACK END OF BEAM.

- 1. Monitor and measure beams ends for any bearing loss.
- 2. Clean and patch Concrete Spalls

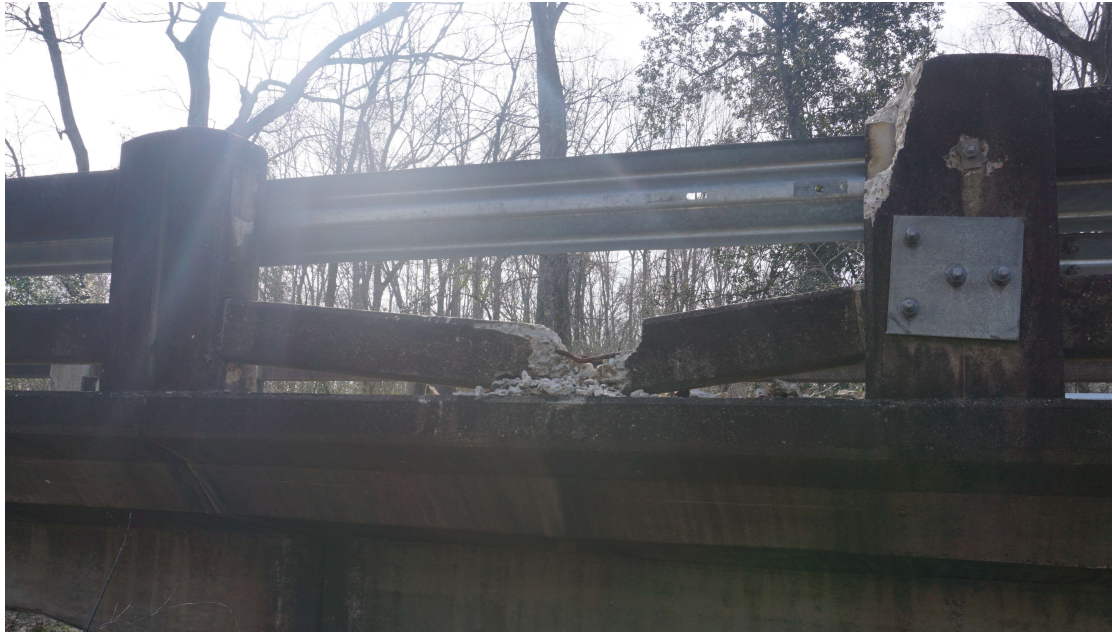
- 1.LIGHT DECK SCALING AND CRACKING
- 2.ASPHALT OVERLAY AT SPAN 7,1"FAILING PATCHED AREAS.
- 3.REPAIR FAILING AT BRIDGE RAIL AT B-3,SOUTH SIDE.
- 4.DECK REPAIR FAILED AT SPAN 3 18'X6" 24'X20' TOTAL.
- 5 BRIDGERAIL DAMAGE AT SPAN 6 NORTH SIDE 15'
- 6.BRIDGERAIL DAMAGE SPAN 1 NORTH SIDE 10' PATCHED WITH GUARDRAIL

PHOTO 5 Deck

Description BRIDGERAIL DAMAGE SPAN 1 NORTH SIDE PATCHED WITH GUARDRAIL

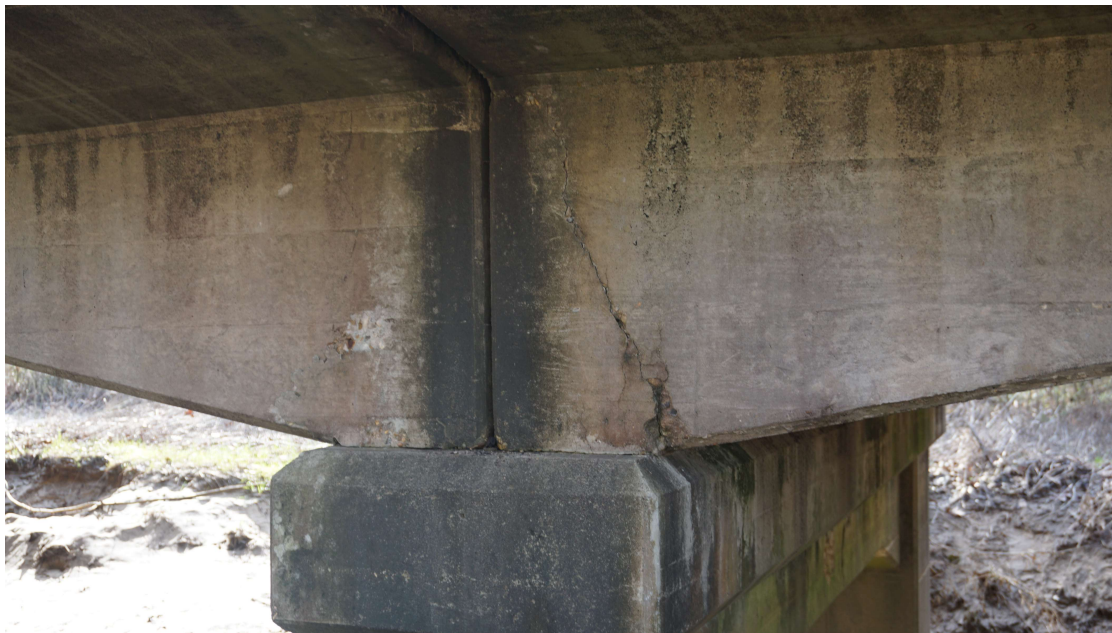
PHOTO 6 Superstructure

Description SPAN 2 BENT 2 BEAM 1.

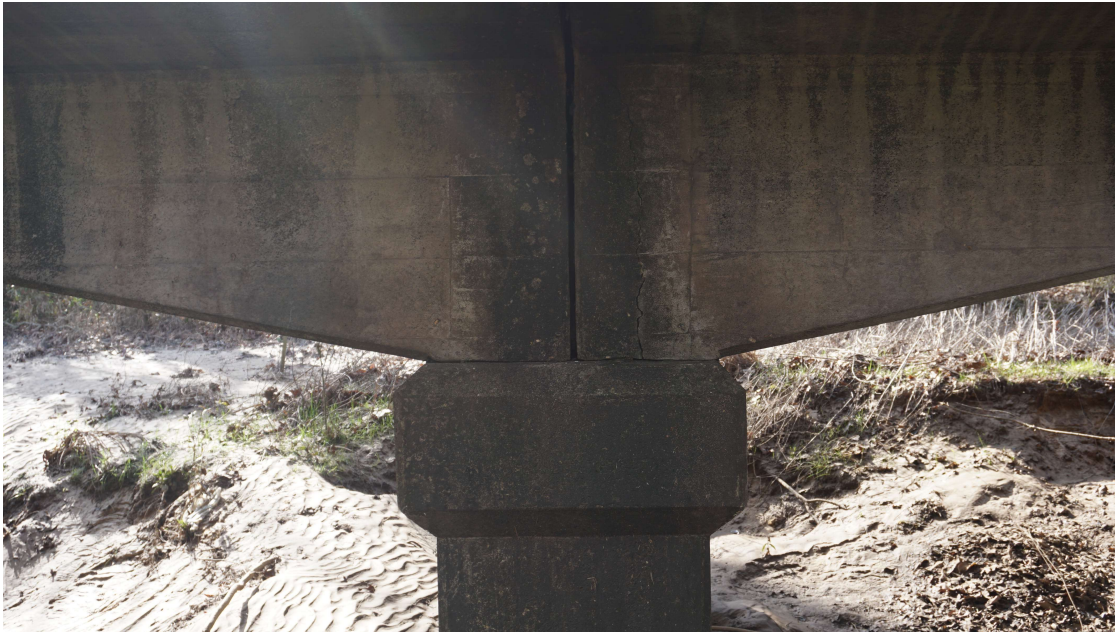
PHOTO 7 Superstructure
Description SPAN 3 BENT 4 BEAM 1 AND 2.

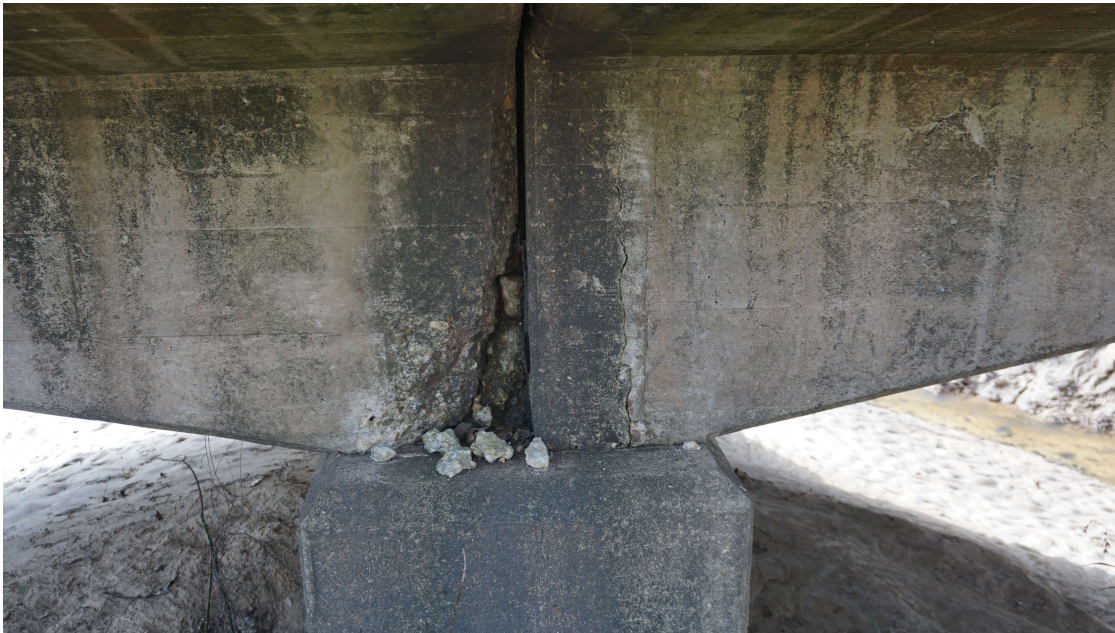
PHOTO 8 Superstructure
Description SPAN 5 BENT 5 BEAM 1 AND 2.

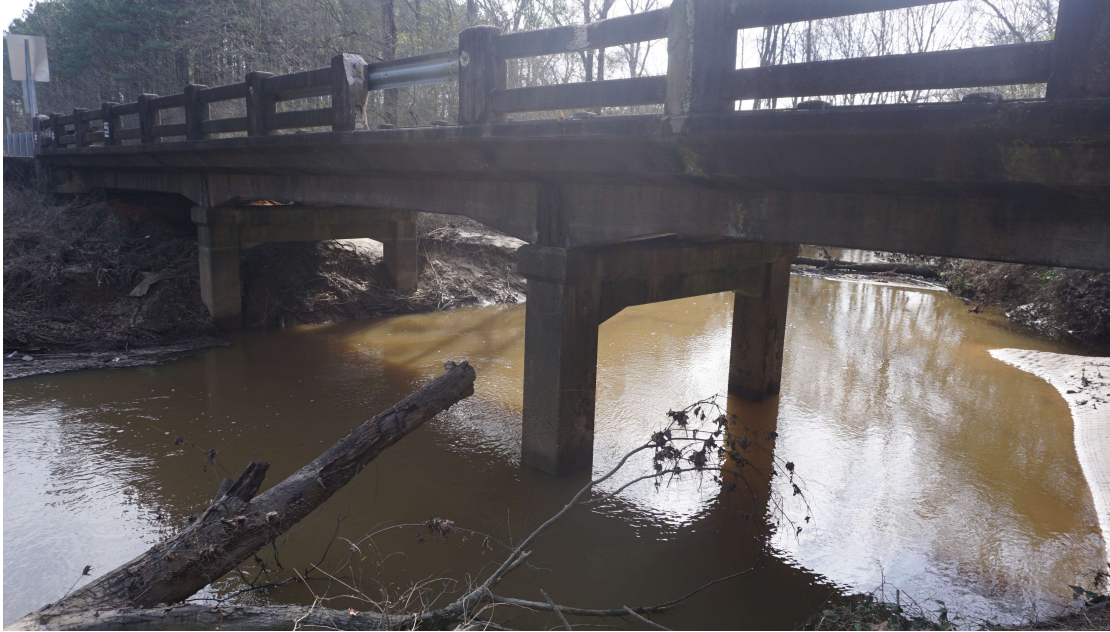
- 1.MOD SCOUR AT BENTS 2 AND 3
- 2.MOD SCOUR AT BOTH BANKS

PHOTO 9 General, Substructure, Channel

Description DS

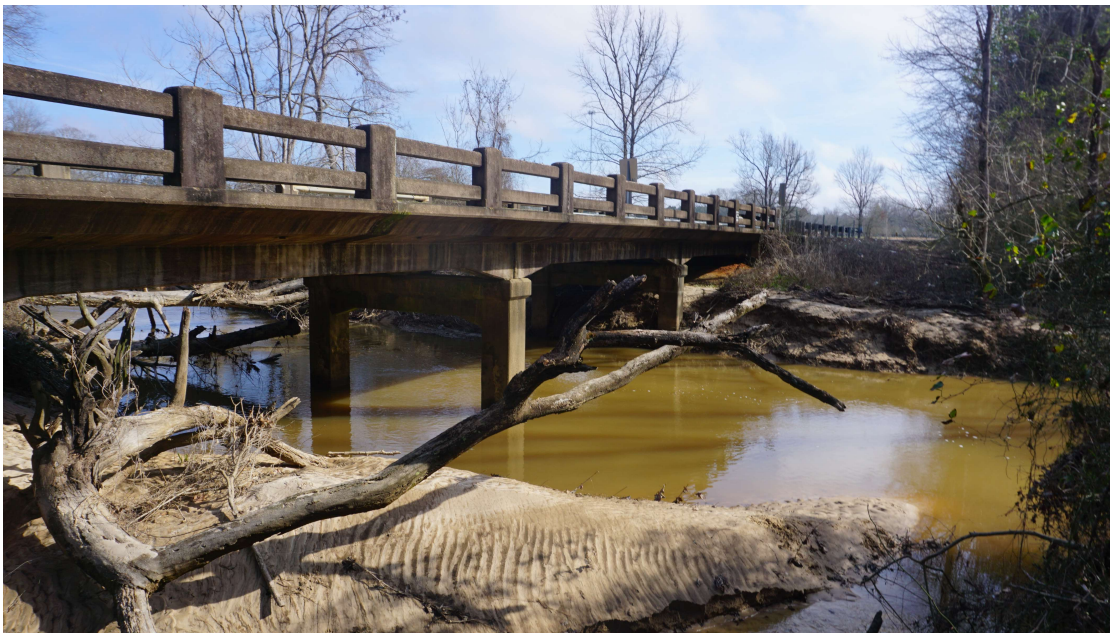
PHOTO 10 General, Substructure, Channel

Description US

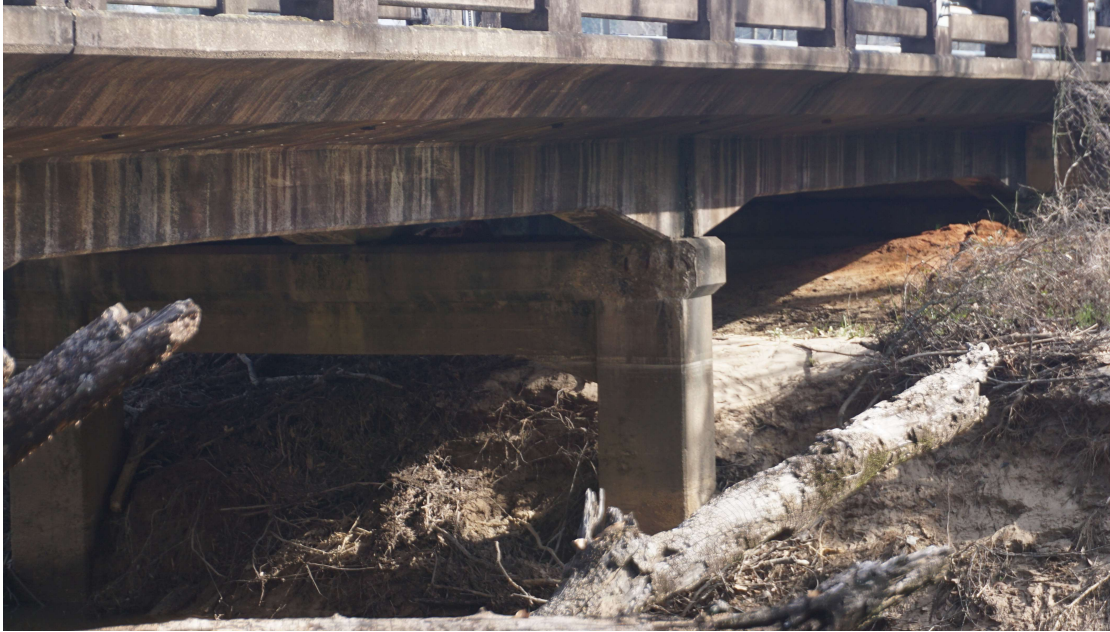
- 1 SPALL AT FACE OF CAP AT SPAN 6 BENT 7 UNDER BEAM 3 3'X2'
- 2 SPALL AT FACE OF CAP AT SPAN 3 BENT 4 UNDER BEAM 3 2'X6"
- 3 SPALL AT FACE OF CAP AT SPAN 2 BENT 3 UNDER BEAM 2,1'X1'
- 4 SPALL IN FACE OF CAP BENT 5 SPAN 6 1'X1'

PHOTO 11 Substructure

Description SPAL AT FACE OF CAP AT SPAN 6 BENT 7

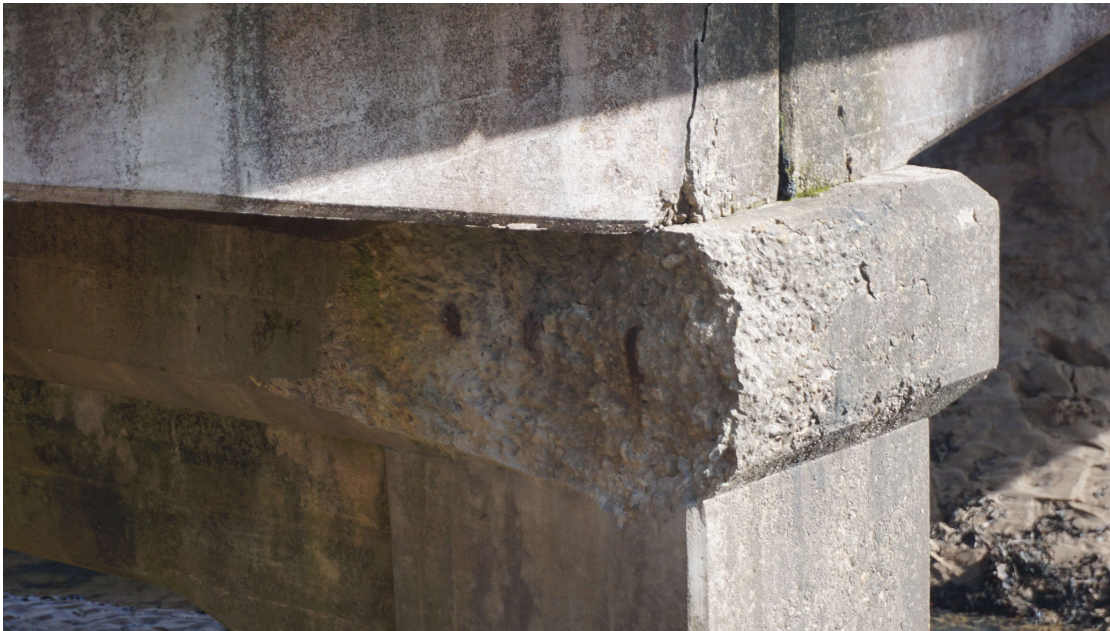
PHOTO 12 Substructure

Description SPALL AT GACE OF CAP AT SPAN 3 BENT 4 UNDER BEAM 3.

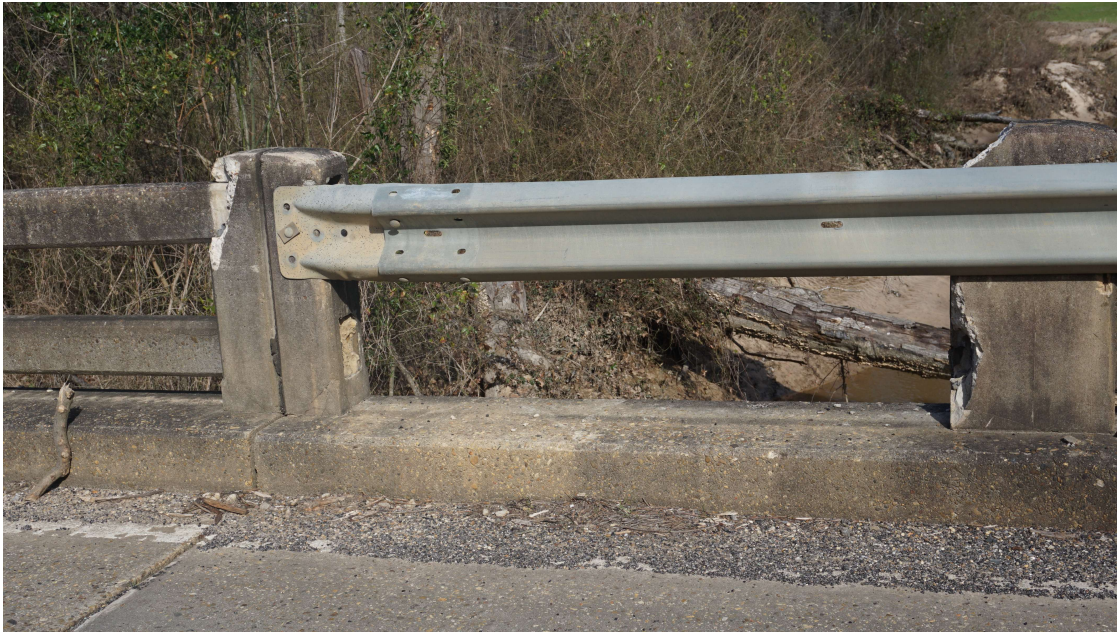
PHOTO 13 Deck
Description BRIDGERAIL DAMAGE AT SPAN 6 NORTH SIDE.
