Bridge Inspection Report

US 51

MADISON County

- INSPECTION DATE
04/12/2023
- STRUCTURE NUMBER
210005104513040
- BRIDGE ID
13025

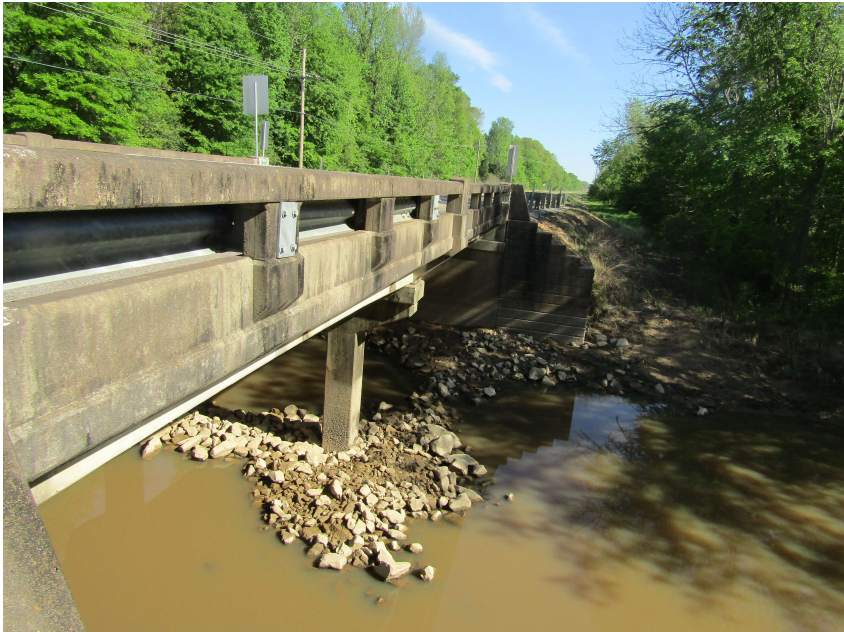
PHOTO 1 General
Description ELEV E

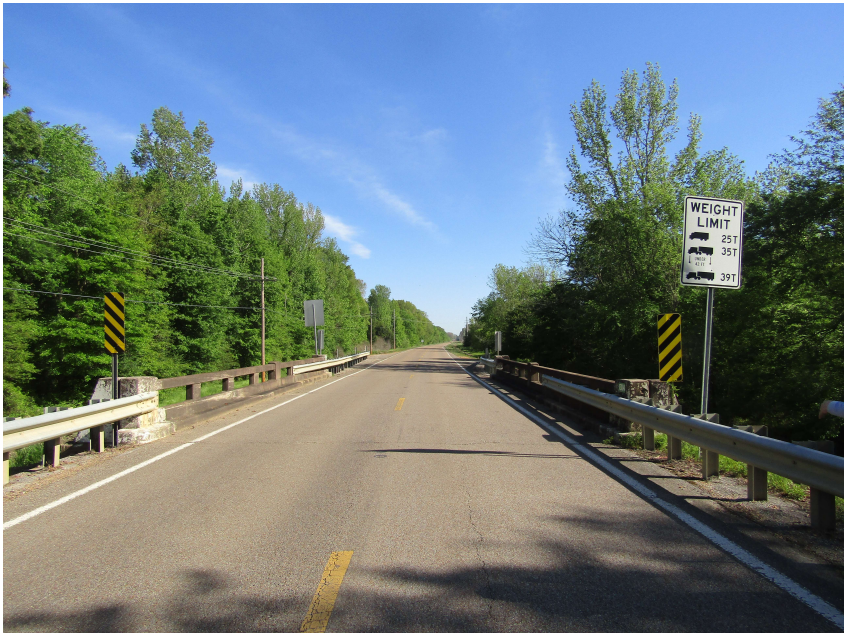
PHOTO 2 General
Description CL NB

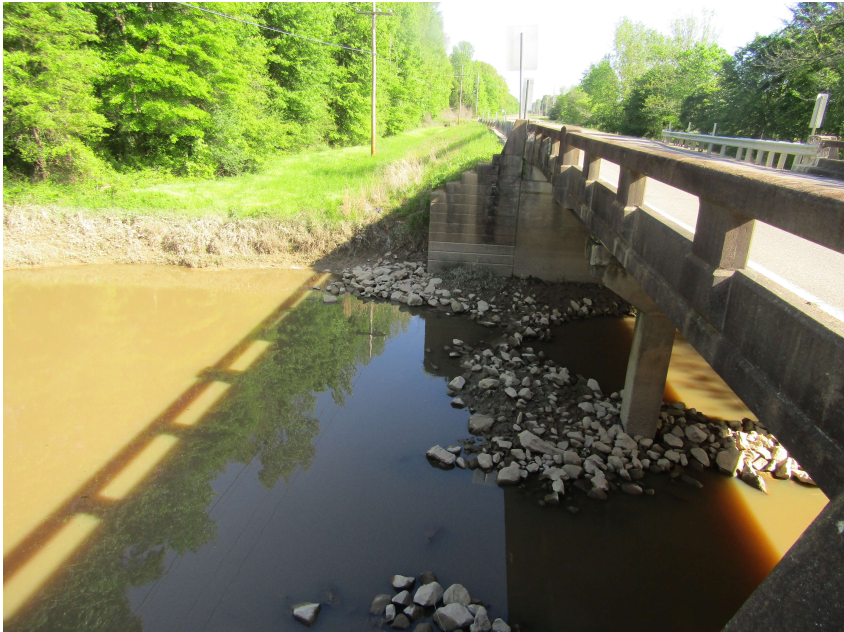
PHOTO 3 General
Description ELEV W

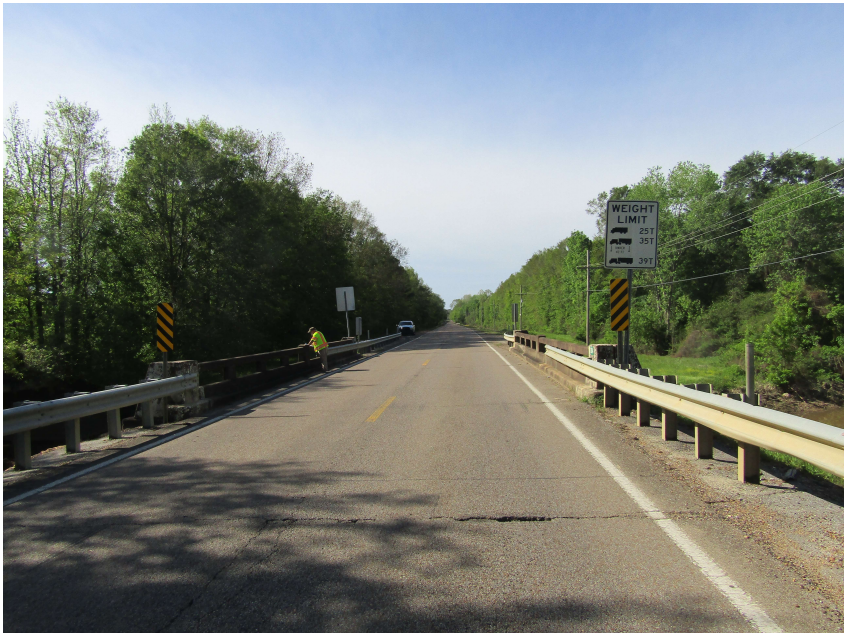
PHOTO 4 General
Description CL SB

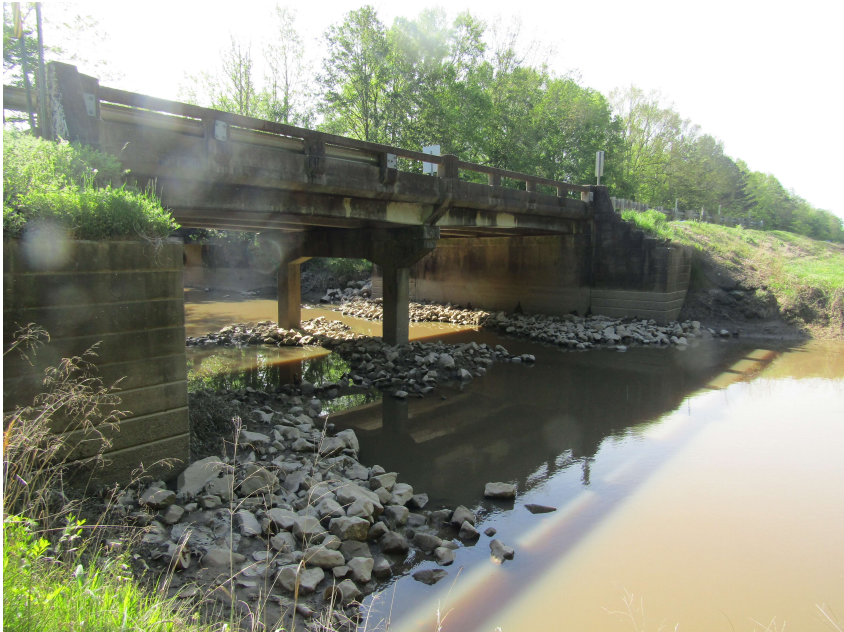
PHOTO 5 General
 Description US

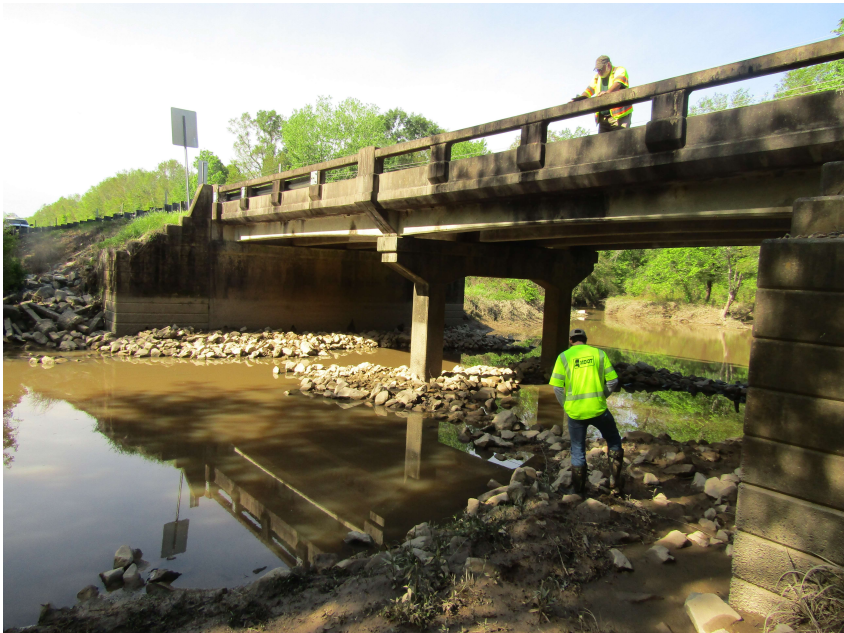
PHOTO 6 General
 Description DS

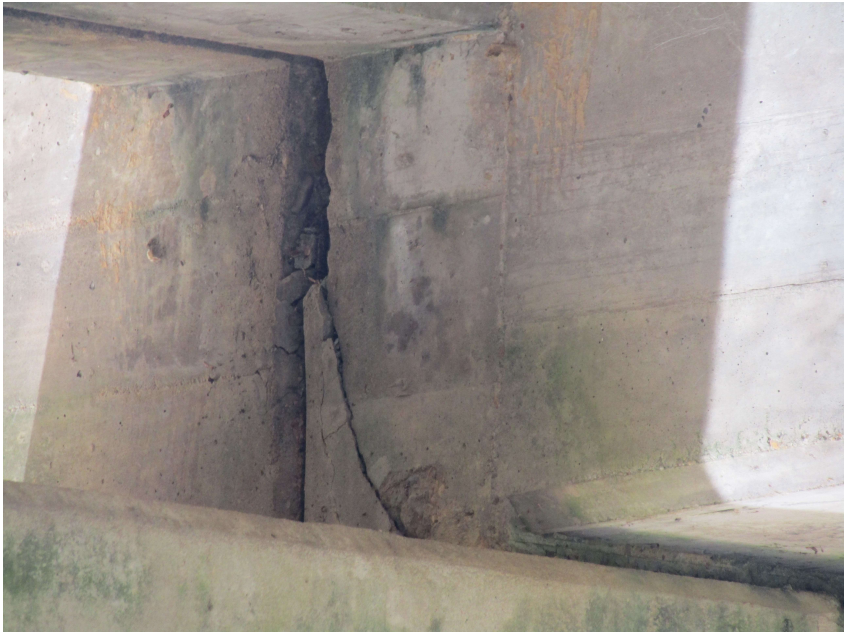
<u>Condition</u>	<u>Notes</u>
Girders:	Good	BACK OF BEAM 2 BENT SPALLED ,LIGHT CRACKING AT BEAMS 1 AT BENT 2 SPAN 1 AND 3BEAM 3 AT BENT 2 SPAN 1
Floor Beams:	NA	
Stringers:	NA	
Steel Risers:	NA	
Bearings:	NA	
Hinge Pins/Hangers:	NA	
Diaphragms/Cross Frames:	Good	DROP SLAB SPALLED AT BAY 2 BENT 2 WITH EXPOSED REBAR
Paint:	NA	
Collision Damage:	NA	
Deflection/Vibration:	Good	
Cap/Girder Debris:	Good	
Navigation Lighting:	NA

PHOTO 7 General
Description BACK OF BEAM END SPALLED

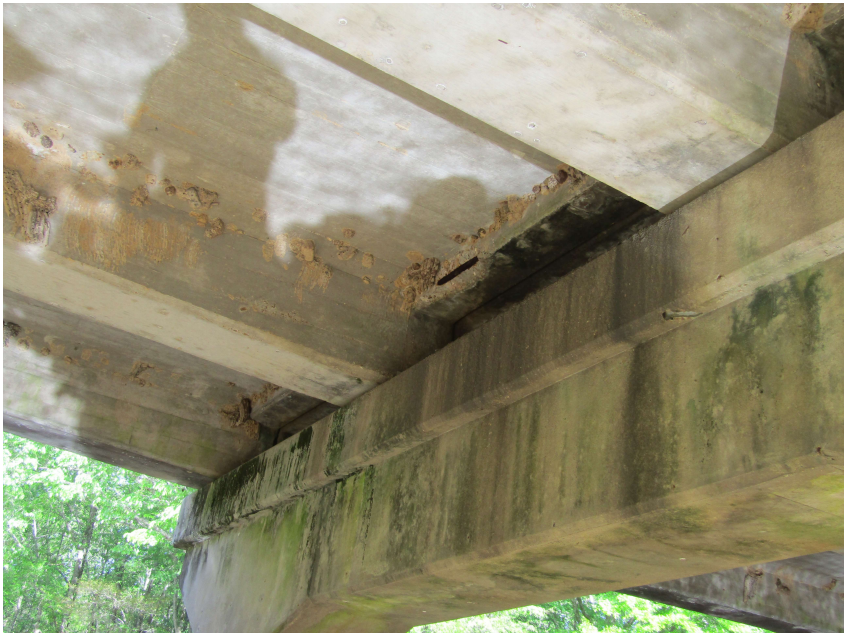
2.CONC. DROP SLAB SPALLED AT BAY 2 WITH EXP. REBAR.

PHOTO 8 General
Description DROP SLAB SPALLED
